Inspection Report

| Site; Tye Lane<br>Place: Warblington | | Division:<br>District: S.W<br>Tape No: 1 | | Start MH: \$11.1<br>End MH: LAT 1<br>Total Length: | |
| Purpose:<br>Use:<br>Catchment: | Structural Defects<br>STORM<br>P1 Schedule | Size/Shape: Circular dia 100mm<br>Material: PLASTIC<br>Lining:<br>Category: | | | |

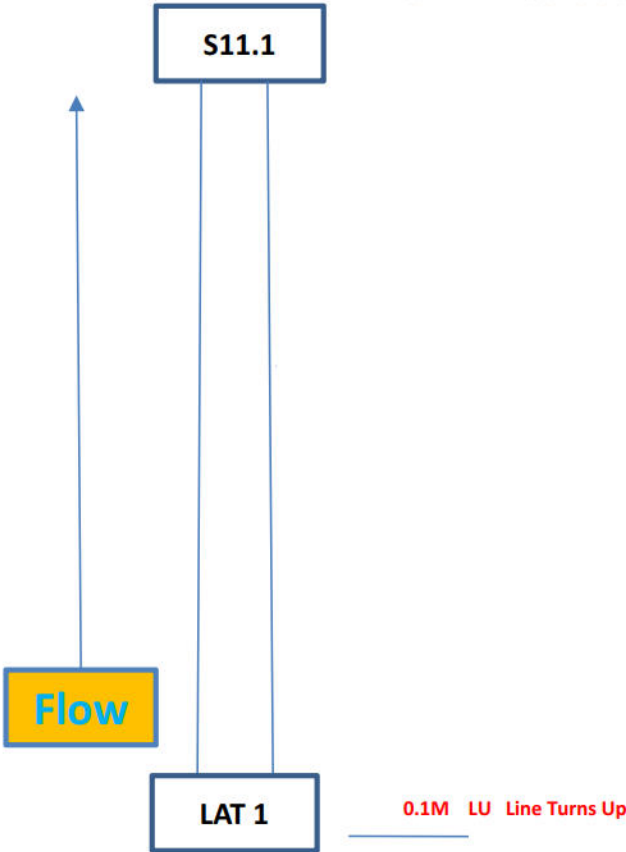
0.0M ST Start Of Survey  
0.0M WL Water Level 0%

REM ; THERE ARE NO DEFECTS IN THIS SECTION OF PIPE
