Inspection Report

| Site; Tye Lane<br>Place: Warblington | | Division:<br>District: S.W<br>Tape No: 1 | | Start MH: S11.1<br>End MH: LAT 2<br>Total Length: | |
| Purpose:<br>Use:<br>Catchment: | Structural Defects<br>STORM<br>P1 Schedule | Size/Shape: Circular dia 100mm<br>Material: PLASTIC<br>Lining:<br>Category: | | | |

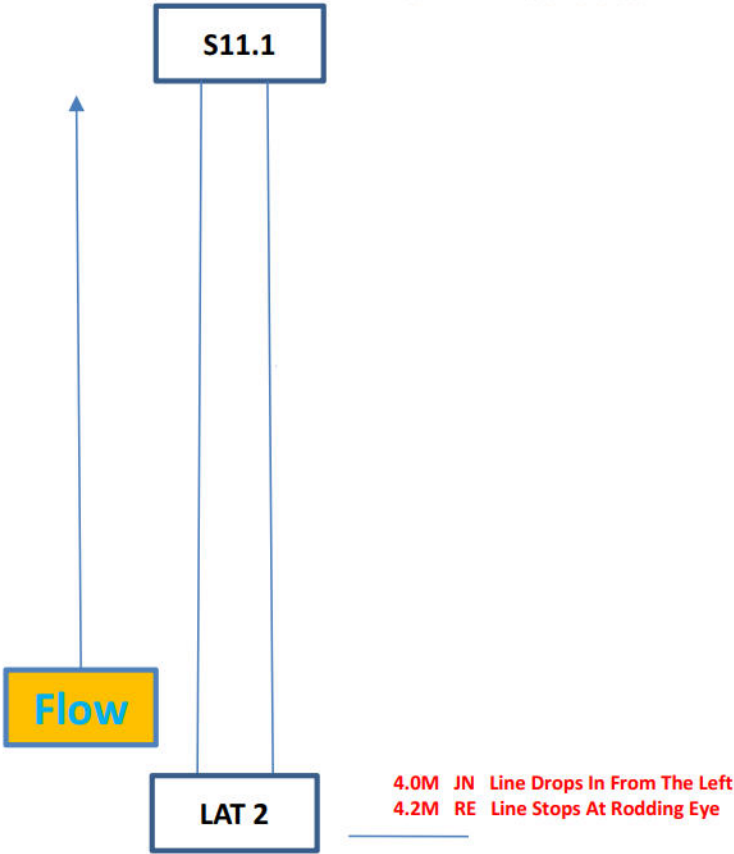
REM ; THERE ARE NO DEFECTS IN THIS SECTION OF PIPE
