Inspection Report

| Site; Tye Lane<br>Place: Warblington | | Division:<br>District: S.W<br>Tape No: 1 | | Start MH: S14<br>End MH: S15<br>Total Length: | |
| Purpose:<br>Use:<br>Catchment: | Structural Defects<br>STORM<br>P1 Schedule | Size/Shape: Circular dia 375mm<br>Material: PLASTIC<br>Lining:<br>Category: | | | |

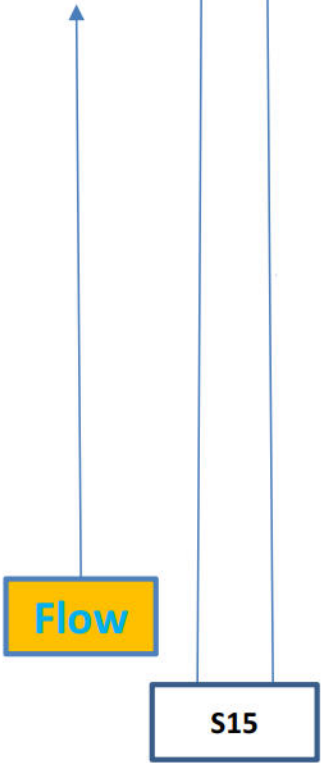
0.0M ST Start Of Survey  
0.0M WL Water Level 0%

8.2M JN Line Drops In From The Left From S 14.1

22.7M JN Line Drops In From The Left From S14.2

28.9M MH Camera Enters Manhole S15

REM ; THERE ARE NO DEFECTS IN THIS SECTION OF PIPE
