Inspection Report

| Site; Tye Lane<br>Place: Warblington | | Division:<br>District: S.W<br>Tape No: 1 | | Start MH: S14<br>End MH: S13<br>Total Length: | |
| Purpose:<br>Use:<br>Catchment: | Structural Defects<br>STORM<br>P1 Schedule | Size/Shape: Circular dia 375mm<br>Material: PLASTIC<br>Lining:<br>Category: | | | |

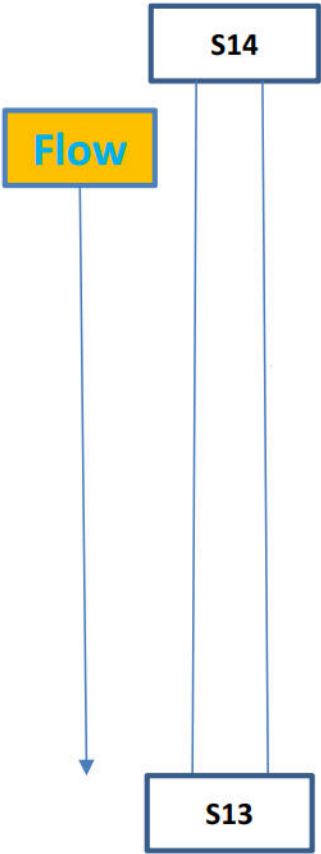
0.0M ST Start Of Survey  
0.0M WL Water Level 0%

5.0M JN Line Drops In From The Left

6.2M JN Line Drops In From The Right From S 13.1

11.0M D Debris In Line, Unable To Pass

REM ; THE MANHOLE S13 IS FULL OF DEBRIS AND THIS IS TOO LARGE FOR THE LORRY TO SUCK OUT, THIS WILL NEED CONFINED SPACE ENTRY TO DIG OUT THE MANHOLE, ALSO S 12 IS LOCATED ON THE VERGE AND UNABLE TO GET LORRY NEAR ENOUGH TO JET AND ROAD IS NOT IN YET TO JET FROM S11 UP TO S 12
