Inspection Report

| Site; Tye Lane<br>Place: Warblington | | Division:<br>District: S.W<br>Tape No: 1 | | Start MH: F31.2B<br>End MH: LAT 2<br>Total Length: | |
| Purpose:<br>Use:<br>Catchment: | Structural Defects<br>FOUL<br>P1 Schedule | Size/Shape: Circular dia 100mm<br>Material: PLASTIC<br>Lining:<br>Category: | | | |

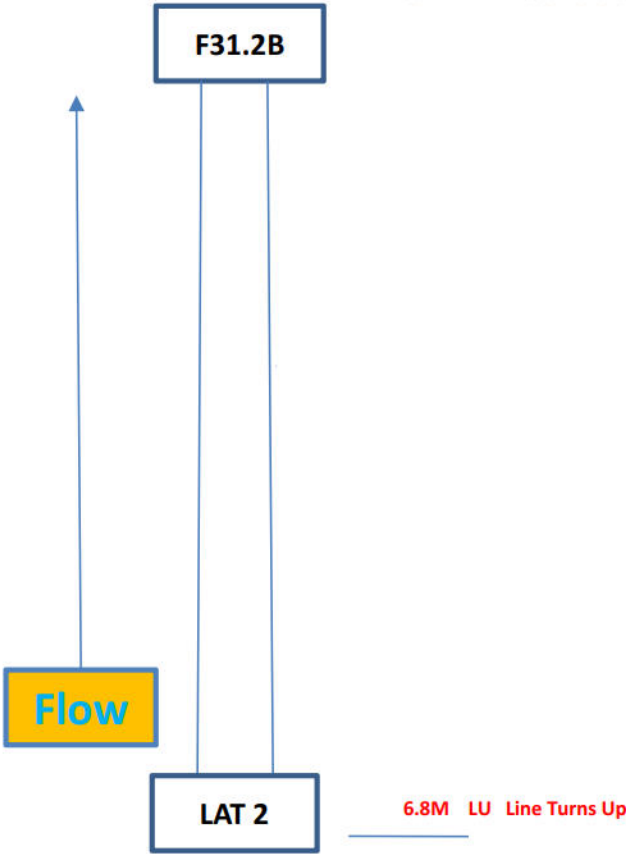
0.0M ST Start Of Survey  
0.0M WL Water Level 0%

REM ; THERE ARE NO DEFECTS WITH THIS SECTION OF PIPE
