Inspection Report

| Site; Tye Lane<br>Place: Warblington | | Division:<br>District: S.W<br>Tape No: 1 | | Start MH: F31.2B<br>End MH: F31.2<br>Total Length: | |
| Purpose:<br>Use:<br>Catchment: | Structural Defects<br>FOUL<br>P1 Schedule | Size/Shape: Circular dia 100mm<br>Material: PLASTIC<br>Lining:<br>Category: | | | |

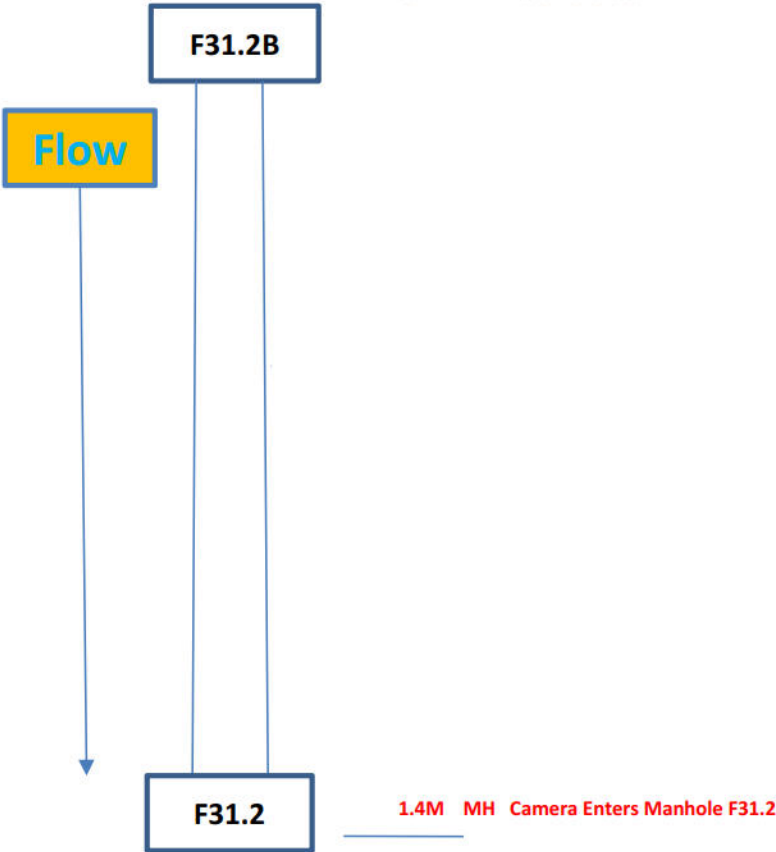
0.0M ST Start Of Survey  
0.0M WL Water Level 0%

REM ; THERE ARE NO DEFECTS WITH THIS SECTION OF PIPE
