Inspection Report

| Site: Tye Lane<br>Place: Warblington | | Division:<br>District: S.W<br>Tape No: 1 | | Start MH: F31.2<br>End MH: LAT 1<br>Total Length: | |
| Purpose:<br>Use:<br>Catchment: | Structural Defects<br>FOUL<br>P1 Schedule | Size/Shape: Circular dia 100mm<br>Material: PLASTIC<br>Lining:<br>Category: | | | |

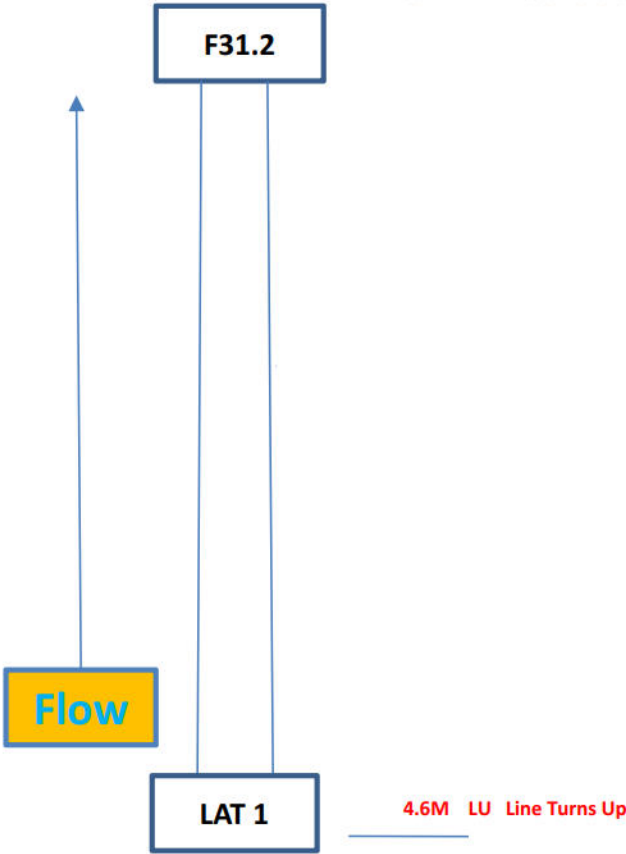
0.0M ST Start Of Survey  
0.0M WL Water Level 0%

REM ; THERE ARE NO DEFECTS WITH THIS SECTION OF PIPE
