Inspection Report

| Site; Tye Lane<br>Place: Warblington | | Division:<br>District: S.W<br>Tape No: 1 | | Start MH: F31.2<br>End MH: MAIN<br>Total Length: | |

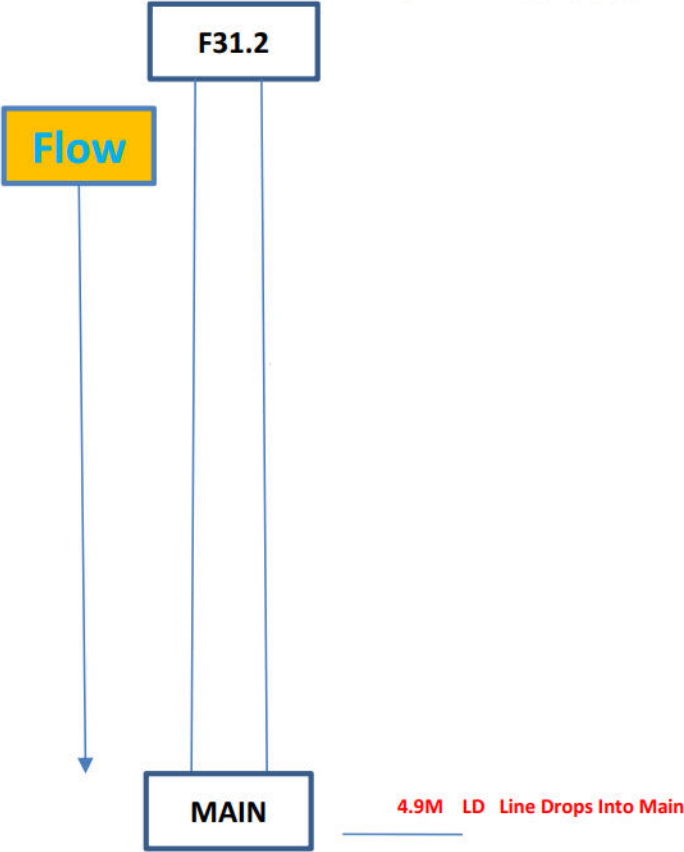
0.0M ST Start Of Survey  
0.0M WL Water Level 0%

REM ; THERE ARE NO DEFECTS WITH THIS SECTION OF PIPE
