Inspection Report

| Site; Tye Lane<br>Place: Walberton | | Division:<br>District: S.W<br>Tape No: 1 | | Start MH: FMH 39.1<br>End MH: FMH 39<br>Total Length: | |
| Purpose:<br>Use:<br>Catchment: | Structural Defects<br>FOUL<br>P1 Schedule | Size/Shape: Circular dia 100mm<br>Material: PLASTIC<br>Lining:<br>Category: | | | |

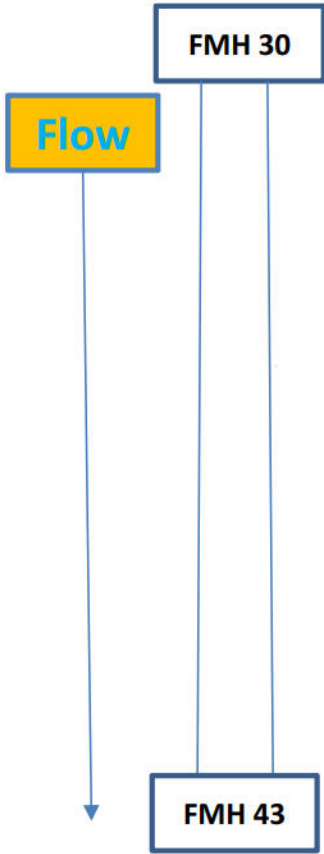
21.4M JN Line Drops In From The Right From F29.1

23.7M MH Camera Enters Manhole F 43

REM ; THERE ARE NO DEFECTS WITH THIS SECTION OF PIPE, MANHOLE F 29.1 IS BURIED UNDER A FLOWER BED SO UNABLE TO ACCESS TO CCTV

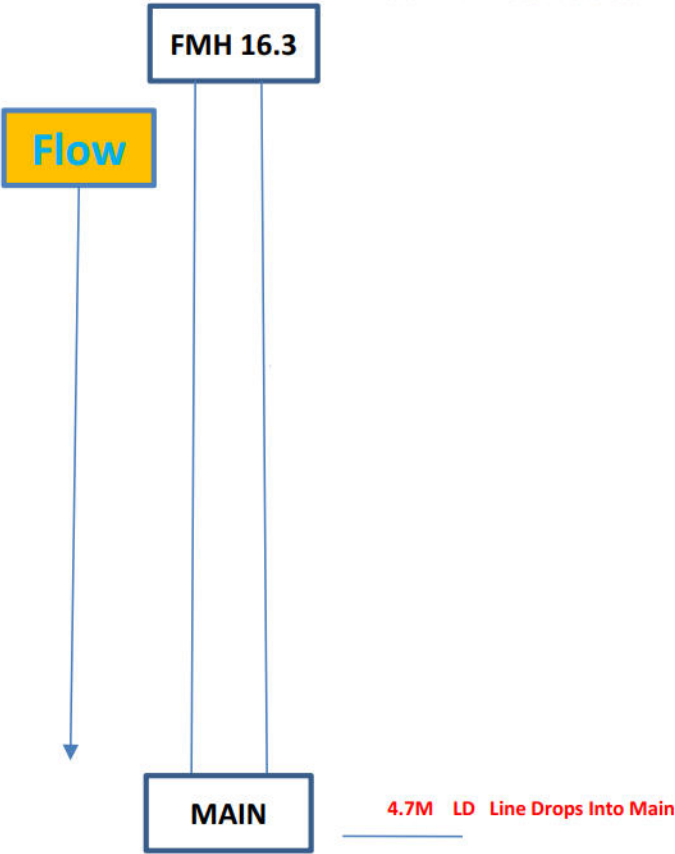
REM ; THERE ARE NO DEFECTS WITH THIS SECTION OF PIPE.  
MANHOLE F 16.1 HAS NOT BEEN INSTALLED YET AND MANHOLE F 16 HAS BEEN TARMAC OVER IN THE ROAD SO UNABLE TO JET AND CAMERA  
RUN FROM F 17 TO F 16

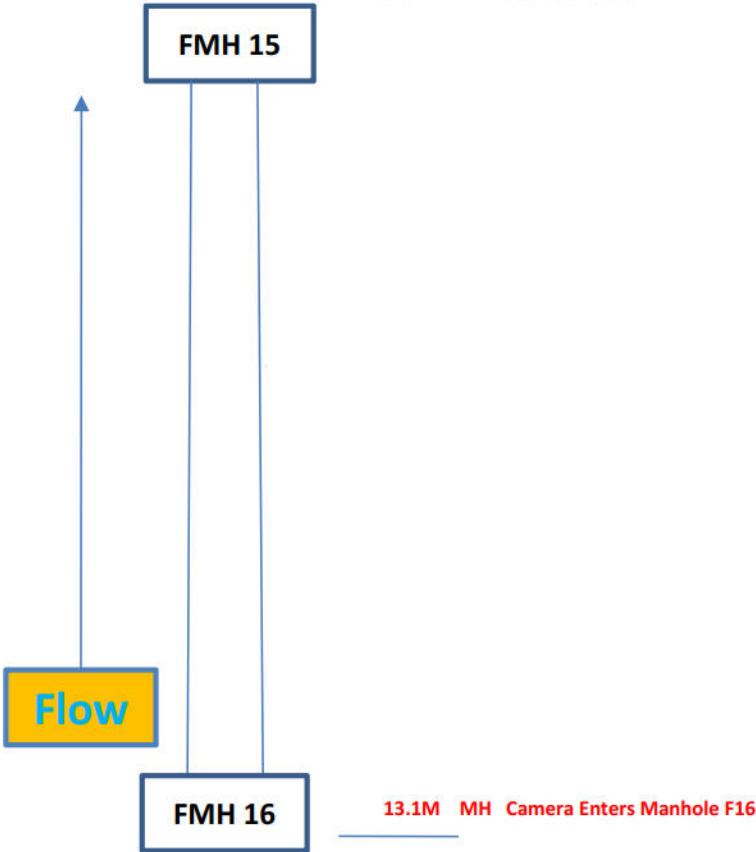
REM ; THERE ARE NO DEFECTS WITH THIS SECTION OF PIPE.  
MANHOLE F 16 IS COVERED OVER IN THE ROAD AND IS FULL OF TARMAC

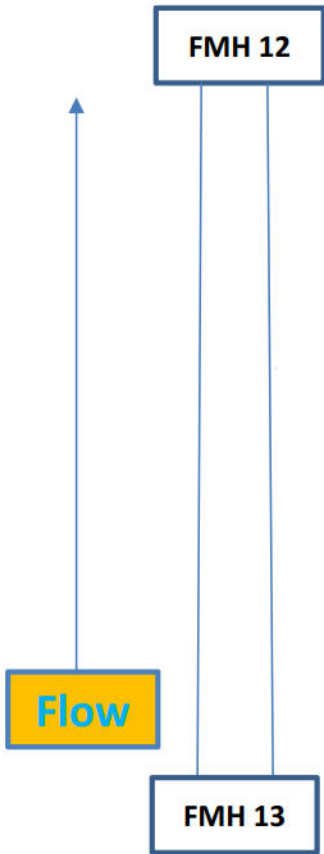
10.0M JN Line Drops In From Above From F 12.1

23.5M MH Camera Enters Manhole F 13

REM ; THERE ARE NO DEFECTS WITH THIS SECTION OF PIPE.  
MANHOLE F13 IS FULL OF BRICKS AND HARDCORE AND NEEDS CONFINED SPACE TO ENTER AND DIG OUT MANHOLE. MANHOLES F 13.8 -F13.7  
F 13.6 - F 13.5 - F13.4 - F13.3 AND F 12.1 HAVE NOT BEEN INSTALLED YET

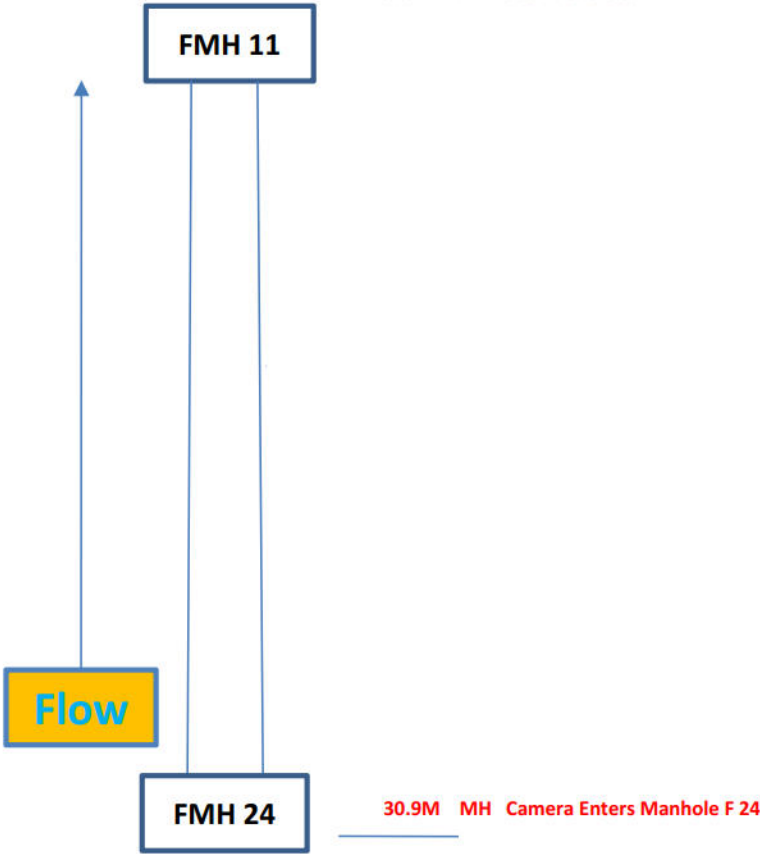
REM ; THERE ARE NO DEFECTS WITH THIS SECTION OF PIPE.  
MANHOLE F 24 IS COVERED OVER IN THE ROAD WITH TARMAC SO UNABLE TO LIFT, MANHOLE F 11.1 HAS NOT BEEN INSTALLED YET

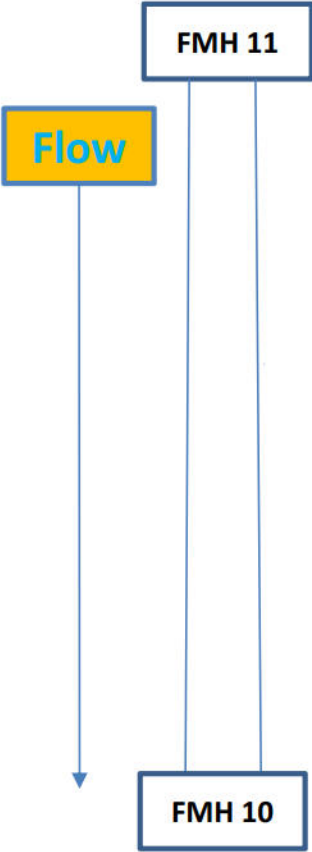
21.1M JN Line Drops In From Above From Manhole F 10.1

28.3M MH Camera Enters Manhole F 10

REM ; THERE ARE NO DEFECTS WITH THIS SECTION OF PIPE.  
MANHOLE F 10.1 HAS NOT BEEN INSTALLED YET

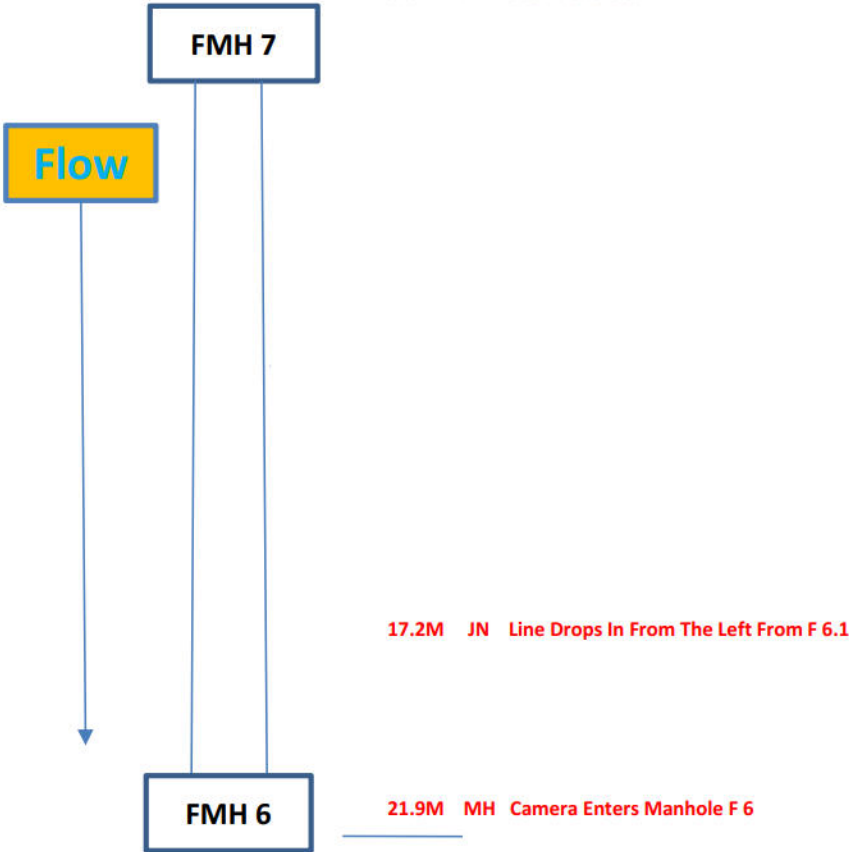
REM ; THERE ARE NO DEFECTS WITH THIS SECTION OF PIPE.  
MANHOLE F 6.1 HAS NOT BEEN INSTALLED YET

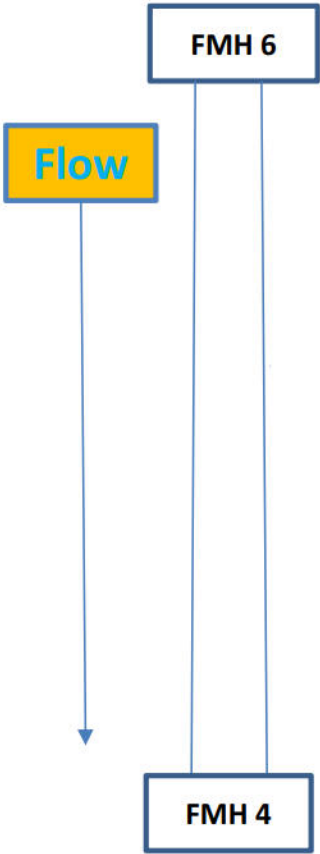
20.0M JN Line Drops In From The Left From F 5.1

33.9M MH Camera Enters Manhole F 4

REM ; THERE ARE NO DEFECTS WITH THIS SECTION OF PIPE.  
MANHOLE F 5.1 & F 5.2 HAVE NOT BEEN INSTALLED YET

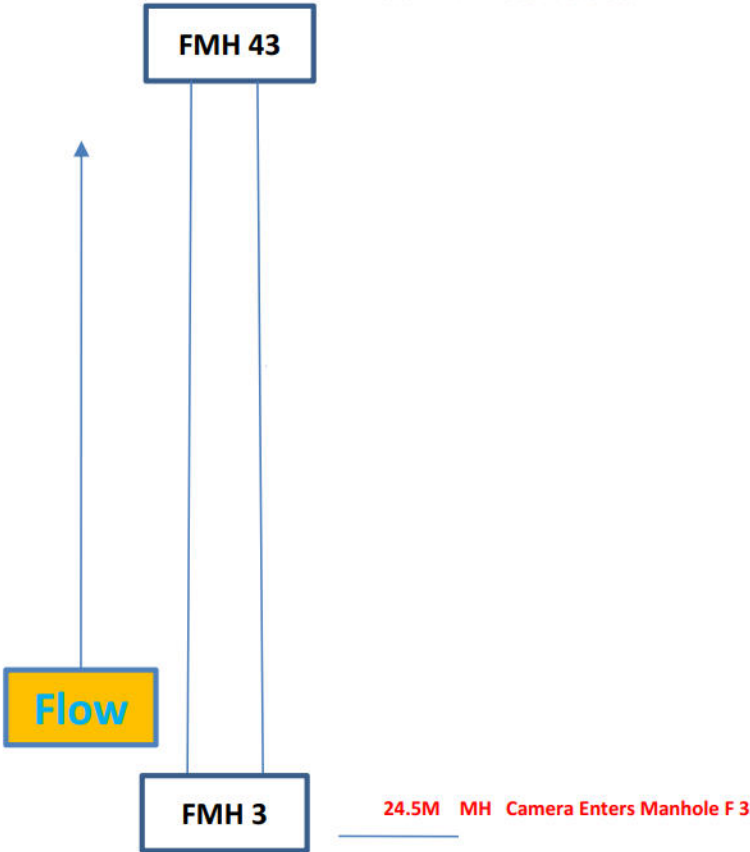
REM ; THERE ARE NO DEFECTS WITH THIS SECTION OF PIPE  
MANHOLE FMH 45 HAS A LARGE PILE ON SAND ON IT SO UNABLE TO ACCESS MANHOLE AND ALSO THE LINE FROM FMH 45 TO FMH 3 IS COMPLETELY BLOCKED WITH CONCRETE WHICH WE ARE UNABLE TO REMOVE WITH THE JETTER SO WILL NEED CONFINED SPACE ENTRY TO TRY AND BREAK IT OUT OF THE LINE
