**1. MASTER CONTROL PAGE (ASBESTOS SURVEY)**

| Original Survey Type & Date: | Asbestos Demolition Survey - Tuesday 7 <sup>th</sup> May 2019 & Wednesday 8 <sup>th</sup> May 2019 |

| 1 | Site Location | Stakers Farm, North End Road, Yapton, Arundel, BN18 0DU, United Kingdom |

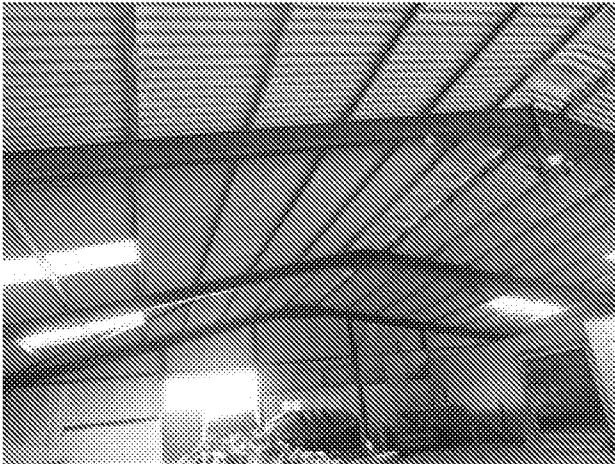
**Finding Code:** 07052019PGJA002

| Item | Extent | Material Details | Recommendations | References |
|---|---|---|---|---|
| Internal<br>Roof<br>Agricultural Shed.<br>Ceiling/Roof Sheets<br>Cement Sheets | 400m2 | Chrysotile (white asbestos); Cement products<br><br>Asbestos composites (Artex, floor tiles, cement etc.); Enclosed sprays, lagging & AIB, asbestos cement; Good condition: no visible damage; Exposed overall, but above head height; | Recommendation: Remove<br><br>Specific Comment: Remove item prior to Demolition Works commencing | Finding: 07052019PGJA002<br>Sample: A/002/07052019/PGJ<br>Algorithm Score: 3<br><br>Potential for Fibre Release: Very low risk |

| <b>Floor:</b> | Roof | Internal |
| <b>Area:</b> | Agricultural Shed | |

MC: 0. Good condition: no visible damage

### Recommendation

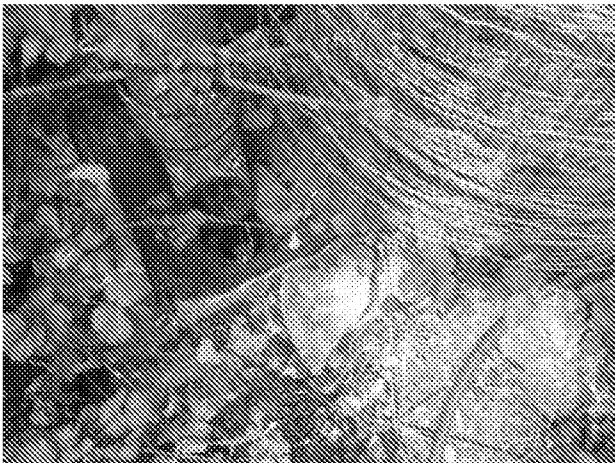
**Finding Code:** 07052019PGJA006

| Item | Extent | Material Details | Recommendations | References |
|---|---|---|---|---|
| External<br>Ground Floor<br>Agricultural Shed. Loose on Floor by South-East Corner<br>Cement Pipe Debris | 1 Qty | Chrysotile (white asbestos); Cement products<br><br>Asbestos composites (Artex, floor tiles, cement etc.); Enclosed sprays, lagging & AIB, asbestos cement; High Damage or Delamination of Materials: visible Debris; Easily accessed, below head height; | Recommendation: Remove<br><br>Specific Comment: Remove item prior to Demolition Works commencing | Finding: 07052019PGJA006<br>Sample: A/006/07052019/PGJ<br>Algorithm Score: 6<br><br>Potential for Fibre Release: Low risk |

| <b>Floor:</b> | Ground Floor | External |
| <b>Area:</b> | Agricultural Shed | |
| <b>Location:</b> | Loose on Floor by South-East Corner | |

MC: 3. High Damage or Delamination of Materials: visible Deb

### Recommendation

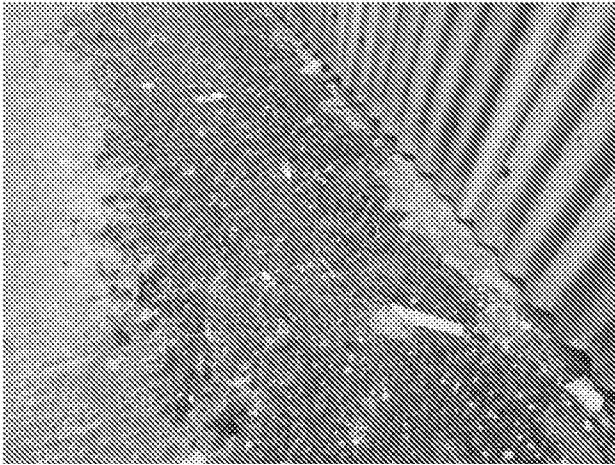
**Finding Code:** 07052019PGJA007

| Item | Extent | Material Details | Recommendations | References |
|---|---|---|---|---|
| External<br>Ground Floor<br>In Front of Agricultural<br>Shed.<br>Loose on Floor by Out of<br>Scope Unit<br>Cement Debris | 5m2 | Chrysotile (white asbestos); Cement products<br><br>Asbestos composites (Artex, floor tiles, cement etc.); Enclosed sprays, lagging & AIB,<br>asbestos cement; High Damage or Delamination of Materials: visible Debris; Easily<br>accessed, below head height; | Recommendation: Remove<br><br>Specific Comment: Remove<br>item prior to Demolition<br>Works commencing | Finding: 07052019PGJA007<br>Sample: A/007/07052019/PGJ<br>Algorithm Score: 6<br><br>Potential for Fibre Release:<br>Low risk |

| <b>Floor:</b> | Ground Floor | External |
| <b>Area:</b> | In Front of Agricultural Shed | |
| <b>Location:</b> | Loose on Floor by All of Scope Unit | |

PT: 1. Asbestos composites (Artex, floor tiles, cement etc.)  
MC: 3. High Damage or Delamination of Materials: visible Deb  
ST: 1. Enclosed sprays, lagging & AIB, asbestos cement

### Recommendation

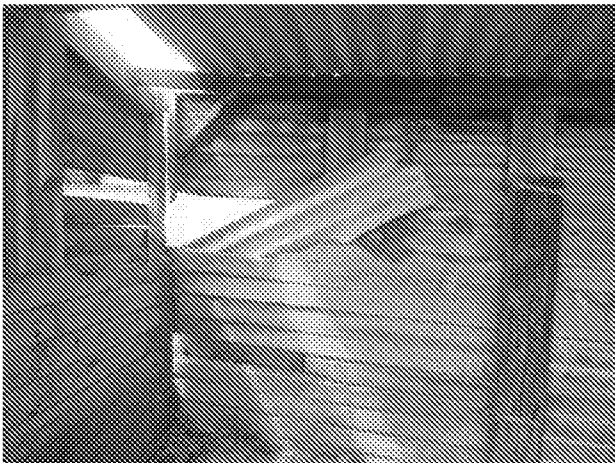
**Finding Code:** 07052019PGJA008

| Item | Extent | Material Details | Recommendations | References |
|---|---|---|---|---|
| Internal<br>Ground Floor<br>Feeding Shed.<br>Ceiling/Roof Sheets<br>Cement Sheets | 20m2 | Chrysotile (white asbestos); Cement products<br><br>Asbestos composites (Artex, floor tiles, cement etc.); Enclosed sprays, lagging & AIB, asbestos cement; Good condition: no visible damage; Exposed overall, but above head height; | Recommendation: Remove<br><br>Specific Comment: Remove item prior to Demolition Works commencing | Finding: 07052019PGJA009<br>Sample: A/009/07052019/PGJ<br>Algorithm Score: 3<br><br>Potential for Fibre Release: Very low risk |

| <b>Floor:</b> | Ground Floor | Internal |
| <b>Area:</b> | Feeding Shed | |

PT: 1. Asbestos composites (Artex, floor tiles, cement etc.)  
MC: 0. Good condition: no visible damage  
ST: 1. Enclosed sprays, lagging & AIB, asbestos cement

### Recommendation

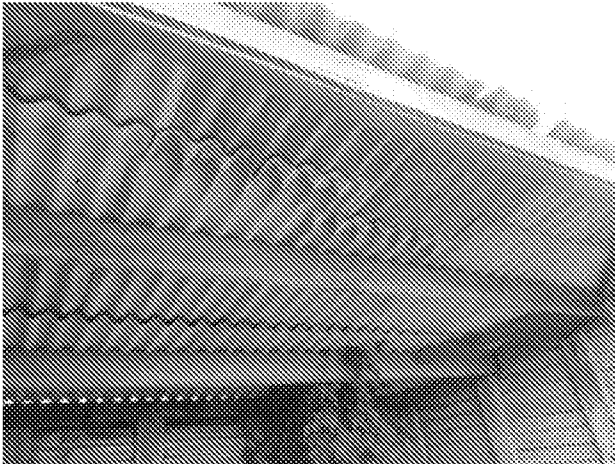
**Finding Code:** 07052019PGJA009

| Item | Extent | Material Details | Recommendations | References |
|---|---|---|---|---|
| Internal<br>Ground Floor<br>Feeding Shed.<br>Sheet to Rear Wall<br>Cement Sheet | 2m2 | Chrysotile (white asbestos); Cement products<br><br>Asbestos composites (Artex, floor tiles, cement etc.); Enclosed sprays, lagging & AIB, asbestos cement; Good condition: no visible damage; Easily accessed, below head height; | Recommendation: Remove<br><br>Specific Comment: Remove item prior to Demolition Works commencing | Finding: 07052019PGJA008<br>Sample: A/008/07052019/PGJ<br>Algorithm Score: 3<br><br>Potential for Fibre Release: Very low risk |

| <b>Floor:</b> | Ground Floor | Internal |
| <b>Area:</b> | Feeding Shed | |

MC: 0. Good condition: no visible damage

### Recommendation

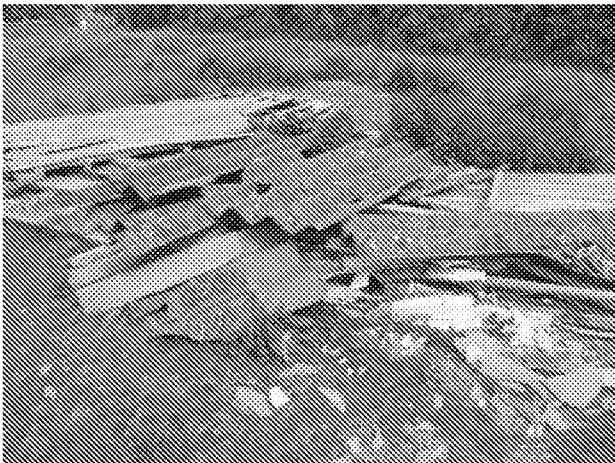
**Finding Code:** 07052019PGJA010

| Item | Extent | Material Details | Recommendations | References |
|---|---|---|---|---|
| External<br>Ground Floor<br>Collapsed Shed.<br>Loose on Floor<br>Cement Sheet Debris | 50m2 | Chrysotile (white asbestos); Cement products<br><br>Asbestos composites (Artex, floor tiles, cement etc.); Enclosed sprays, lagging & AIB, asbestos cement; High Damage or Delamination of Materials: visible Debris; Easily accessed, below head height; | Recommendation: Remove<br><br>Specific Comment: Remove item prior to Demolition Works commencing | Finding: 07052019PGJA010<br>Sample: A/010/07052019/PGJ<br>Algorithm Score: 6<br><br>Potential for Fibre Release: Low risk |

| <b>Floor:</b> | Ground Floor | External |
| <b>Area:</b> | Collapsed Shed | |
| <b>Location:</b> | Loose on Floor | |

MC: 3. High Damage or Delamination of Materials: visible Deb

### Recommendation

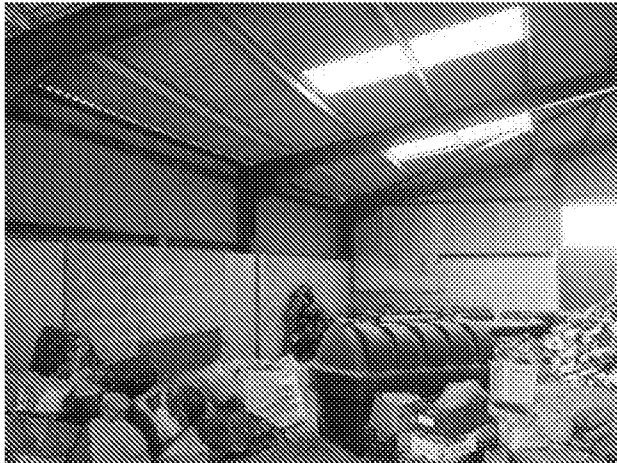
**Finding Code:** 07052019PGJA001

| Item | Extent | Material Details | Recommendations | References |
|---|---|---|---|---|
| Internal<br>Ground Floor<br>Agricultural Shed.<br>Wall Sheets to Left & Rear<br>Elevations<br>Cement Sheets | 15 m2 | No Asbestos Detected; Cement products<br><br>Non-asbestos material; Easily accessed, below head height; | Recommendation:<br>No asbestos detected<br><br>Specific Comment:<br>No action required | Finding: 07052019PGJA001<br>Sample: A/001/07052019/PGJ<br><br>Algorithm Score: 0<br><br>Potential for Fibre Release: N/A |

**Floor:** Ground Floor Internal  
**Area:** Agricultural Shed  
**Location:** Wall Sheets to Left & Rear Elevations  
**Description:** Cement Sheets  
**Extent:** 150 m2  
**Accessibility:** 4. Easily accessed, below head height

### Recommendation

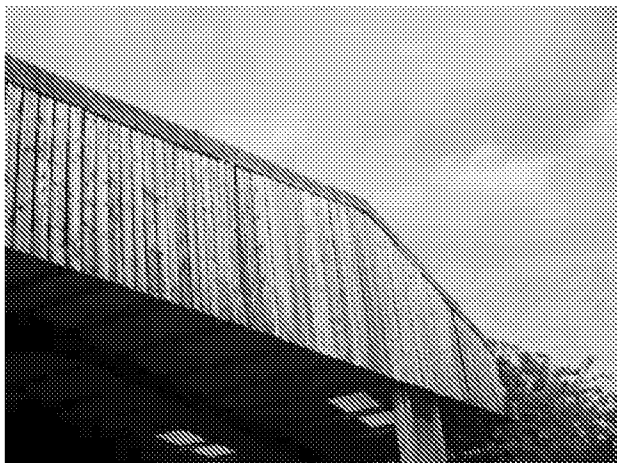
**Finding Code:** 07052019PGJA003

| Item | Extent | Material Details | Recommendations | References |
|---|---|---|---|---|
| External<br>Ground Floor<br>Agricultural Shed.<br>Front & Rear Roof<br>Edgings<br>Cement Sheets | 40 L/m | No Asbestos Detected; Cement products<br><br>Non-asbestos material; Exposed overall, but above head height; | Recommendation:<br>No asbestos detected<br><br>Specific Comment:<br>No action required | Finding: 07052019PGJA003<br>Sample: A/003/07052019/PGJ<br><br>Algorithm Score: 0<br><br>Potential for Fibre Release: N/A |

**Floor:** Ground Floor External  
**Area:** Agricultural Shed  
**Location:** Front & Rear Roof Edgings  
**Description:** Cement Sheets  
**Extent:** 40 L/m  
**Accessibility:** 3. Exposed overall, but above head height

### Recommendation

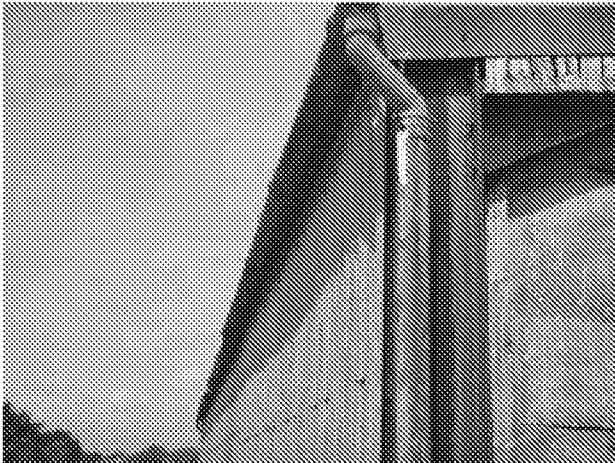
**Finding Code:** 07052019PGJA004

| <b>Floor:</b> | Ground Floor | External |
| <b>Area:</b> | Agricultural Shed | |

### Recommendation

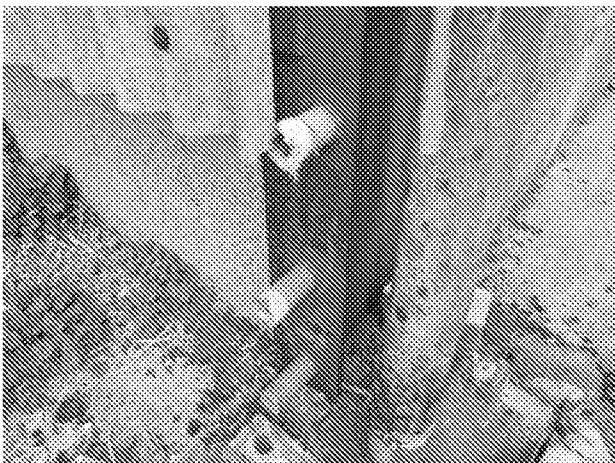
**Finding Code:** 07052019PGJA005

| <b>Floor:</b> | Ground Floor | External |
| <b>Area:</b> | Agricultural Shed | |

### Recommendation

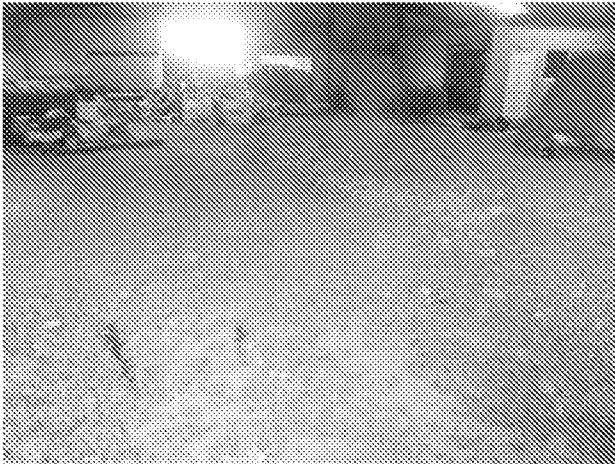
**Finding Code:** 07052019PGJA011

| <b>Floor:</b> | Ground Floor | Internal |
| <b>Area:</b> | Throughout Site | |

### Recommendation
