**REMEDIATION STRATEGY & VERIFICATION REPORT**

**BURNDILL ROAD, YAPTON**

**BOVIS HOMES**

| Reference: | GE18533-RSVR-SEP19 |

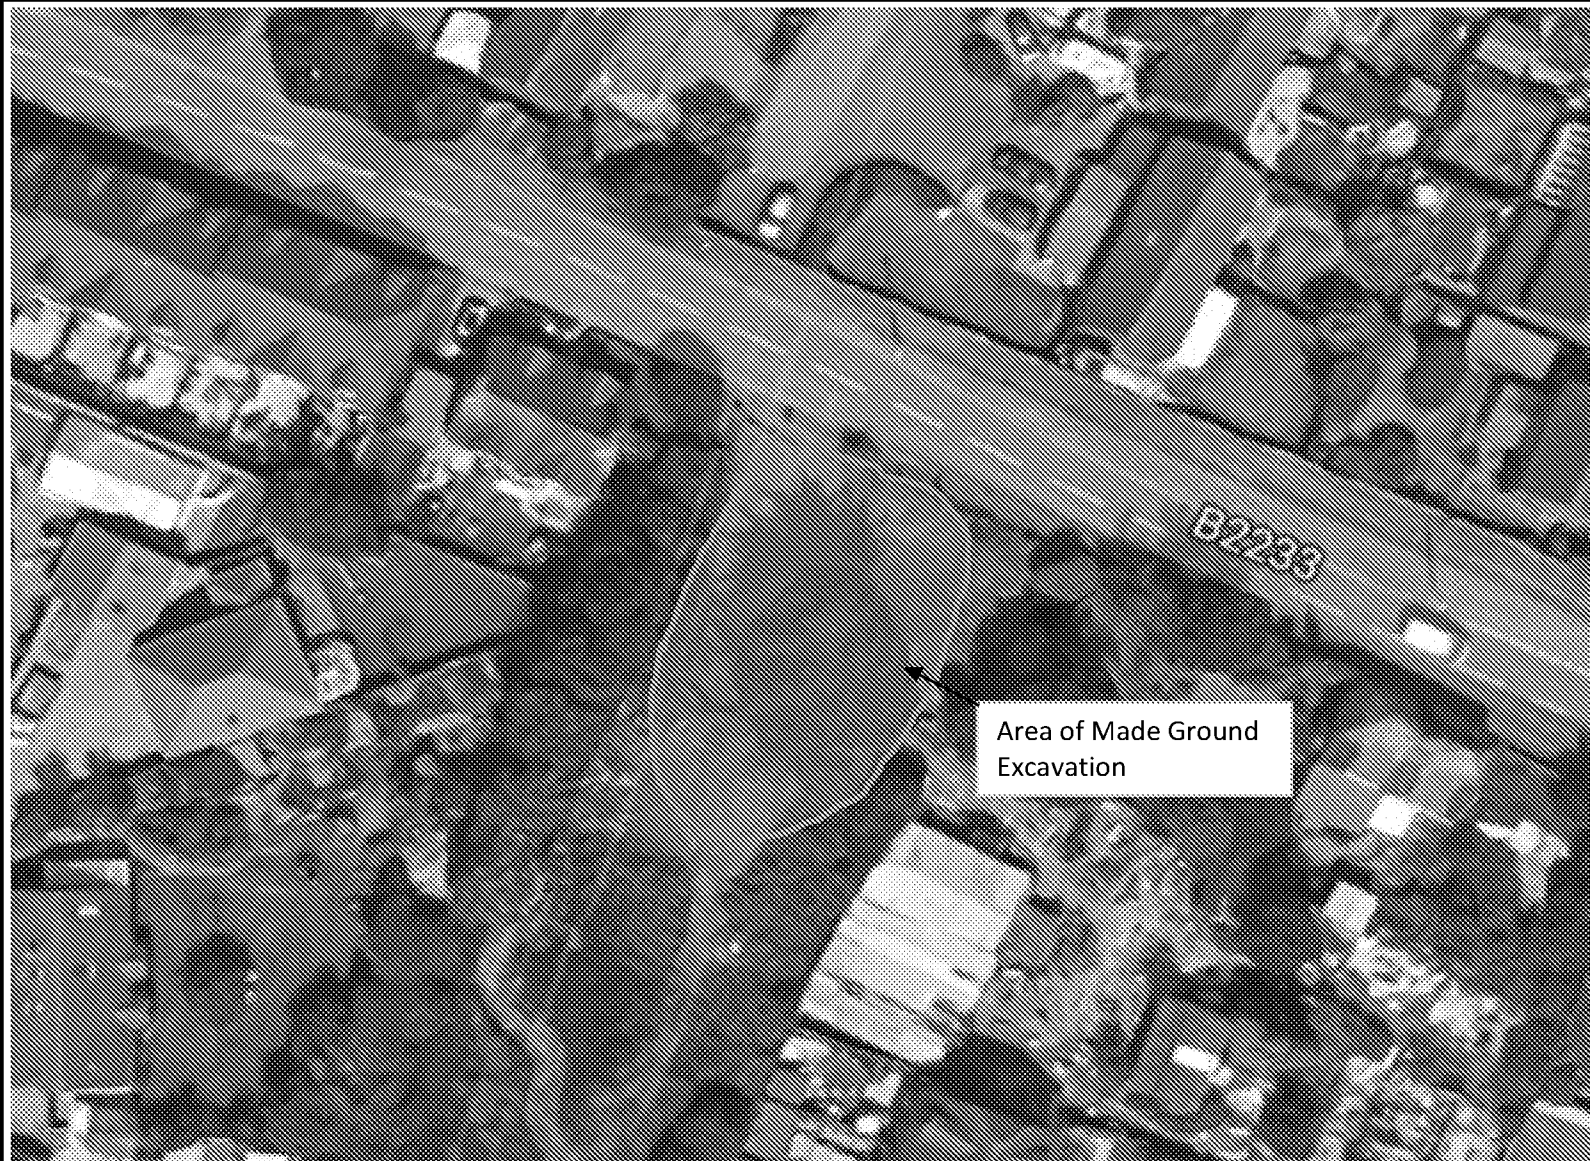
Area of Made Ground  
Excavation

The area subject to the mass excavation is presented in Figure 3 and site photographs of the excavation are presented in Appendix A.

As noted in Section 3, the site was visited during the remediation exercise, i.e. towards the end of the mass excavation and removal of the Made Ground down to the natural strata was evident, visual distinction between the Made Ground and underlying natural soils both in colour and composition. The portion of mass excavation at the boundary with Burndell Road had been partially backfilled with imported Chalk to enable vehicles to enter and exit the site. The area of mass excavation was located at the junction with Burndell Road and the access spur into the site, as shown in Figure 3.

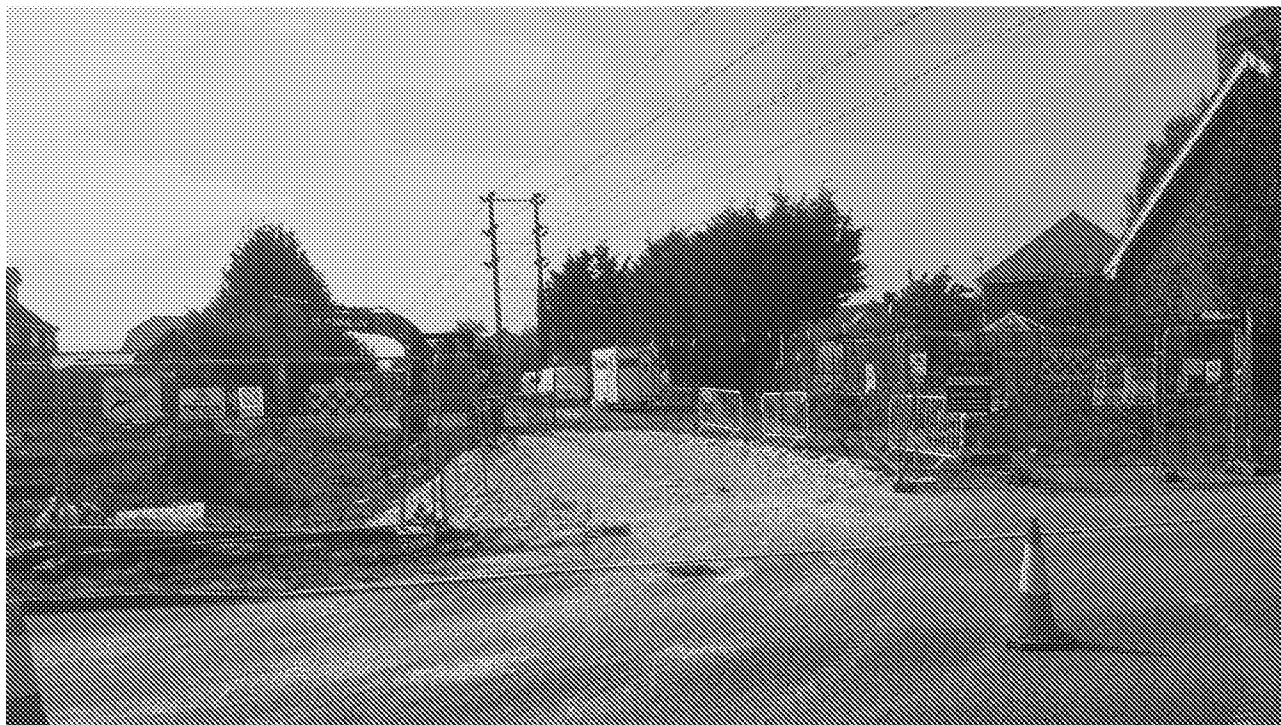
Plate 1 View of Made Ground excavation with chalk backfill along access route

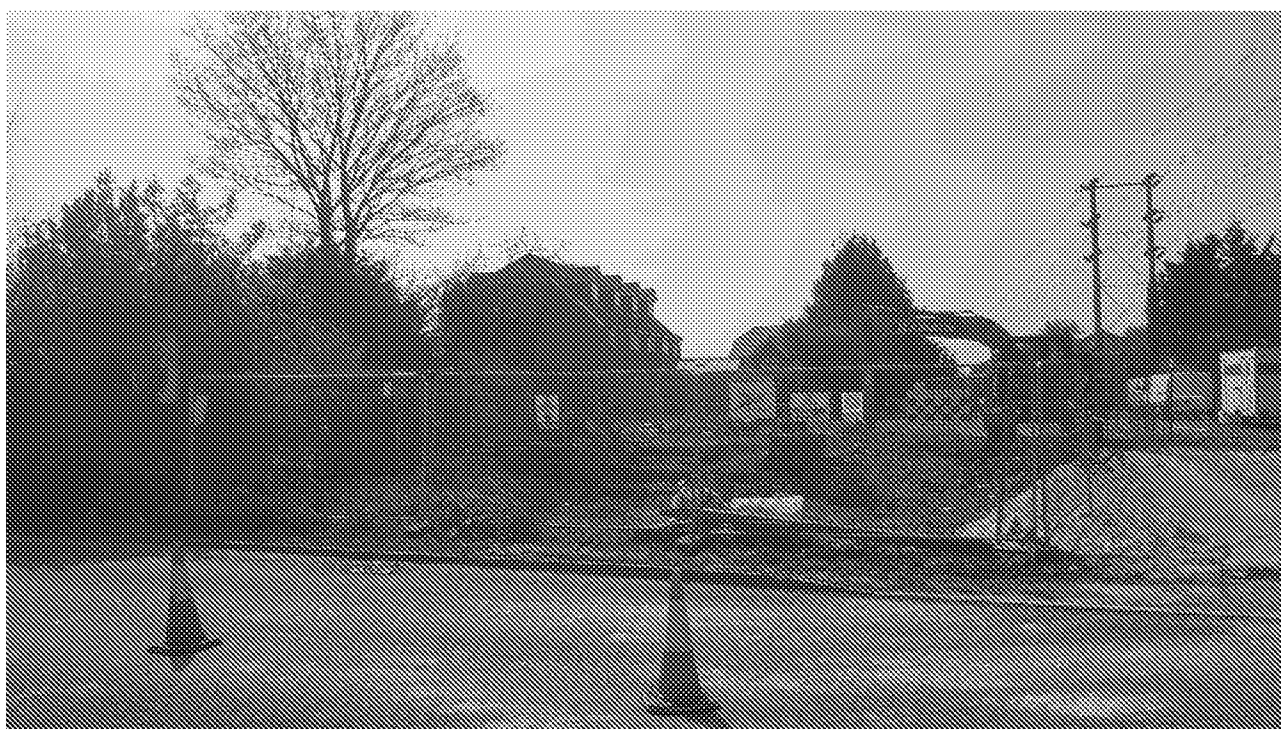
excavated *en masse* to the natural underlying strata, thereby removing all Made Ground and associated contamination hazards within the vicinity of HP201-HP205. Mass excavation down to and exposing the underlying natural strata was observed during a site visit on 15<sup>th</sup> April 2019. It was possible to distinguish visibly between the Made Ground and underlying natural strata both by colour and soil composition.

Plate 2 View of the Made Ground excavation

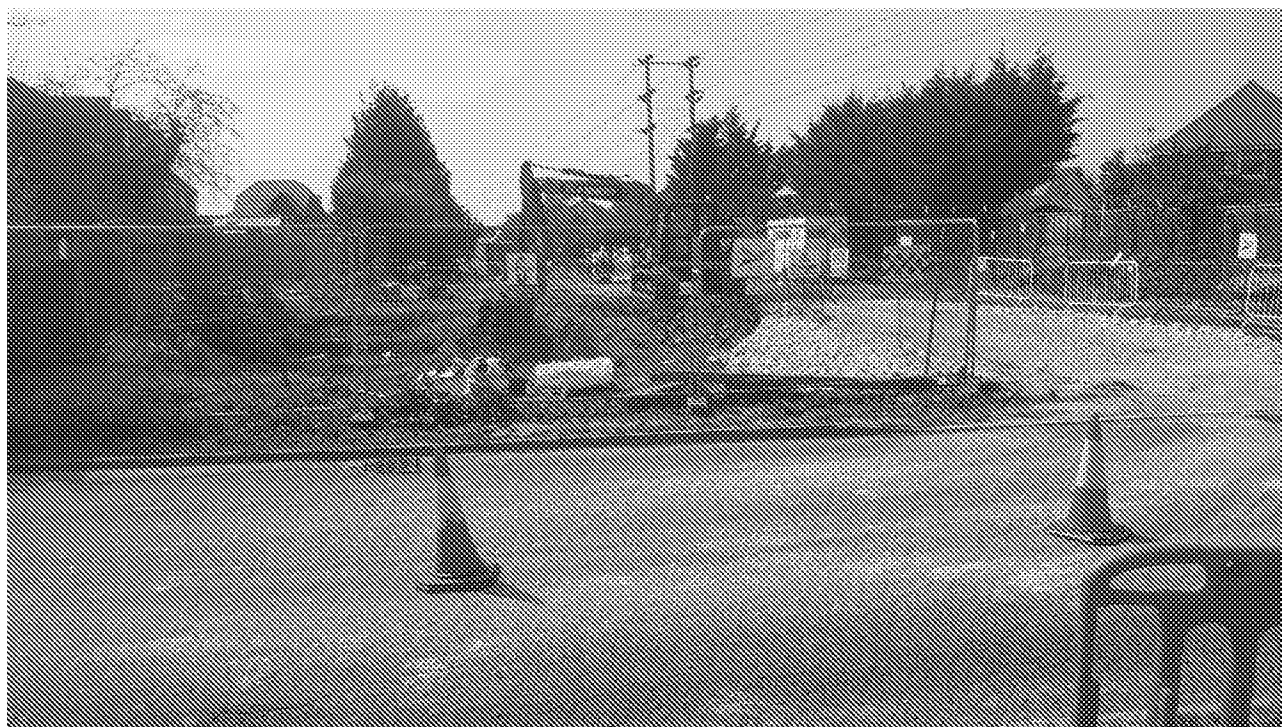
Plate 3 View across the site following the Made Ground excavation
