# Yapton Burndell Road: Project Completion Report

| Ebsford Contract no | 2793 | |
| Completion Document Ref.: | CD2793 | Pages: 19 |
| Scope of work<br>(Operation to carry out work) | Excavation and disposal of Japanese knotweed contaminated material | |

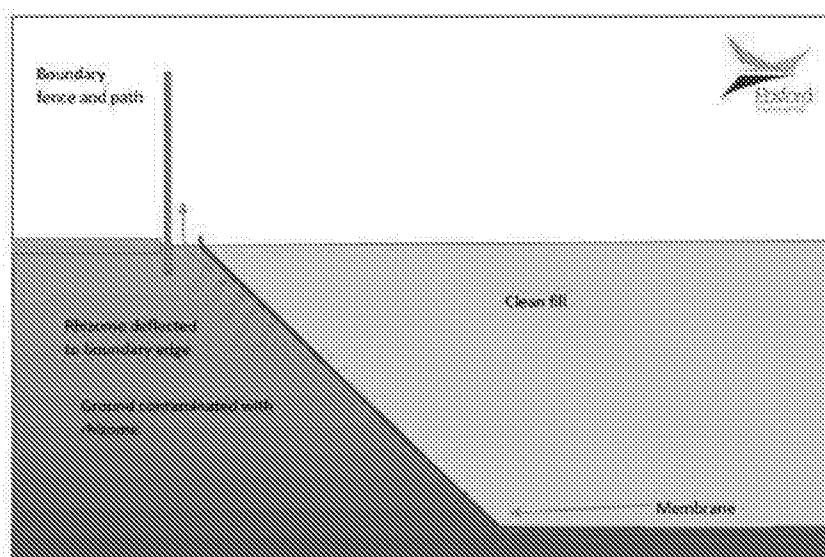
The diagram above depicts a cross section of how root barrier membrane is installed; the 45 degree angle is to ensure the integrity of the boundary is maintained. The area of contaminated material left in situ should not cause any concern as the root barrier will stop any new growth appearing on site. Any new growth within the contaminated area will naturally grow up to gain sunlight, it will achieve this by chasing the root barrier to the surface. Should any new growth appear it will do so on the site boundary behind the root barrier - any growth found will be treated as part of the warranty conditions.

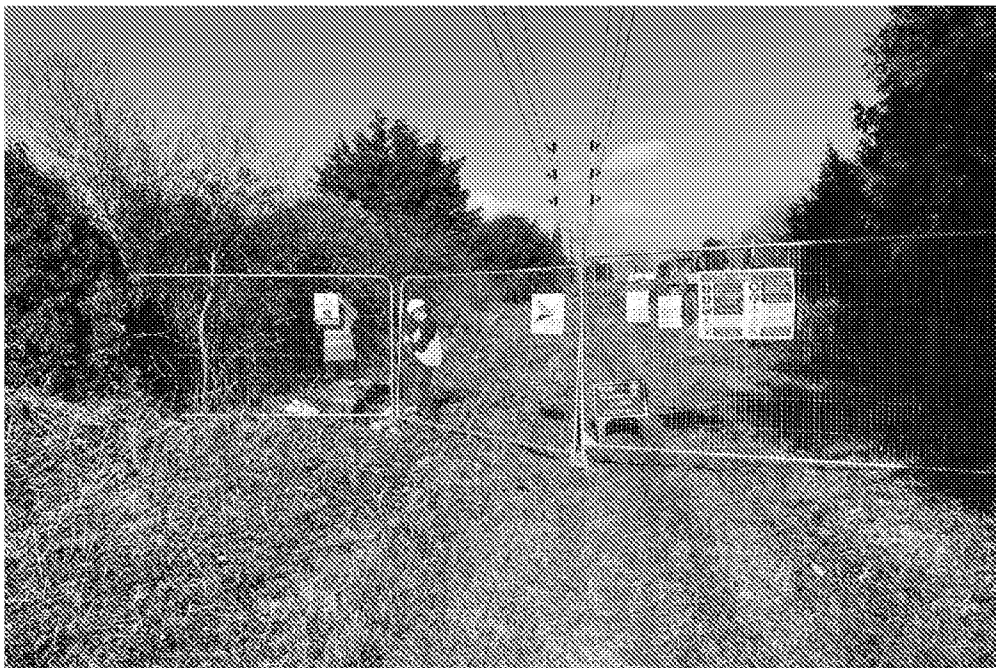
Figure 1: Heras fencing and site safety signage is installed

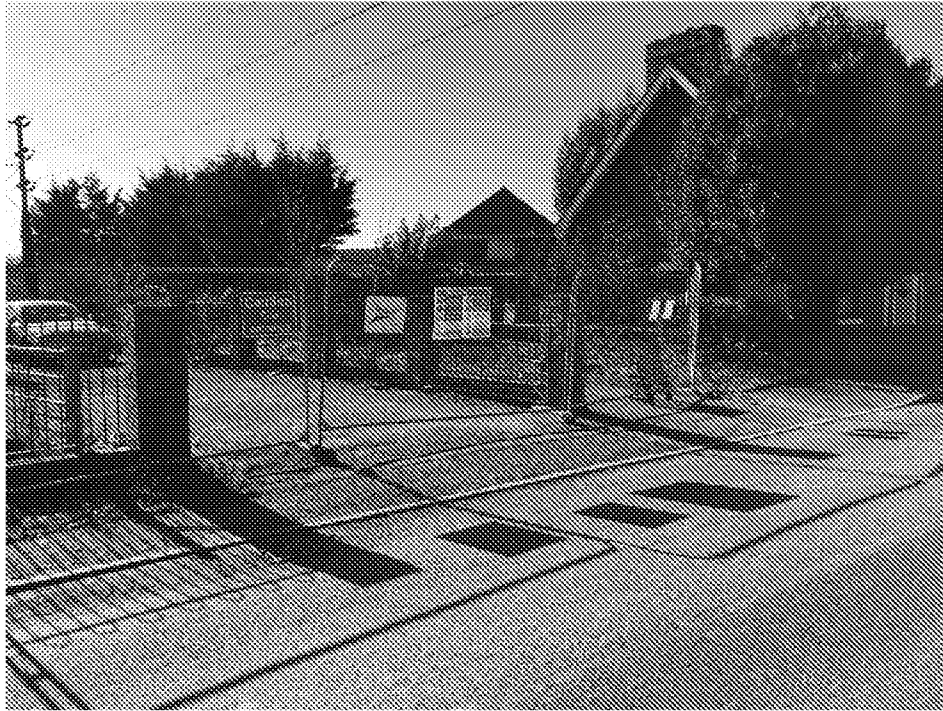
Figure 2: The site entrance is also secured

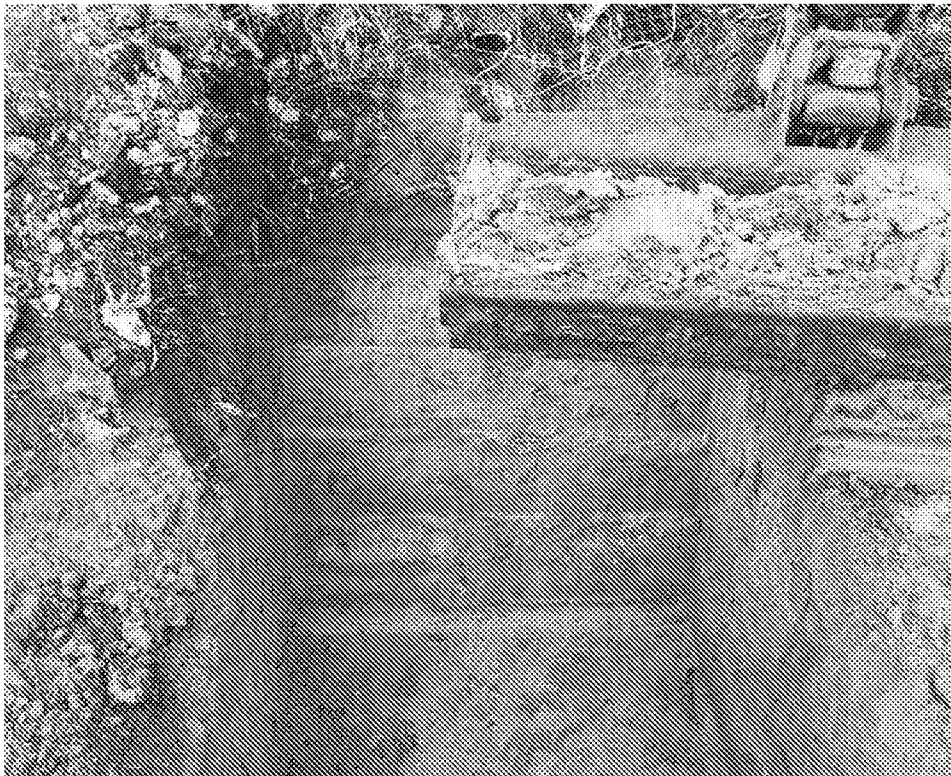
Figure 3: Excavations commence

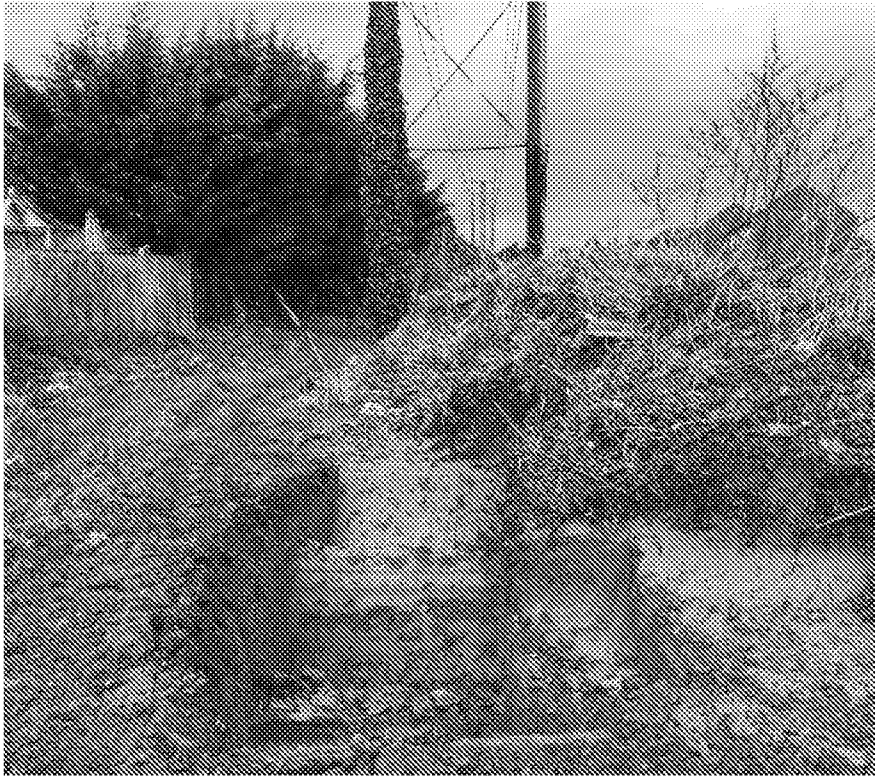
Figure 4: Excavations proceed underneath overhead cables

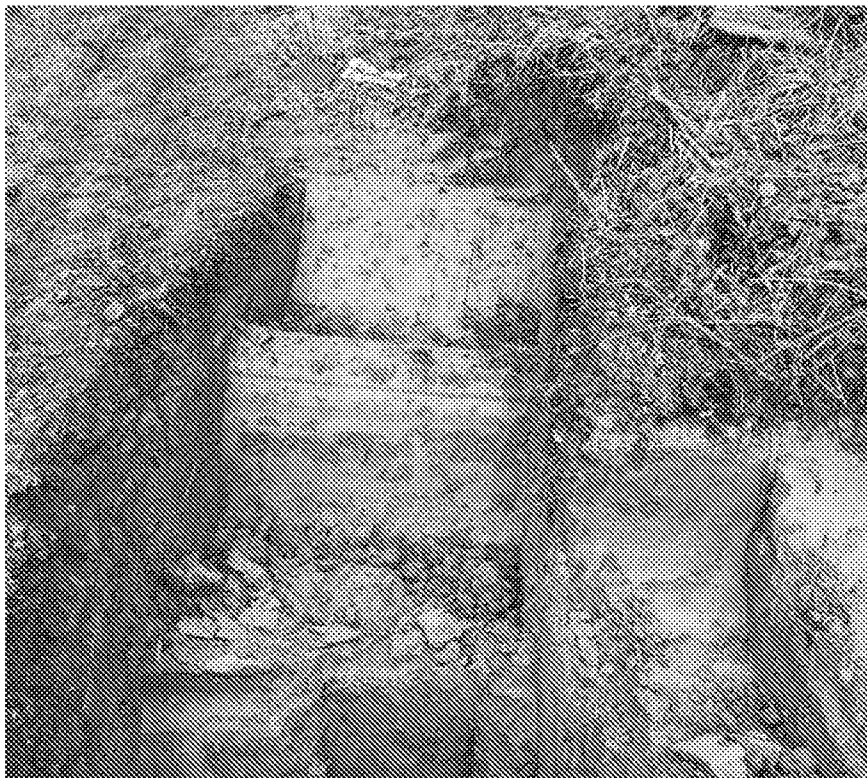
Figure 5: Further excavations

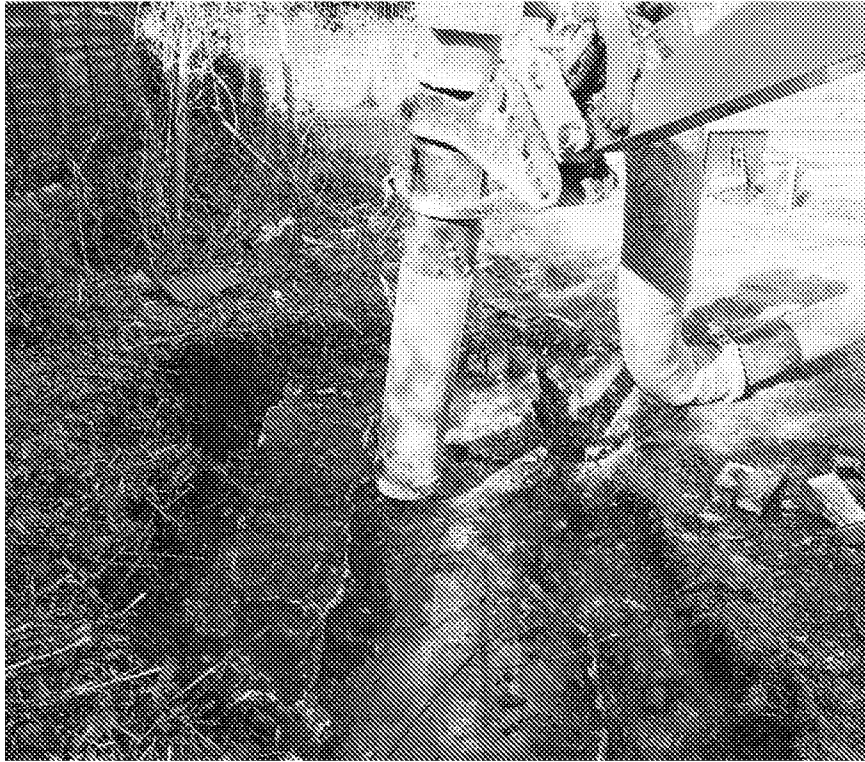
Figure 6: The vacuum excavator is utilised

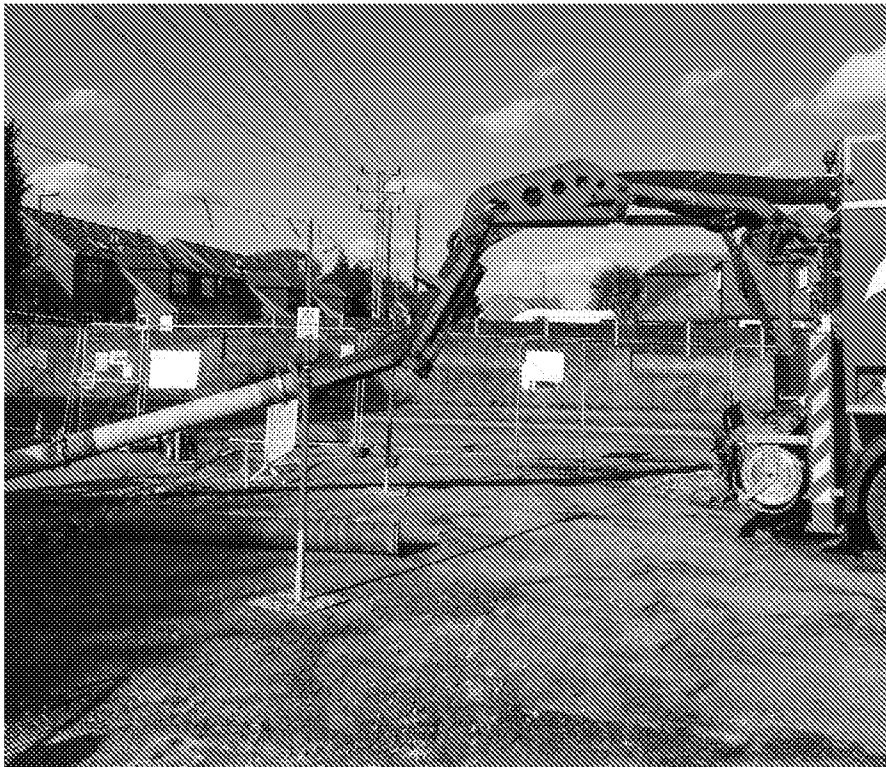
Figure 7: Height restrictions are adhered to

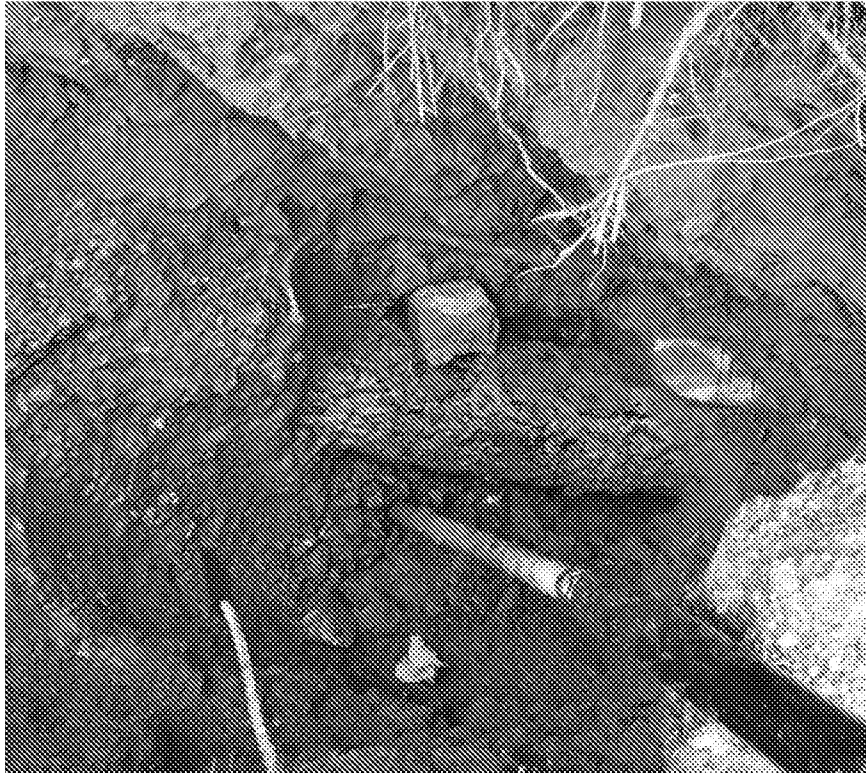
Figure 8: Soil is broken around the underground cable

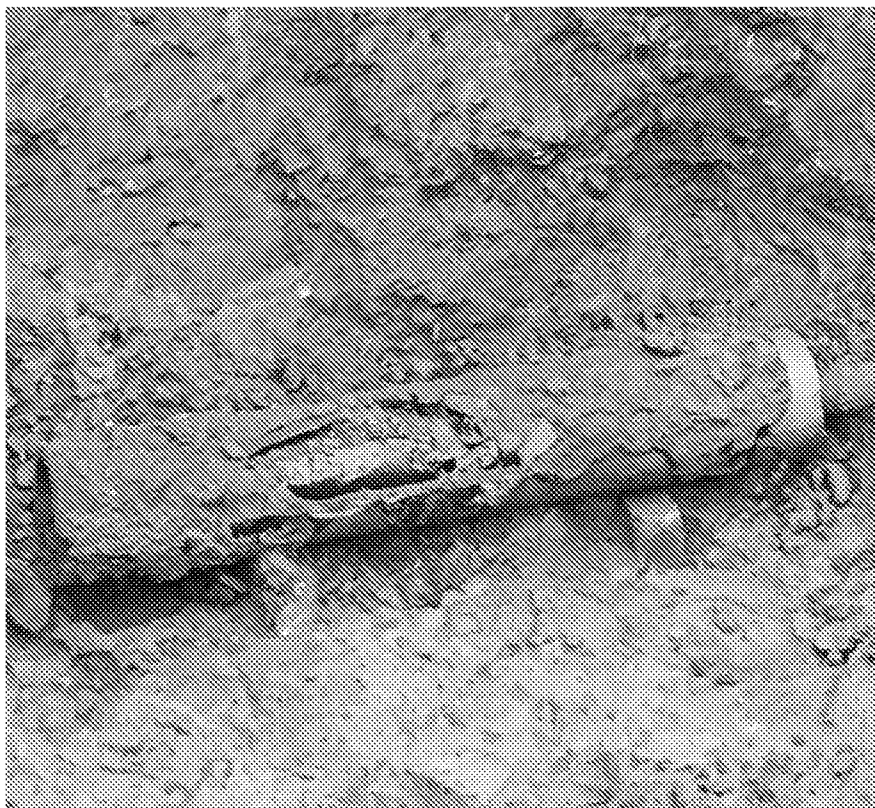
Figure 9: The cable is fully exposed

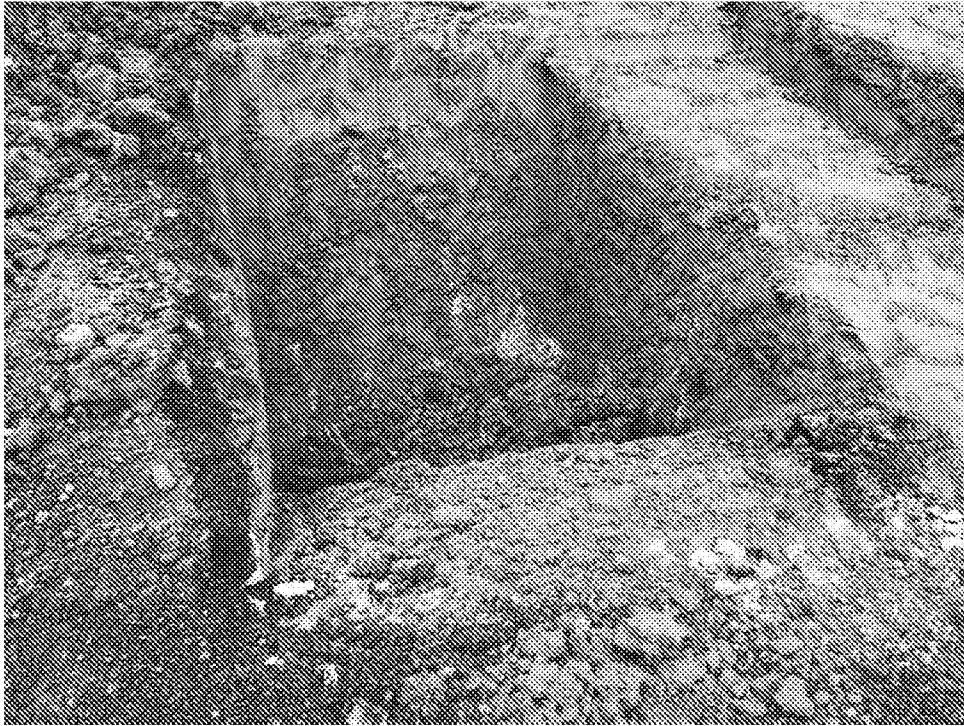
Figure 10: Further excavation works

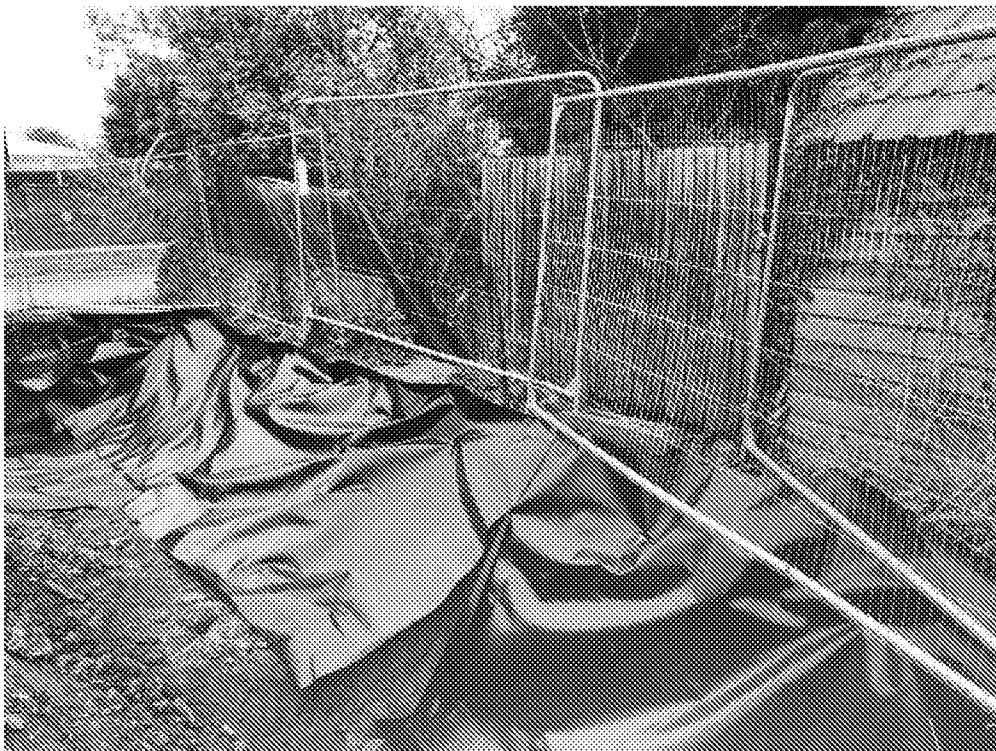
Figure 11: Root barrier membrane installation works

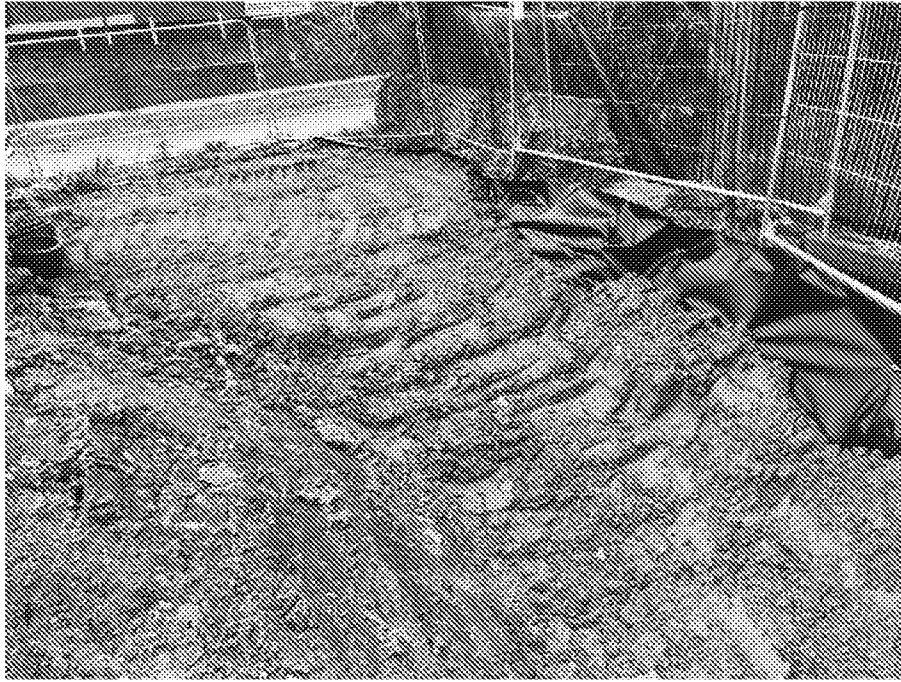
Figure 12: The root barrier membrane is backfilled with clean site won material

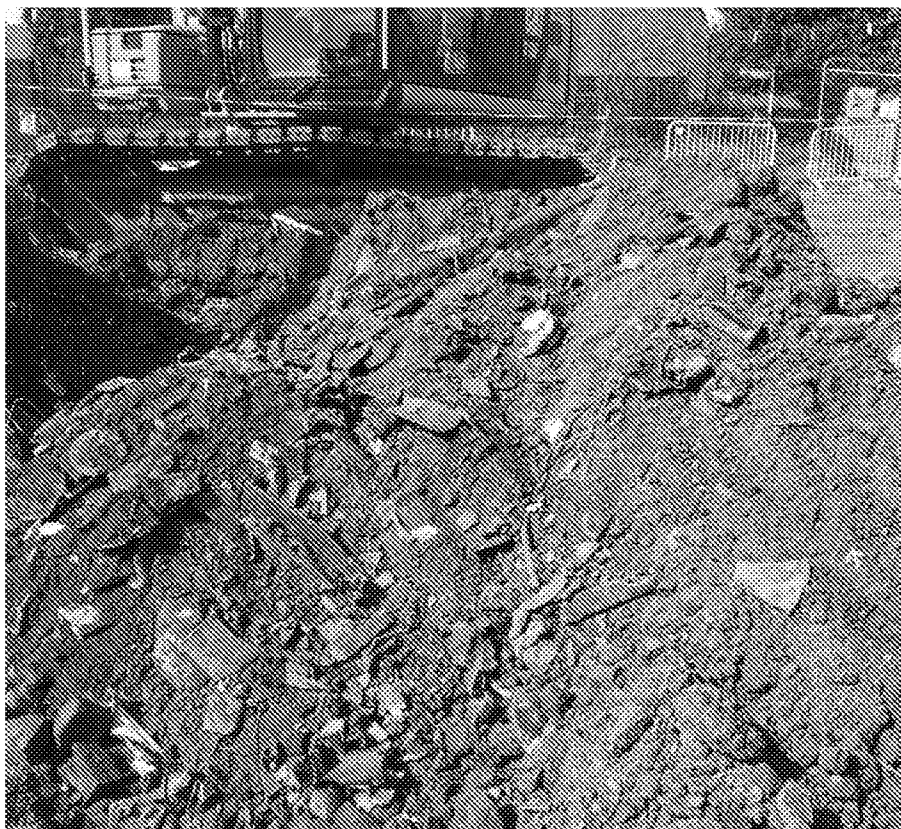
Figure 13: Asbestos removal commences

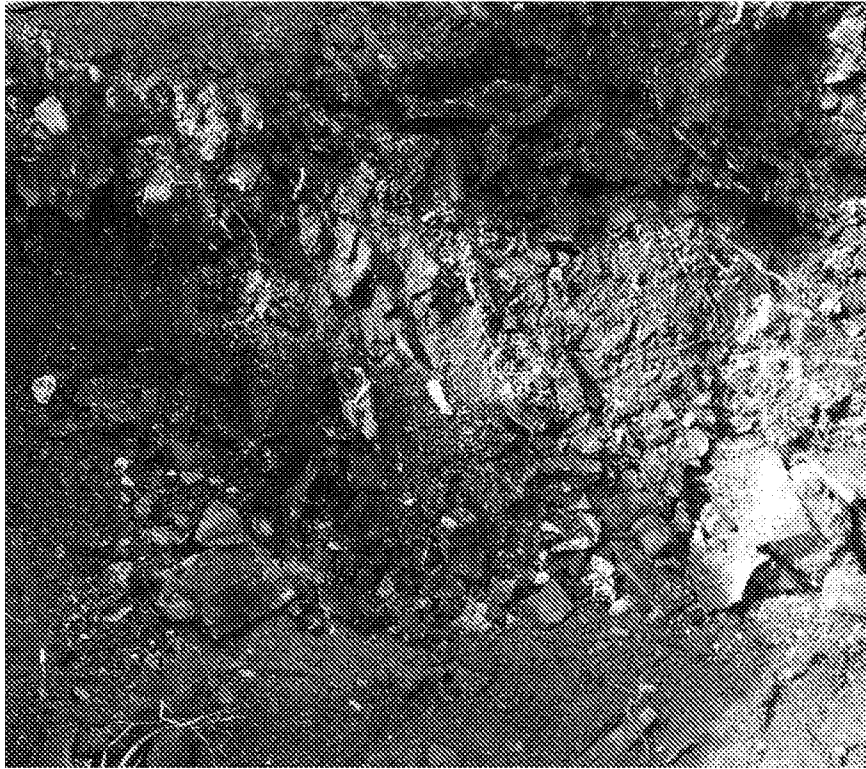
Figure 14: Example of the contaminated fill being excavated

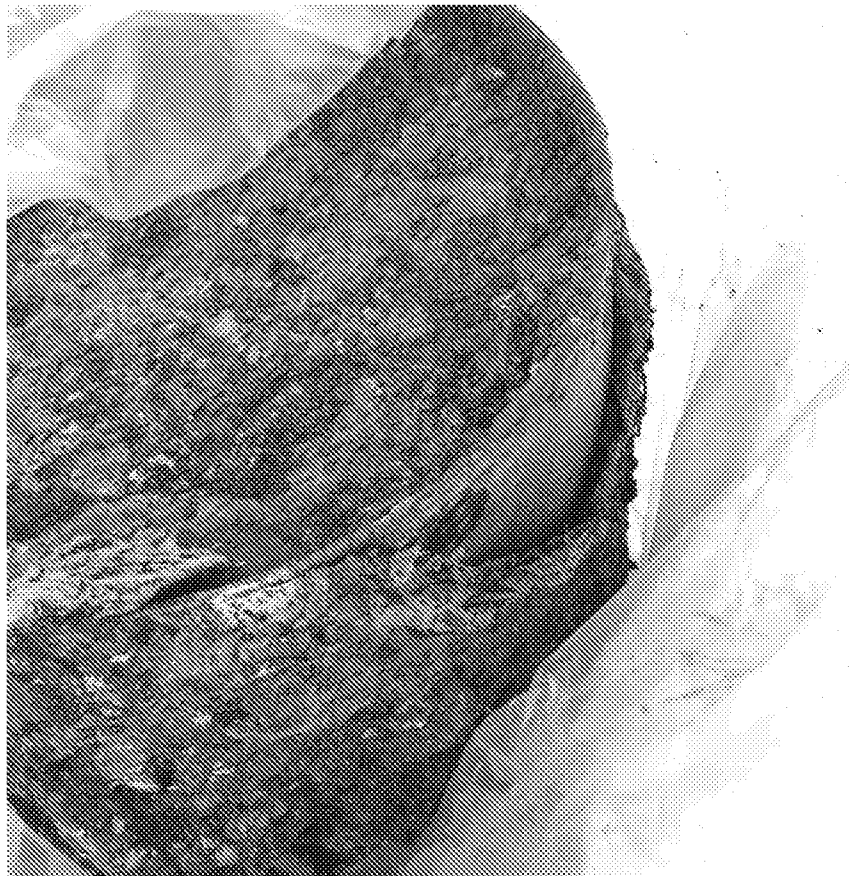
Figure 15: Asbestos lined tank discovered

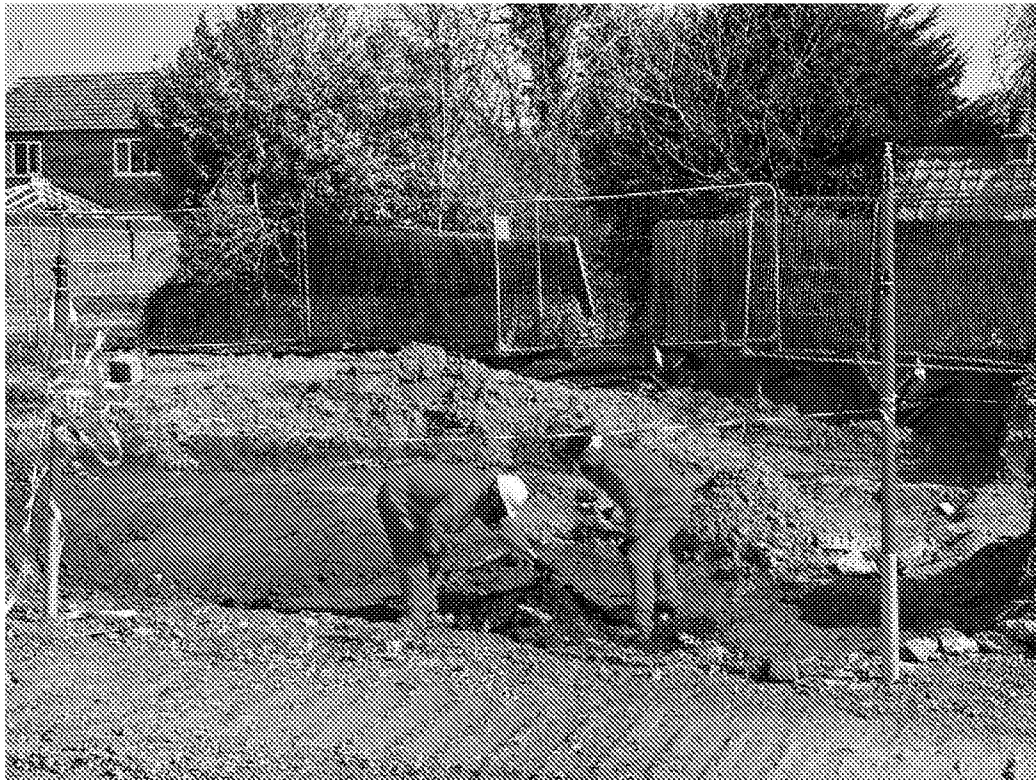
Figure 16: Asbestos contractors locate and dispose of materials

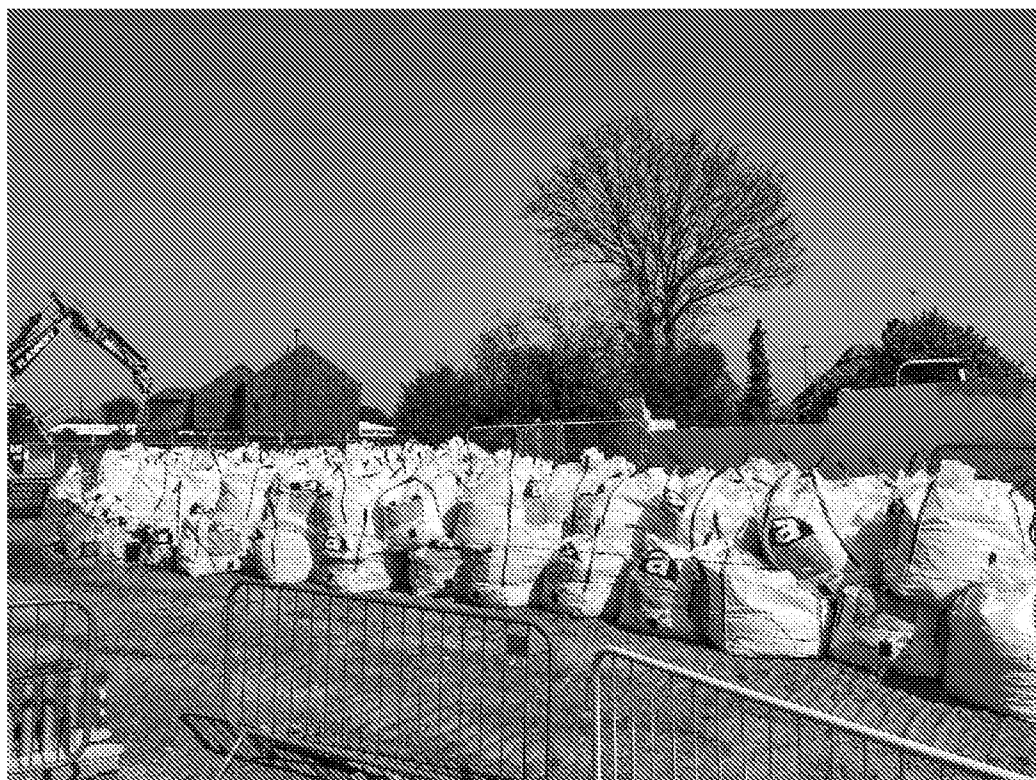
Figure 17: Double lined bags containing asbestos materials

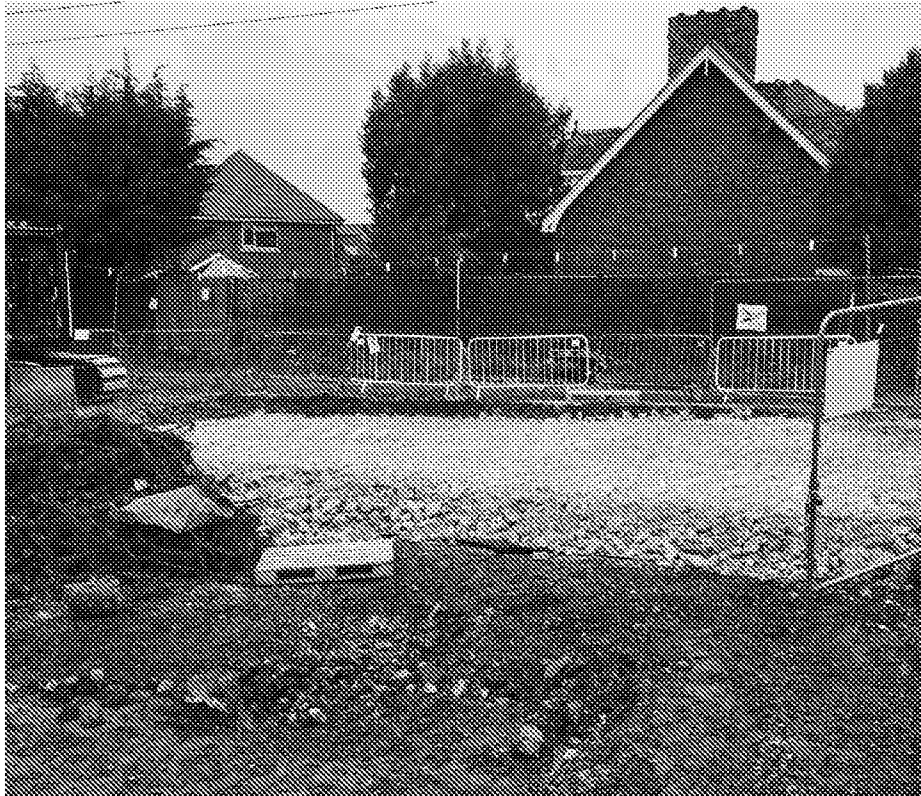
Figure 18: Imported clean stone used as backfill following asbestos removal works

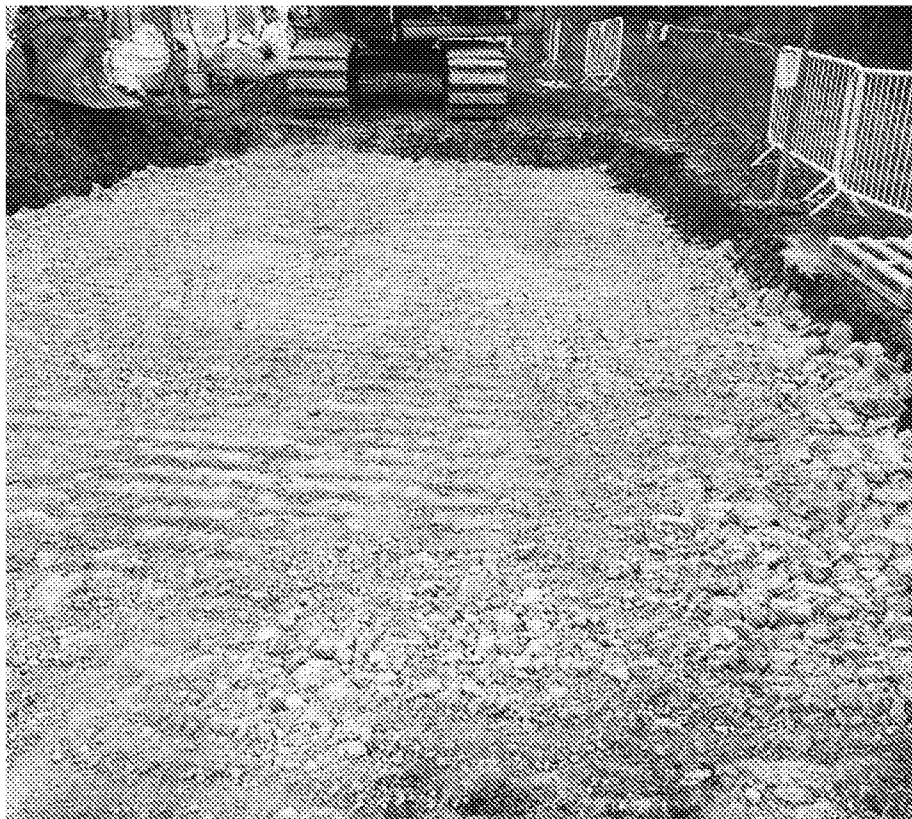
Figure 19: The area is fully backfilled
