Project Name: Stakers Farm Barns, Yapton, BN10 0PU

QED Ref: 19-211

Date of Issue: 26 July 2019

Date of Site Visit: 27 June 2019

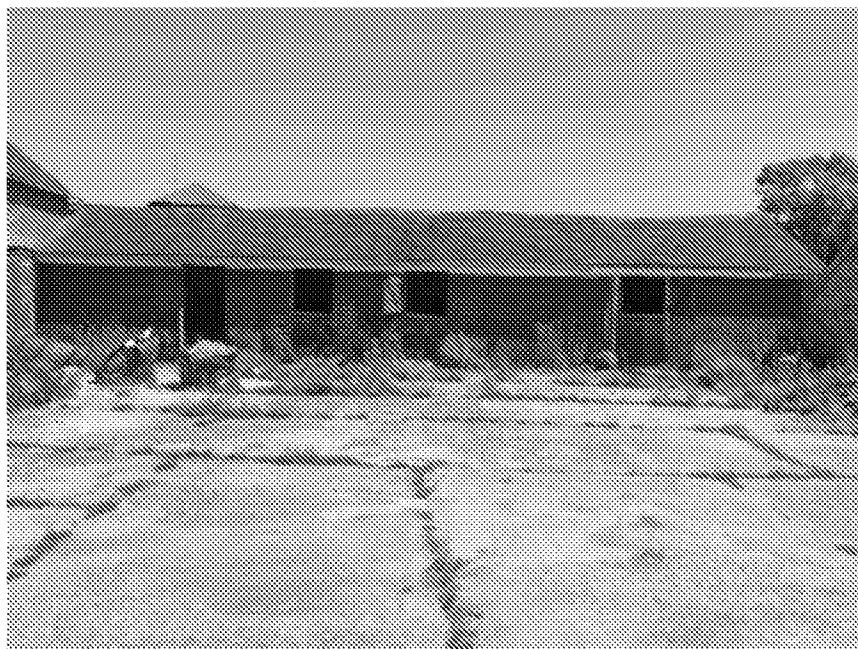
Front Elevation - It appears the existing building originally had an open front elevation with 4 number posts providing open areas for animals to be able to enter the building for feeding. The front elevation has since been altered and a series of low level flint/brick walls built together with some timber cladding to form 4 number separate rooms.

Building 1 – Front elevation

**Front Wall** – The front brickwork/flint walls with timber cladding above would need to be demolished and rebuilt, as they are not in very good condition and it is assumed there are no or minimal foundations supporting these walls. The posts supporting the main timber trusses are to be underpinned to be able to provide a good firm foundation. The new wall would need to be built off a new foundation that would be constructed between the underpin sections for the posts. The new walls would then provide a good solid support for the roof with new Catnic or similar lintels as required for any new windows or doors. The depths of the existing foundation and proposed underpinning or new foundations are all subject to the depth requirement for foundations in line with the NHBC Standards in relation to the soil type, plasticity of the soil and proximity and type of trees.

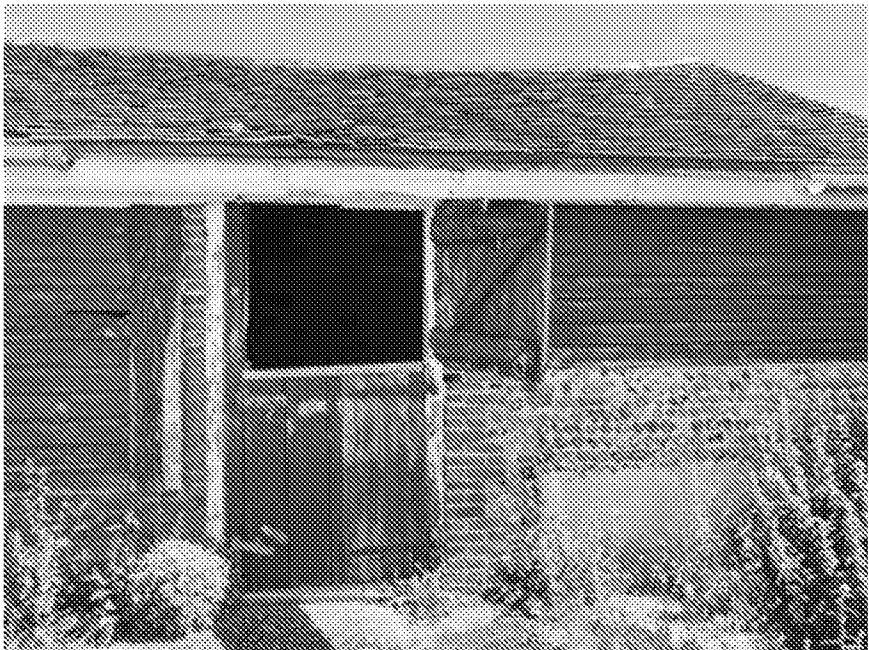
The roof has clay tiles with clay ridge tiles on a series of timber trusses and rafters. The ridge itself is very uneven which suggests there has been a certain amount of movement in the roof historically. There is a gutter at the eaves of the roof at the front which is partially missing.

Building 1 – front elevation showing uneven ridge and infill external walls

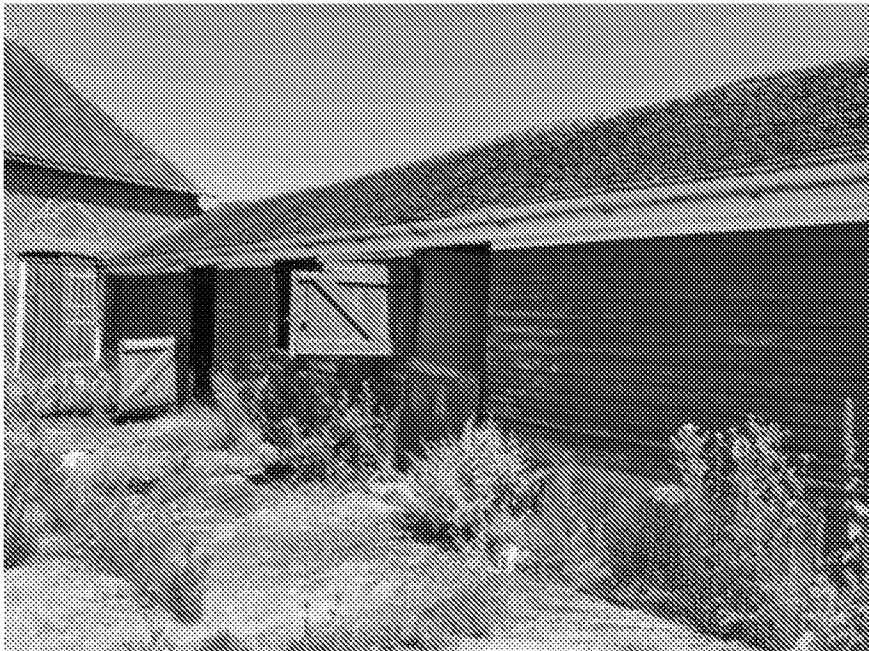
Building 1 – Front elevation showing uneven ridge and infill external walls

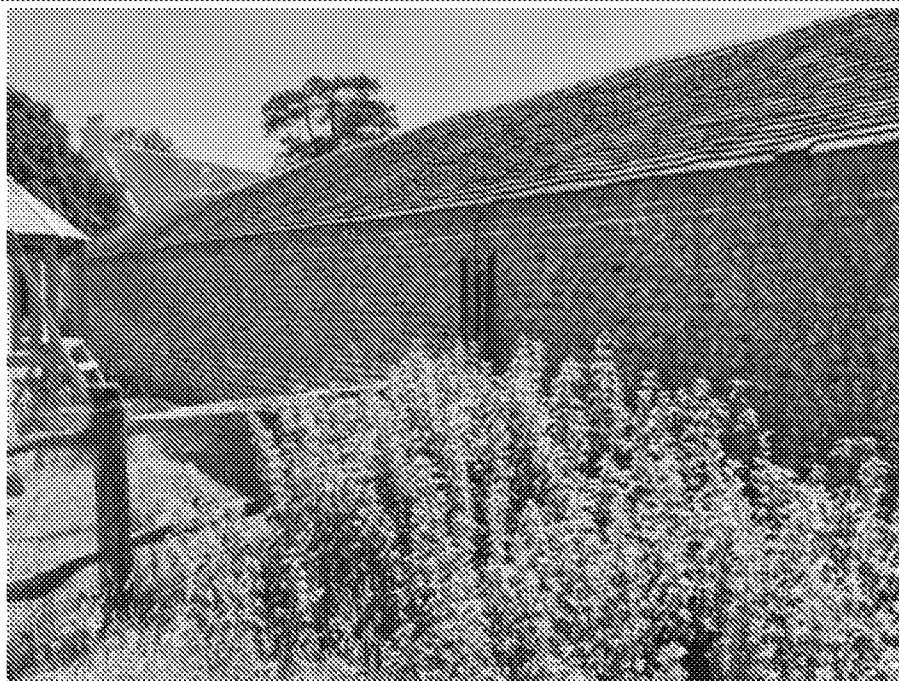
Rear Elevation - The rear elevation is formed from solid flint/brickwork with no openings. There is no eaves gutter along the rear elevation.

Building 1 – Rear elevation

**Rear Wall** – The rear wall has been pushed outwards by the spread of the roof, therefore it is recommended this wall be underpinned along its full length to provide a good firm foundation. Any new openings within this wall would need to be supported with Catnic or similar lintels. The rear wall is to be fixed back to the internal and side walls running perpendicular to the rear wall with Helifix ties or similar to provide a lateral restraint at each junction. Where possible it would also be prudent to carry out some local stitch repairs between walls. The depths of the existing foundation and proposed underpinning or new foundations are all subject to the depth requirement for foundations in line with the NHBC Standards in relation to the soil type, plasticity of the soil and proximity and type of trees.

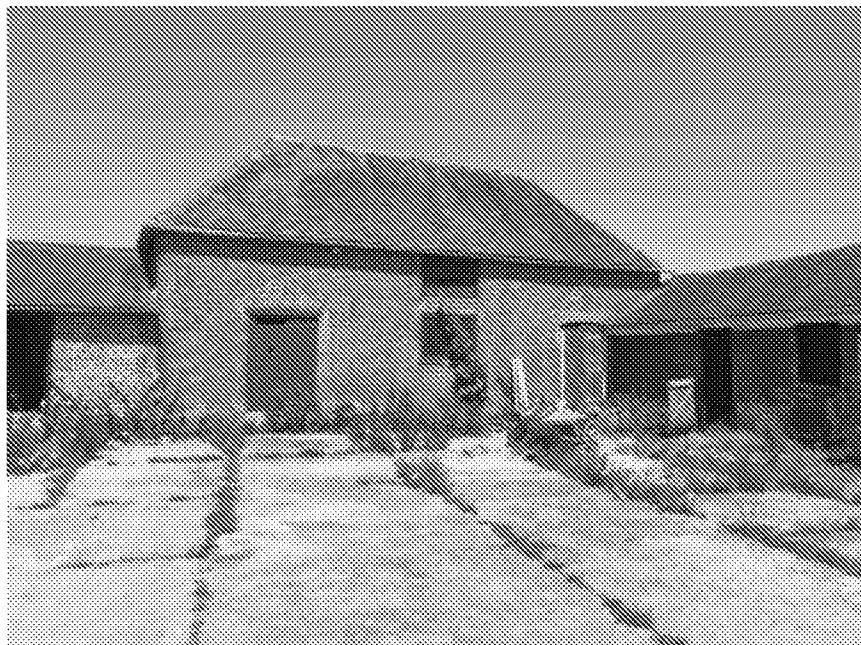
Front Elevation - The front elevation is formed from brickwork with 2 number doors and 2 number windows within the elevation. The mortar joints in the brickwork were in poor condition with large areas or repointing required. There was cracking through the lintel above one of the doors and historic diagonal cracking above the other door which has been repointed.

Building 2 – Front elevation

Front Wall – The front brickwork wall appeared to be in relatively good condition with diagonal cracking locally over the doors, it is suggested this cracking is localized only and not due to any settlement in the ground. It is recommended new Catnic or similar lintels are installed for all openings. The elevation would need to be fully repointed. At this stage it is not considered a requirement to underpin this wall unless the removal of the ground floor and/or introduction of a new slab and insulation and lowering of the slab undermines the existing foundations. This is also subject to a detailed design and load assessment on the existing foundations once the depth and profile of the existing foundations and type of bearing strata is known. If following the detailed design of this load assessment foundation strengthening is required, this this would be in the form of underpinning. The depths of the existing foundation and proposed underpinning or

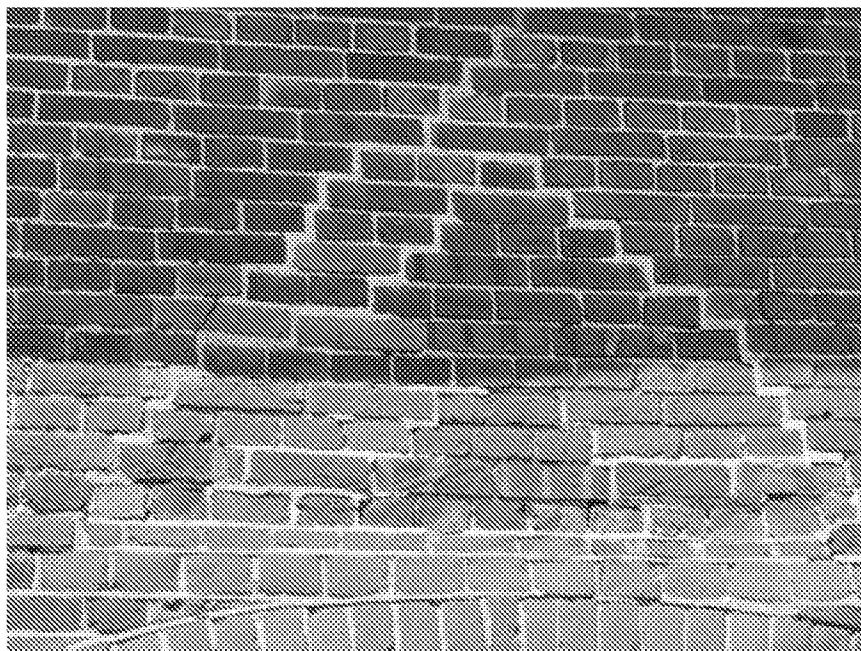
Building 2 – front elevation showing diagonal cracking above one of the doors, which has been repointed

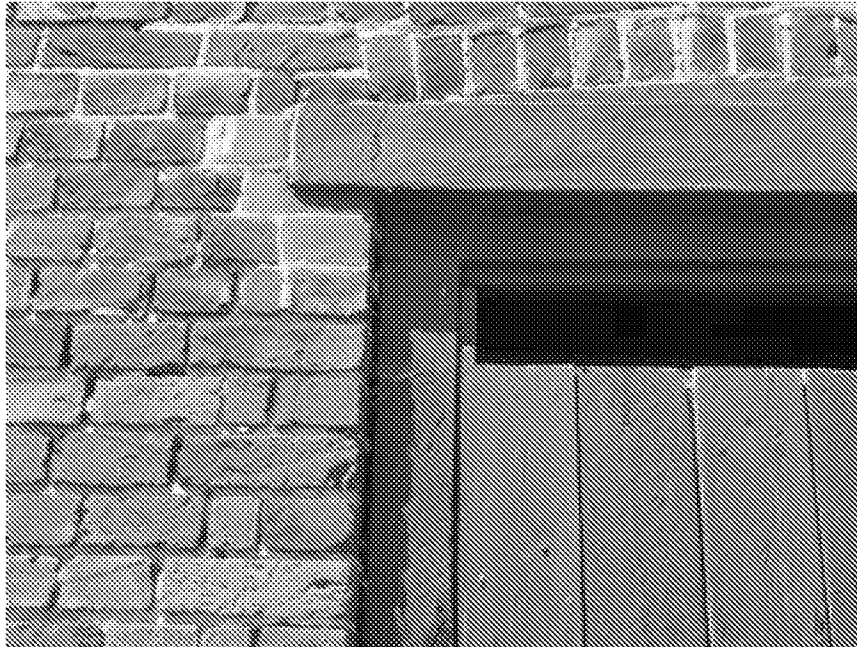
Building 2 – Front elevation showing vertical crack through the lintel above one of the doors

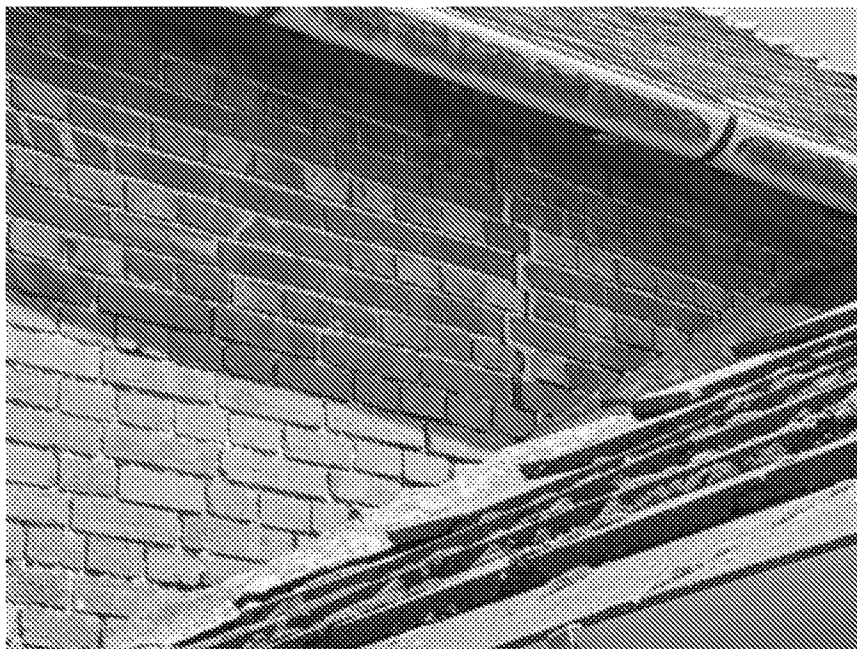
Rear Elevation –The rear elevation was solid brickwork with no openings. There was some vertical cracking on the side wall at high level which abuts Building 3. There is an eaves gutter and downpipe at one corner of the rear elevation.

Building 2 – Side elevation showing vertical cracking in side wall abutting Building 3

End/Side Walls – It is recommended that these walls may require underpinning to provide a good solid foundation to each wall due to the cracking visible. This underpinning may need to be extended around the corners of the front and rear walls to a degree to avoid any hard spots and future cracking. This is however subject to more intrusive investigation works with regards to the existing foundations. It is recommended a series of trial pits be dug to be able to ascertain the depth and profile of the existing foundation and the type of bearing strata. Helifix ties or similar to are to be installed across the cracks together with replacement of any cracked bricks. However, if the front and rear walls require underpinning as described above, it would be prudent and advisable to also underpin these walls to avoid any hard spots and potential long term cracking. The depths of the existing foundation and proposed underpinning or new foundations are all subject the depth requirement for foundations in line with the NHBC Standards in relation to the soil type, plasticity of the soil and proximity and type of trees.

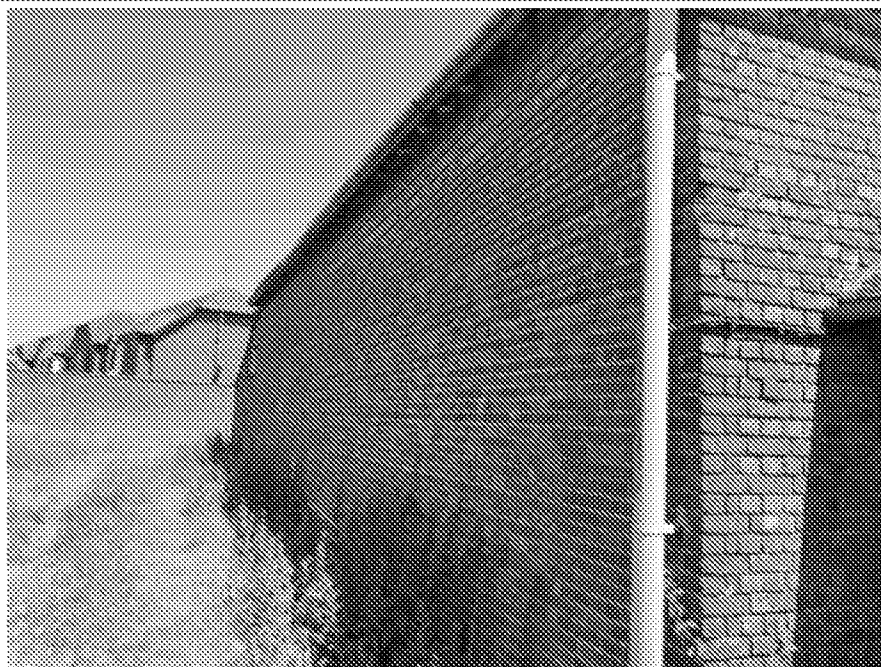
Building 2 - Rear elevation

Rear Wall – The rear wall appeared to be in relatively good condition. It is recommended new Catnic or similar lintels are installed for any new openings. The elevation would need to be fully repointed. At this stage it is not considered a requirement to underpin this wall unless the removal of the ground floor and/or introduction of a new slab and insulation and lowering of the slab undermines the existing foundations. This is also subject to a detailed design and load assessment on the existing foundations once the depth and profile of the existing foundations and type of bearing strata is known. If following the detailed design of this load assessment foundation strengthening is required, this this would be in the form of underpinning. The depths of the existing foundation and proposed underpinning or new foundations are all subject the depth requirement for foundations in line with the NHBC Standards in relation to the soil type, plasticity of the soil and proximity and type of trees.

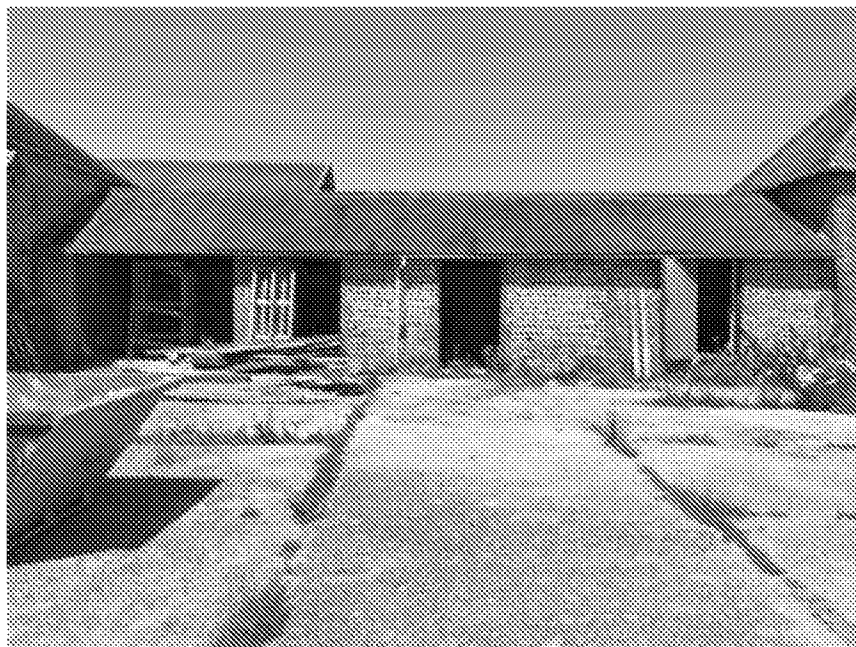
Front Elevation - The front elevation is formed from brickwork and flint with 4 number openings into the building, there was no visible signs of cracking to the front elevation wall, however there were gaps between the timber wall plate and wall with one loose brick next to one of the doors. The timber lintel across the larger opening was clearly deflecting at mid-span.

Building 3 - Front elevation

Front Wall – The front brickwork/flint walls with would need to be underpinned to be able to provide a good firm foundation. Any new wall would need to be built off a new foundation that would be constructed between the underpin sections for the existing walls. The new walls would then provide a good solid support for the roof with new Catnic or similar lintels as required for any new windows or doors. The depths of the existing foundation and proposed underpinning or new foundations are all subject the depth requirement for foundations in line with the NHBC Standards in relation to the soil type, plasticity of the soil and proximity and type of trees.

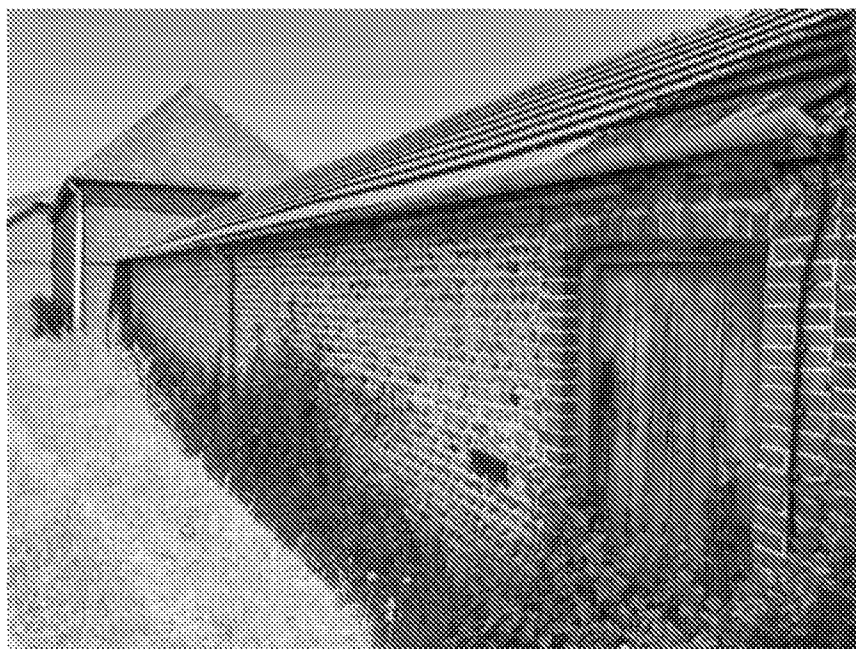
Building 3 - Rear elevation

Rear Wall – The rear wall has been pushed outwards by the spread of the roof, therefore it is recommended this wall be underpinned along its full length to provide a good firm foundation. Any new openings within this wall would need to be supported with Catnic or similar lintels. The rear wall is to be fixed back to the internal and side walls running perpendicular to the rear wall with Helifix ties or similar to provide a lateral restraint at each junction. Where possible it would also be prudent to carry out some local stitch repairs between walls. The depths of the existing foundation and proposed underpinning or new foundations are all subject the

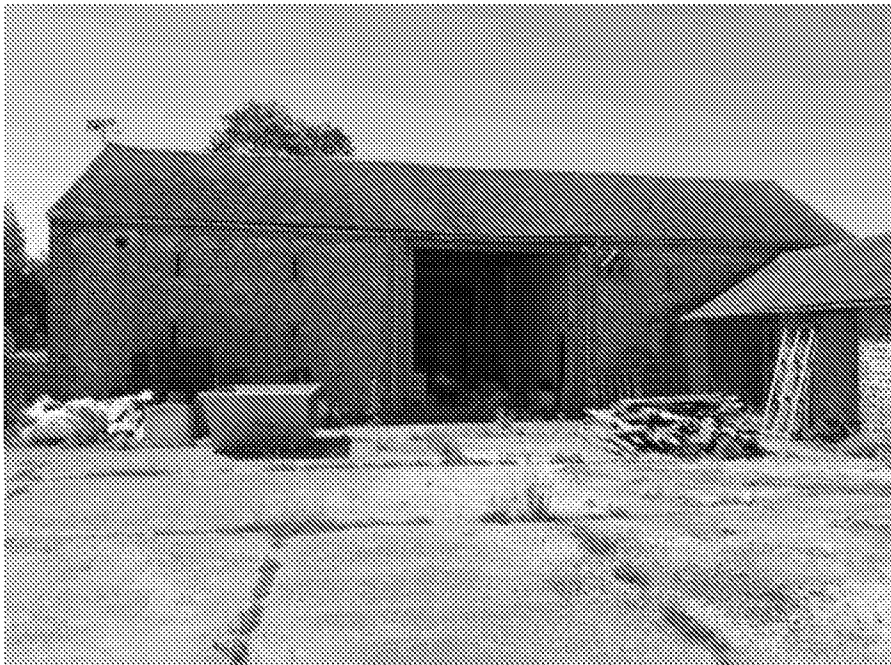
Front Elevation - The front elevation is formed from brickwork and flint with 1 number large full height opening into the building. There were also 6 number small vertical slot windows in the elevation. There is a timber frame around the large opening, the base of the two columns were rotten and the beam at eaves level was sagging in the center. There was vertical cracking between the flint and brickwork at the corner of the building at the junction where you enter the courtyard.

Building 4 - Front elevation

**Front Wall** – The front brickwork wall appeared to be in relatively good condition with only cracking apparent at the junction of the brickwork and flint sections of wall. Helifix ties or similar are to be provided across any cracked joints between brickwork walls and flint walls. It is recommended new Catnic or similar lintels are installed for all openings. The elevation would need to be fully repointed. At this stage it is not considered a requirement to underpin this wall unless the removal of the ground floor and/or introduction of a new slab and insulation and lowering of the slab undermines the existing foundations. The timber frame around the main door opening is to be either strengthened and treated or replaced with a galvanized steel frame. The depths of the existing foundation and proposed underpinning or new foundations are all subject the depth requirement for foundations in line with the NHBC Standards in relation to the soil type, plasticity of the soil and proximity and type of trees.

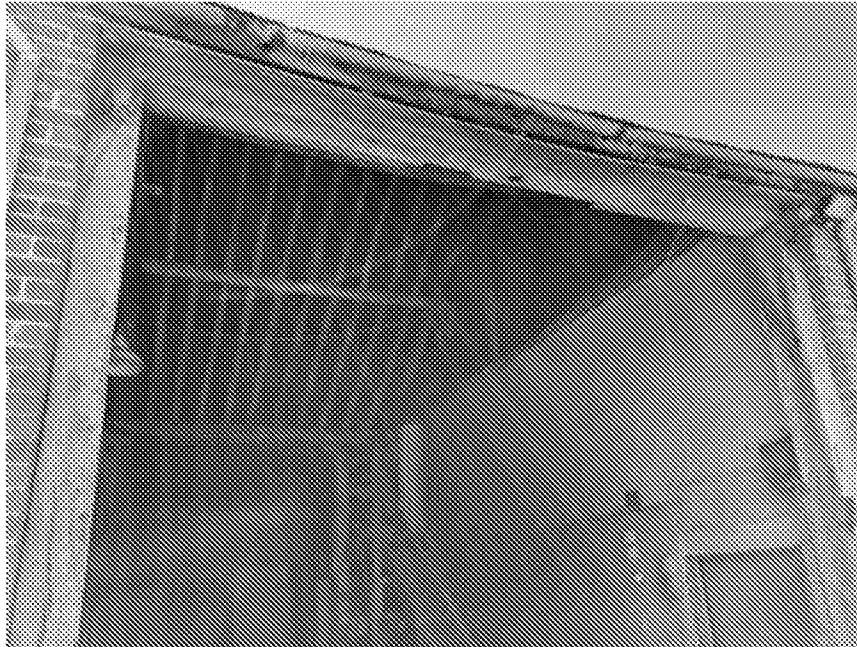
Building 4 – Sagging timber beam at eaves level of door opening

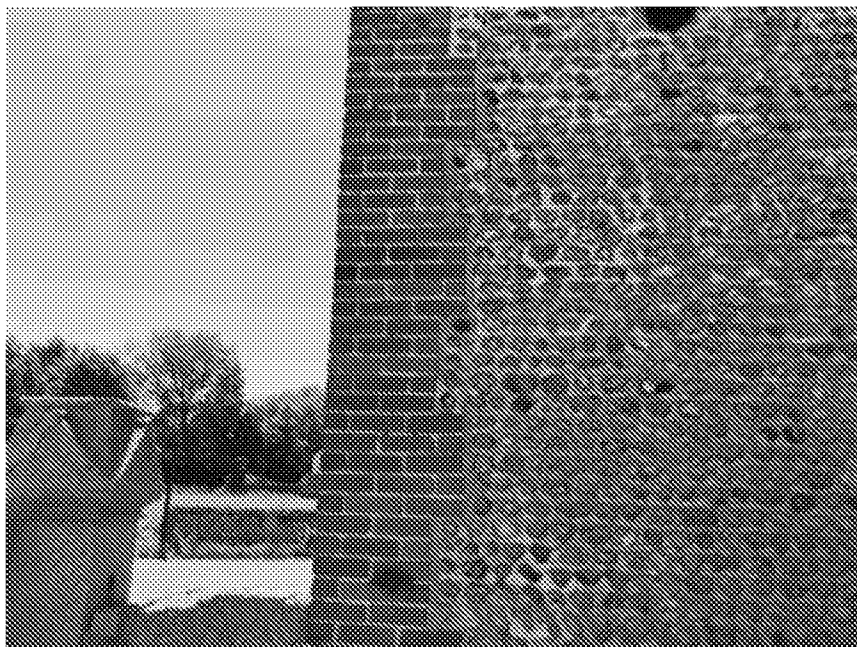
Building 4 – Cracking between flint and brickwork on corner

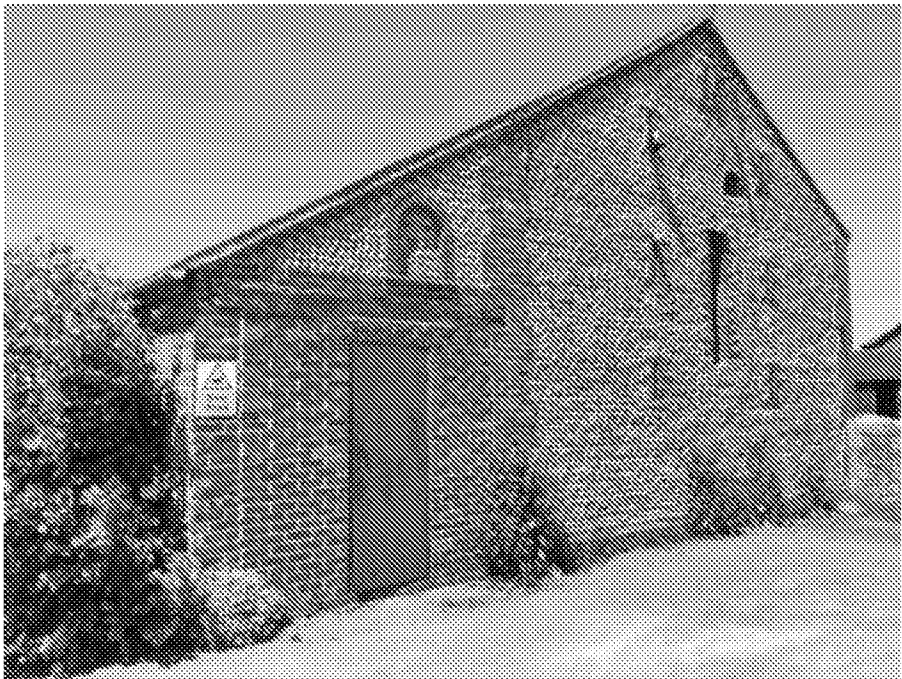
Side Elevation – The side elevation as you enter the courtyard has vertical cracking between the flint and brickwork at the corner of the building.

Building 4 – Side elevation as you enter the courtyard

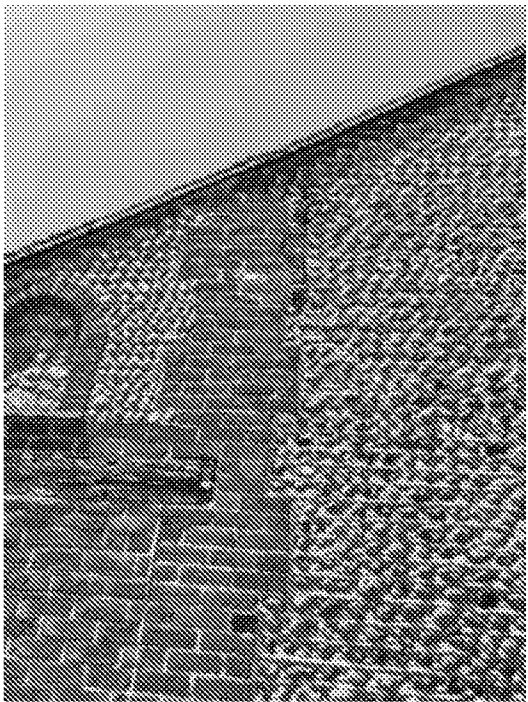
Building 4 – Cracking between flint and brickwork

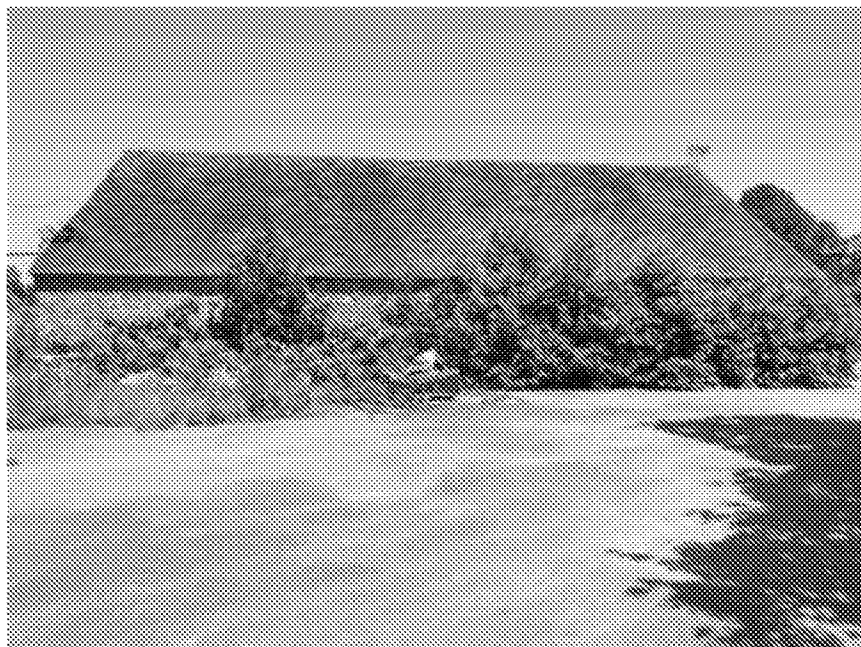
Rear Elevation – The rear elevation is covered with vegetation so is difficult to see the condition of the wall. There is a gutter at the eaves of the roof at the rear of the building.

Building 4 – Rear elevation covered in vegetation

**Rear Wall** – The rear wall could not be inspected in detail due to the vegetation growth. However, it is recommended new Catnic or similar lintels are installed for any new openings. Also, the elevation would need to be fully repointed. At this stage it is not considered a requirement to underpin this wall unless the removal of the ground floor and/or introduction of a new slab and insulation and lowering of the slab undermines the existing foundations. The depths of the existing foundation and proposed underpinning or new foundations are all subject the depth requirement for foundations in line with the NHBC Standards in relation to the soil type, plasticity of the soil and proximity and type of trees.

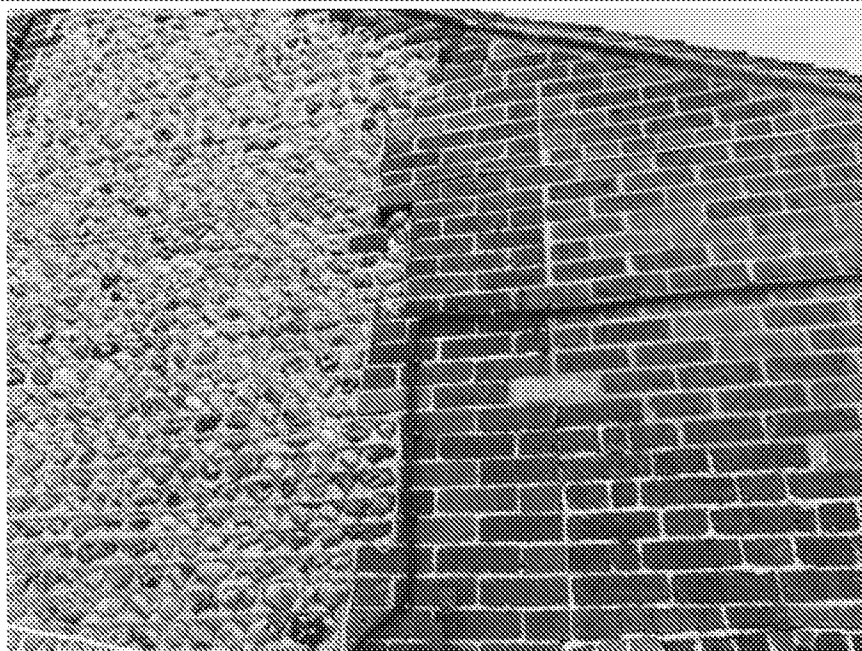
Side Elevation – The side elevation as you walk around the back of the buildings to the rear of building 3 had vertical cracking between the flint and brickwork at the corner of the building.

Building 4 – Side elevation to rear of building 3 showing cracking between flint and brickwork

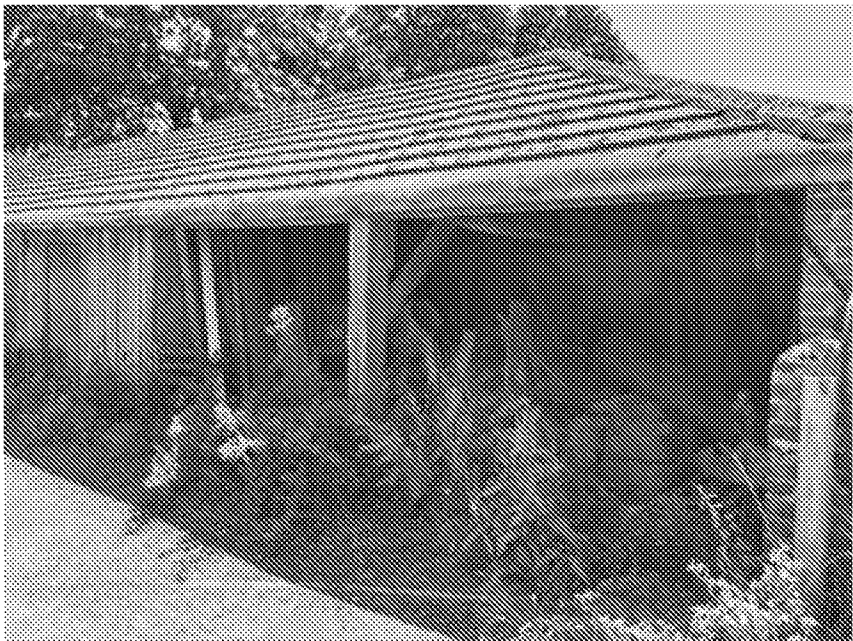
Building 5 – Front elevation showing the open bay end of the elevation

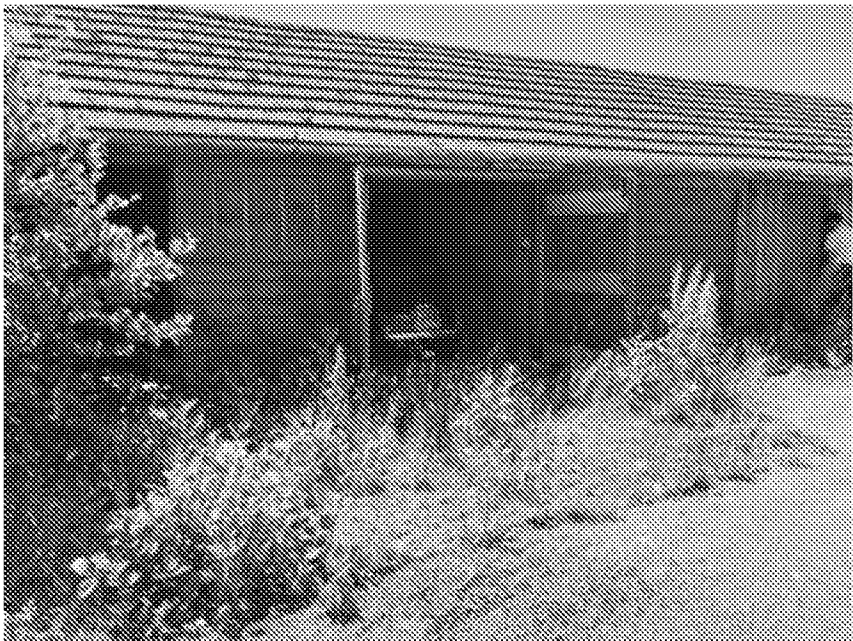
Building 5 – Front elevation showing timber clad sections of the elevation

Front Wall – The front brickwork/flint walls can be retained and underpinned to provide a good firm foundation, the existing timber cladding would need to be demolished and rebuilt, as they are not in very good condition and it is assumed there are no or minimal foundations supporting these walls. The posts supporting the main timber trusses are to be underpinned to be able to provide a good firm foundation. The new wall would need to be built off a new foundation that would be constructed between the underpin sections for the posts. The new walls would then provide a good solid support for the roof with new Catnic or

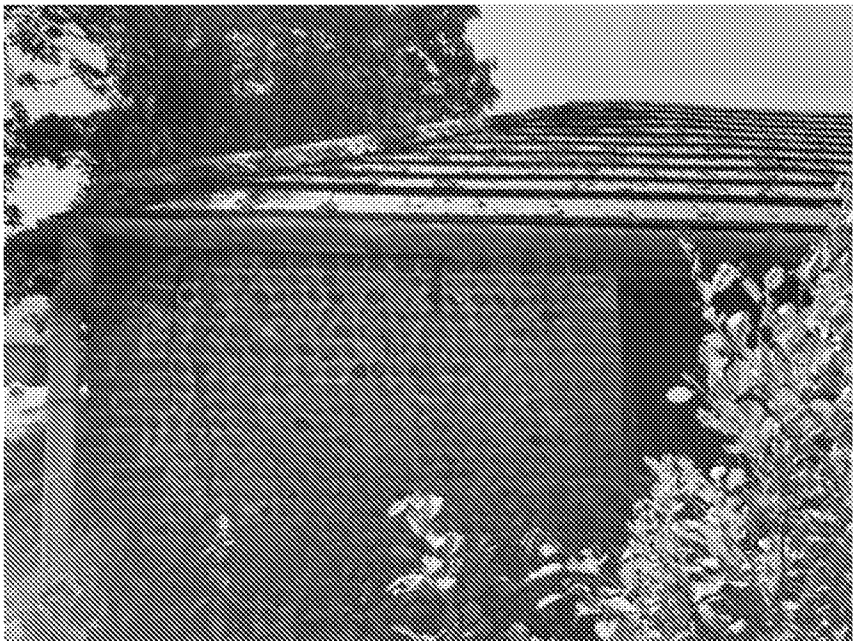
Front Elevation - The front elevation is formed from a series of timber cladding panels with a section of brickwork and flint at one end with 1 number large full height opening into the building at the other end. There was vertical cracking between the flint and brickwork at the corner of the building.

Building 5 – Front elevation showing the flint/brickwork end of the elevation and vertical crack

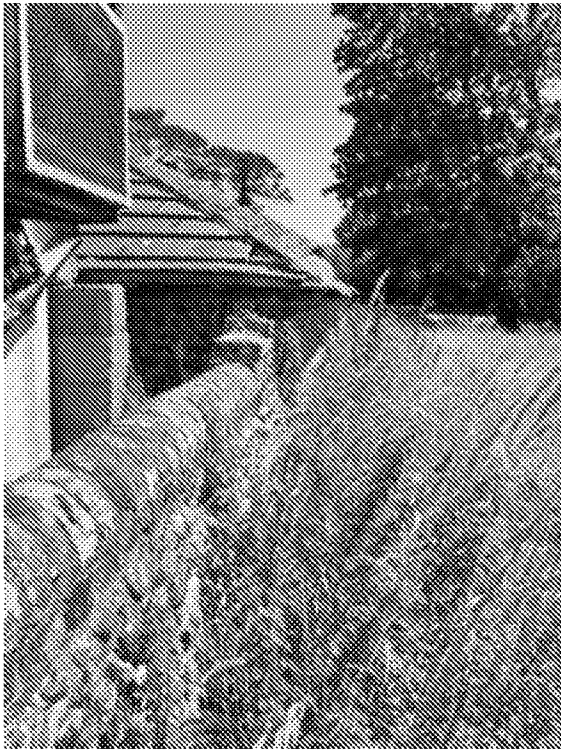
Rear Elevation – The rear elevation was covered with vegetation so was difficult to see the condition of the wall.

Building 5 – Rear elevation showing vegetation

Rear Wall - The rear wall could not be inspected in detail due to the vegetation growth. However, it is recommended new Catnic or similar lintels are installed for any new openings. Also, the elevation would need to be fully repointed. At this stage it is also recommended that this wall be fully underpinned to provide a good firm foundation, this is subject to determining the depth and profile of the existing foundations and bearing strata. Additionally this underpinning will allow the removal of the ground floor and/or introduction of a new slab and insulation and lowering of the slab which may undermine the existing foundations. The depths of the existing foundation and proposed underpinning or new foundations are all subject the depth requirement for foundations in line with the NHBC Standards in relation to the soil type, plasticity of the soil and proximity and type of trees.

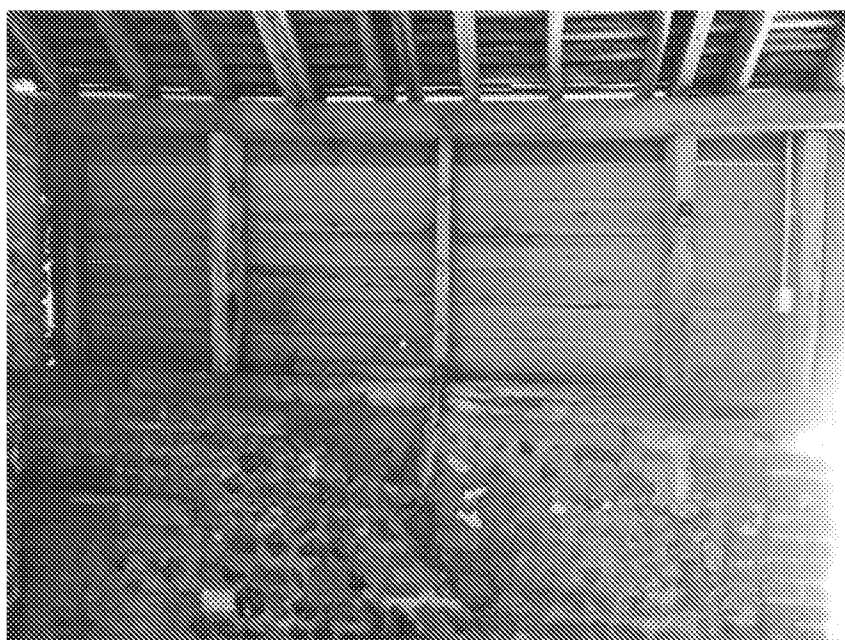
Building 1 – Low level flint and brickwork wall with timber clad above

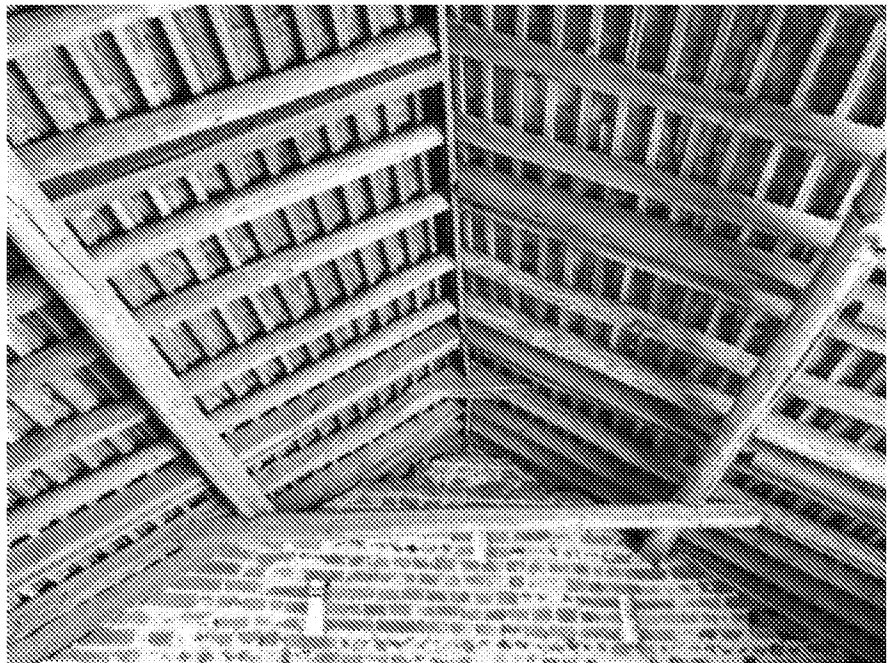
Building 1 – Roof rafters with purlins and one number collar/ties for lateral restraint

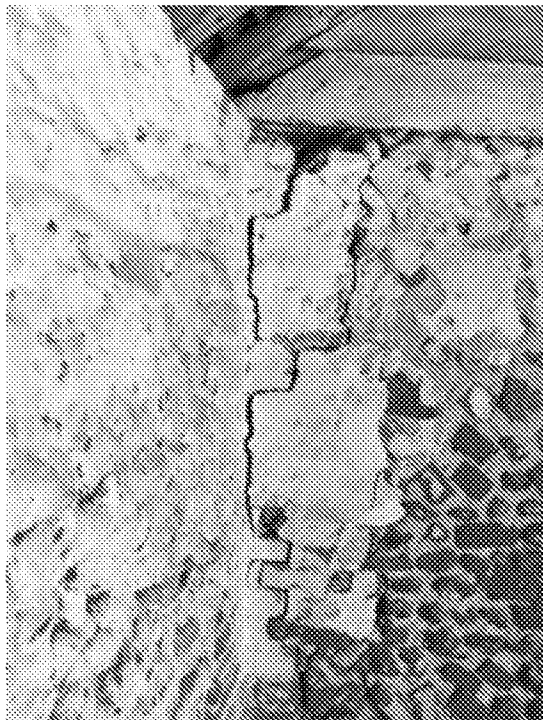
The roof for the building is formed from a series of timber trusses with timber purlins and rafters between. There is evidence of roof spread at the rear wall as the rear wall is clearly leaning outwards. There is also varying degrees of cracking between the rear wall and internal room division walls, which substantiates the suggestion that there has been lateral movement at eaves level. The most significant areas of lateral movement appeared in the areas where there were only a limited number of collars/ties between rafters. In rooms where there were roof trusses present, the lateral movement was less. There are also locations where the truss bearing onto the wall was reduced to approx. 30mm on the rear wall, due to the spreading at eaves level. There is evidence of decaying timbers in areas due to the fact that the rooms are exposed to the elements.

Building 1 – Typical vertical cracking in return wall at junction of rear wall where there has been roof spread

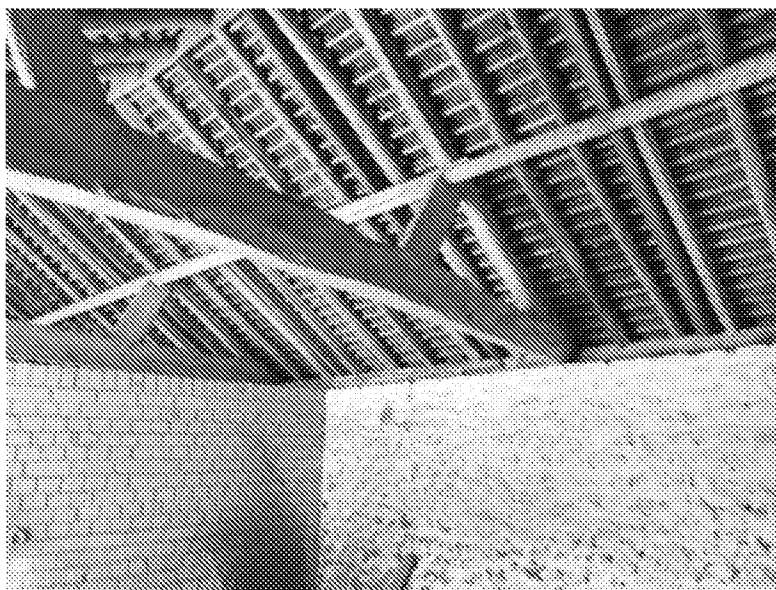
Building 1 – Typical roof truss

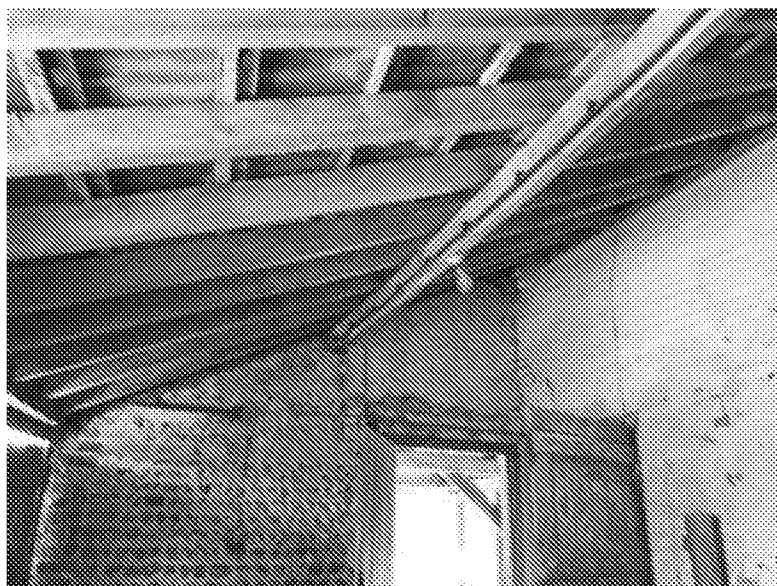
Building 2 – Single storey area with mono-pitched roof, showing diagonal cracking above doorway

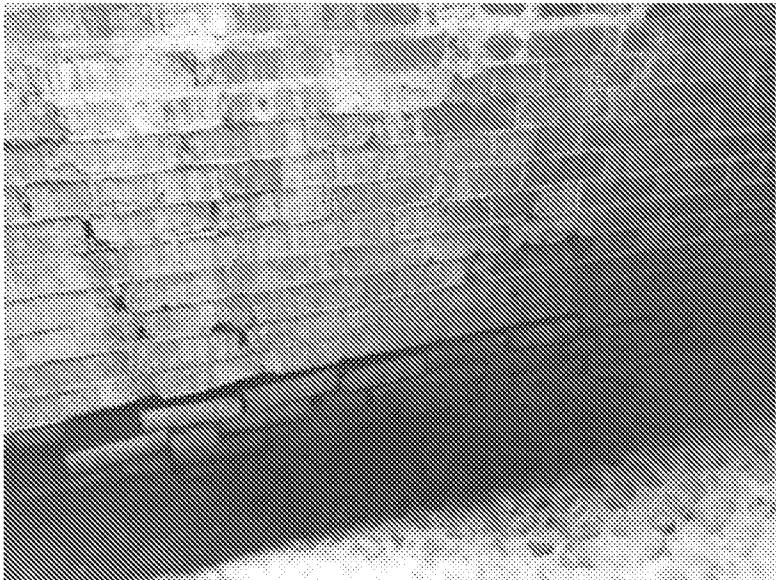
Building 2 – Loose/missing brickwork at low level

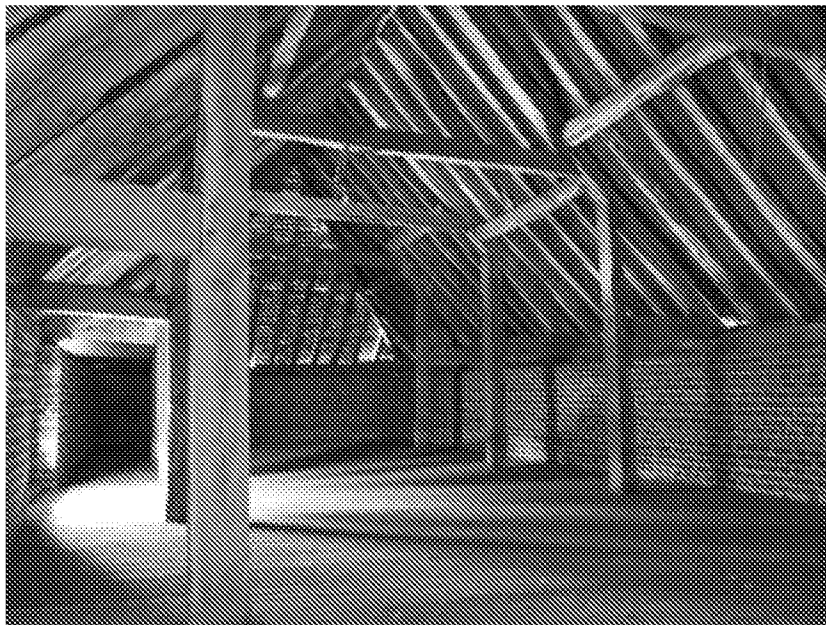
The first roof consisted of a series of timber roof trusses, purlins and rafters.

Building 2 – Timber roof trusses

Roof – New timber rafters may need to be provided to strengthen the existing roof to be able to support the roof covering, insulation and plasterboard and provide a level datum to recover the roof and straighten the ridge line. New ceiling collars/ties may also need to be installed to prevent or limit any future spread at the eaves level. The introduction of new ceiling collars is subject to a detailed design as these may not be required for this roof. Subject to a timber survey and a detailed design there may be areas where existing timbers need to be locally cut away and new sections of timber inserted. The roof structure would need to be fully strapped to all walls with galvanized mild steel restraint straps @ maximum 1200mm centers.

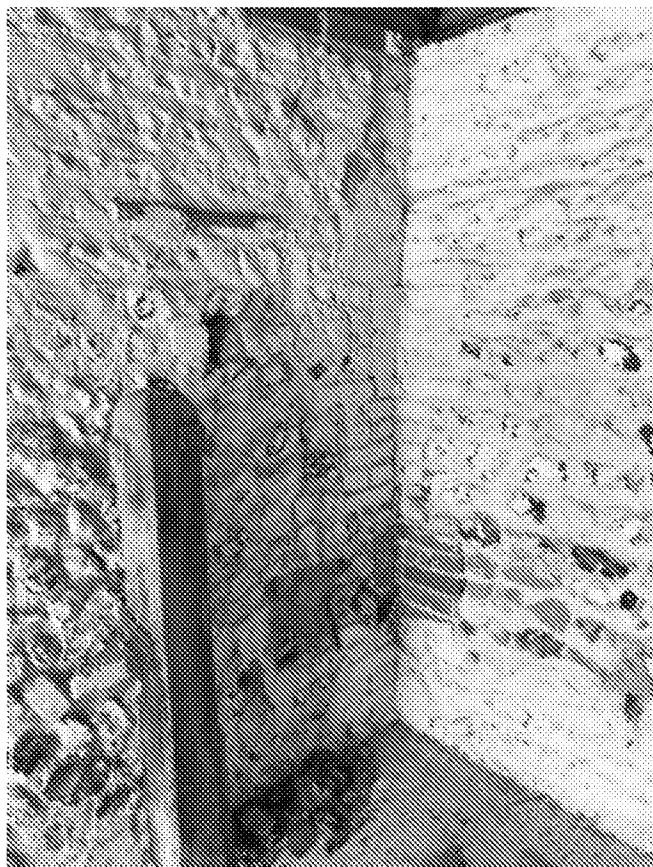
The roof for the building is formed from a series of timber trusses formed of rafters, ties, collars and timber purlins. There is evidence of roof spread at the rear wall. There is also varying degrees of cracking between the rear wall and internal room division walls, which substantiates the lateral movement at eaves level.

Building 3 – Cracking at internal return wall and rear wall

Internal/Side Walls – All original internal and side walls that are to be retained are to be underpinned to provide a good solid foundation to each wall. These walls are to be fixed back to the rear wall running perpendicular with Helifix ties or similar to provide a lateral restraint at each junction. Where possible it would also be prudent to carry out some local stitch repairs between walls. The depths of the existing foundation and proposed underpinning or new foundations are all subject the depth requirement for foundations in line with the NHBC Standards in relation to the soil type, plasticity of the soil and proximity and type of trees.

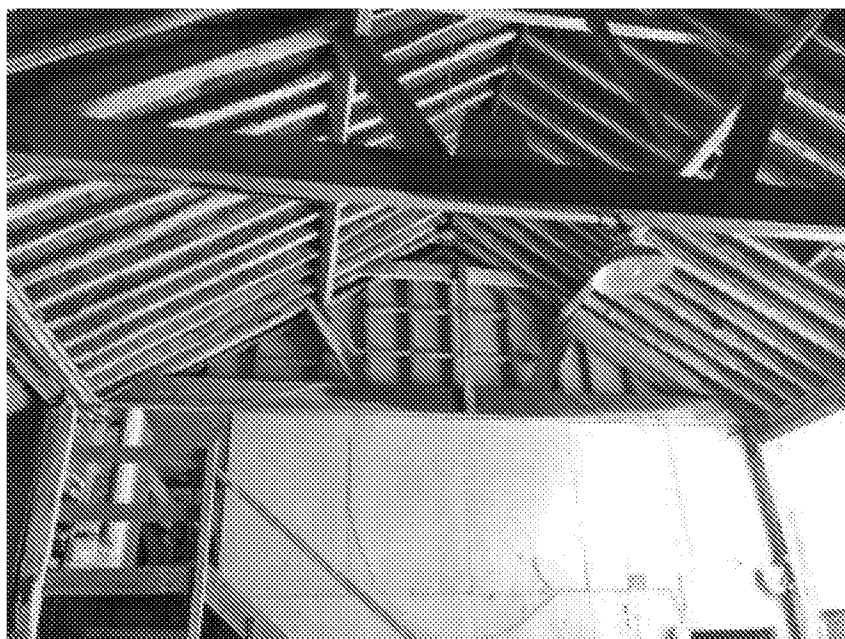
Building 4 – Main space with timber trusses showing steps to first floor level

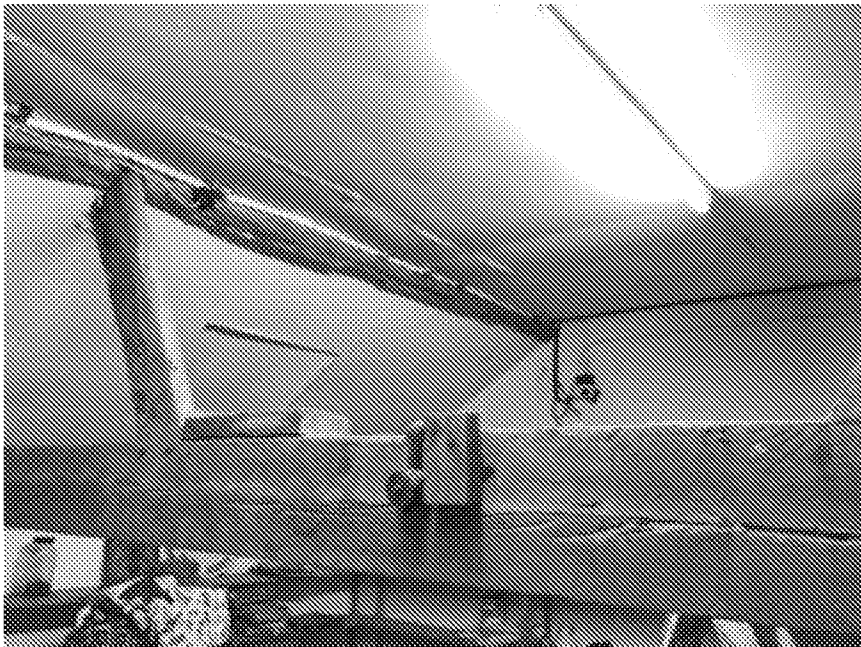
Building 4 – Trusses partially exposed at first floor level

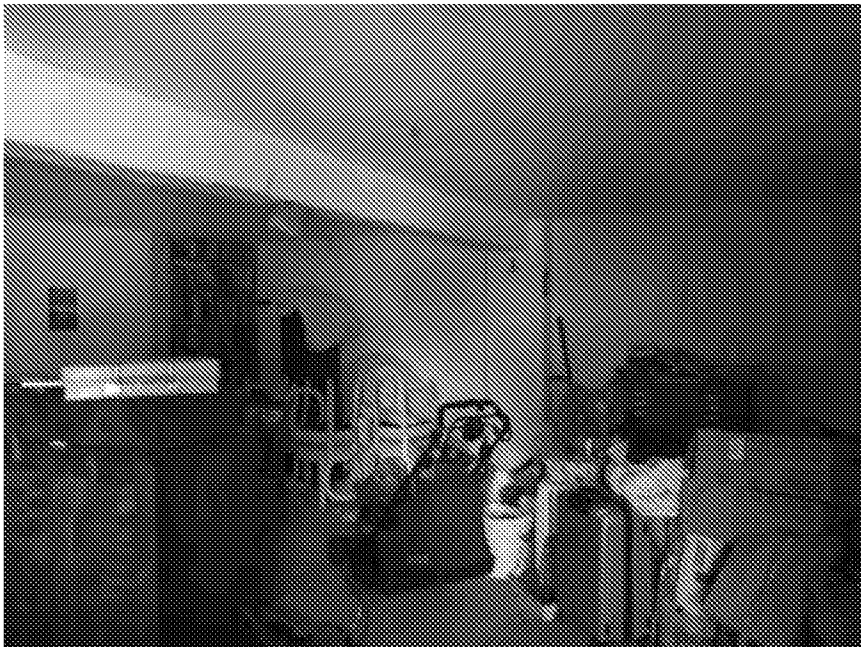
Building 4 – Boxed in steel beam supporting first floor joists
