Project Name: Stakers Farm Barns, Yapton, BN10 0PU

QED Ref: 19-211

Date of Issue: 26 July 2019

Date of Site Visit: 27 June 2019

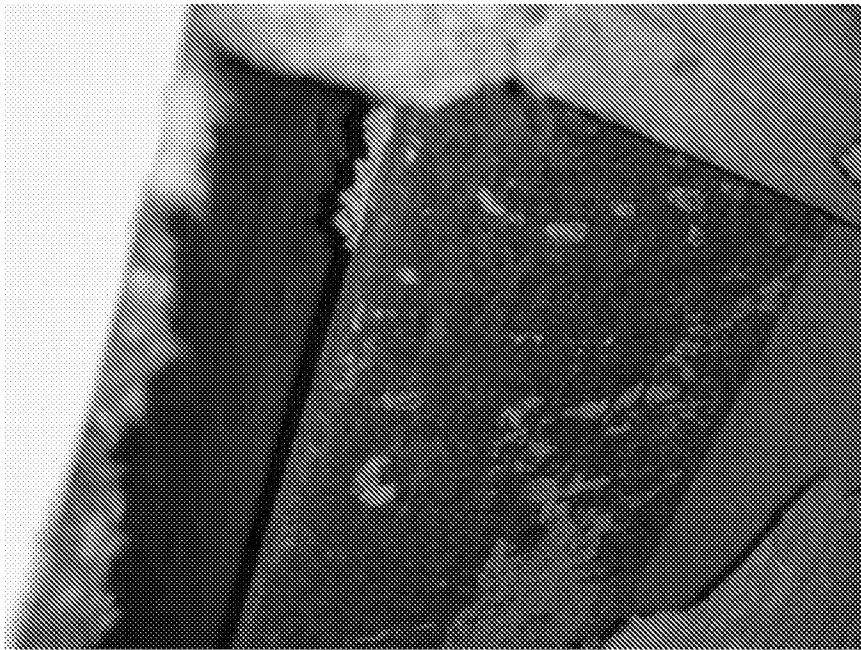
Room 11 – This room has an additional floor added at first floor level, there is a steel beam splitting the span of the timber floor joists, the steel beam is slightly corroded. The steel beam is then supported on masonry piers each end. All walls at ground floor level are boarded or finished therefore it was not possible to see the condition of the brickwork/flint walls. At first floor level the walls are also boarded or finished with some of the timber trusses exposed. The areas of timber truss visible appeared to be in good condition.

Building 4 – Corroded steel beam supporting first floor joists

Existing First Floor – If this section of floor is to be retained, a design check would need to be undertaken on the existing steel beams and joists to ensure they are sufficient for proposed dead and live load requirements. If they are deemed to be insufficient, they can either be strengthened or replaced to suit. The first floor structure would then be fixed back to the existing walls to provide lateral support to the existing walls with slotted holes, so that it only provide lateral restraint and not transfer any vertical load.

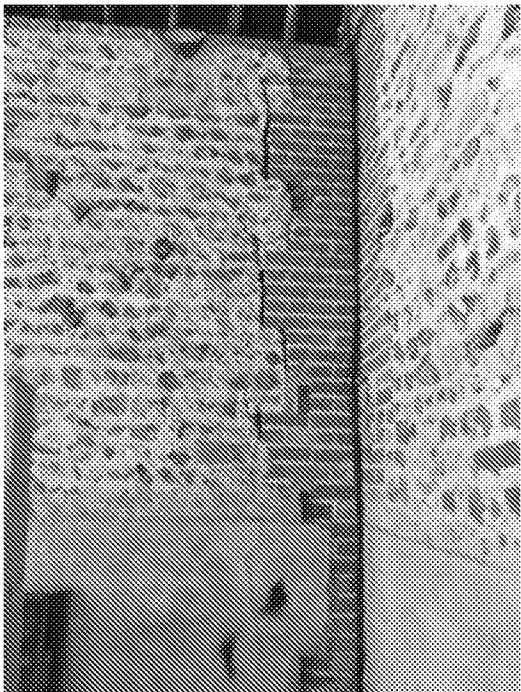
Room 13 – This is the main space to the building with 4 main trusses within the space spanning front to back with purlins and rafters. There is general vertical cracking between the flint and brickwork wall section. The ground floor is concrete.

Building 4 – Typical vertical cracking between brickwork and flint

**Front Wall** – The front brickwork wall appeared to be in relatively good condition with only cracking apparent at the junction of the brickwork and flint sections of wall. Helifix ties or similar are to be provided across any cracked joints between brickwork walls and flint walls. It is recommended new Catnic or similar lintels are installed for all openings. The elevation would need to be fully repointed. At this stage it is not considered a requirement to underpin this wall unless the removal of the ground floor and/or introduction of a new slab and insulation and lowering of the slab undermines the existing foundations. The timber frame around the main door opening is to be either strengthened and treated or replaced with a galvanized steel frame. The depths of the existing foundation and proposed underpinning or new foundations are all subject the depth requirement for foundations in line with the NHBC Standards in relation to the soil type, plasticity of the soil and proximity and type of trees.

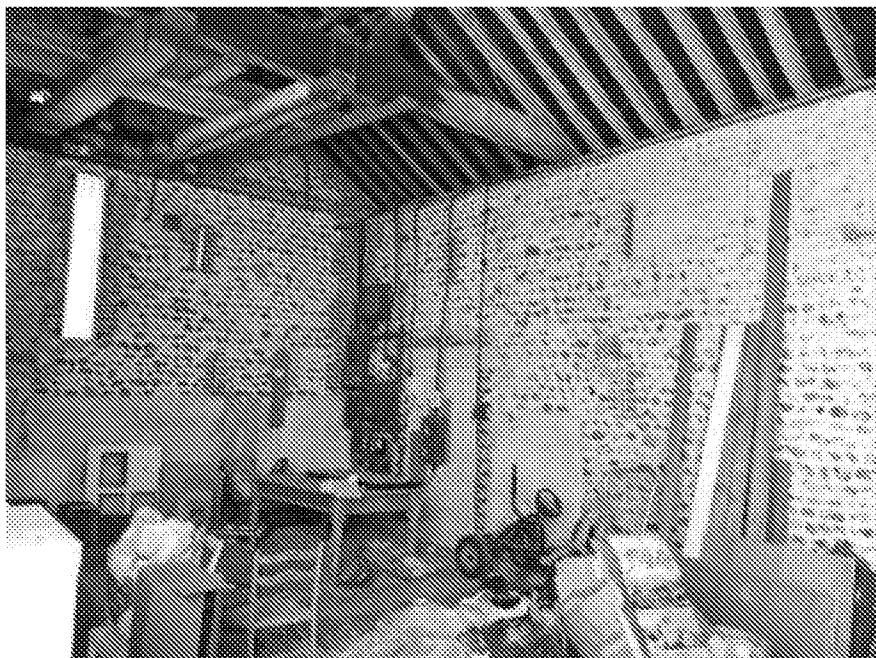
Building 4 – General view of high external walls

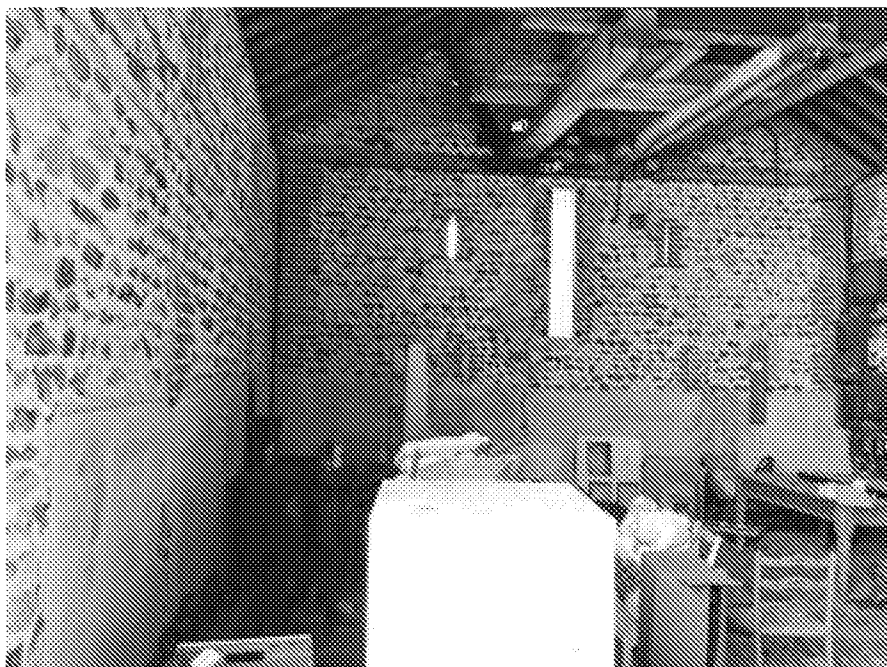
Building 4 – General view of high external walls

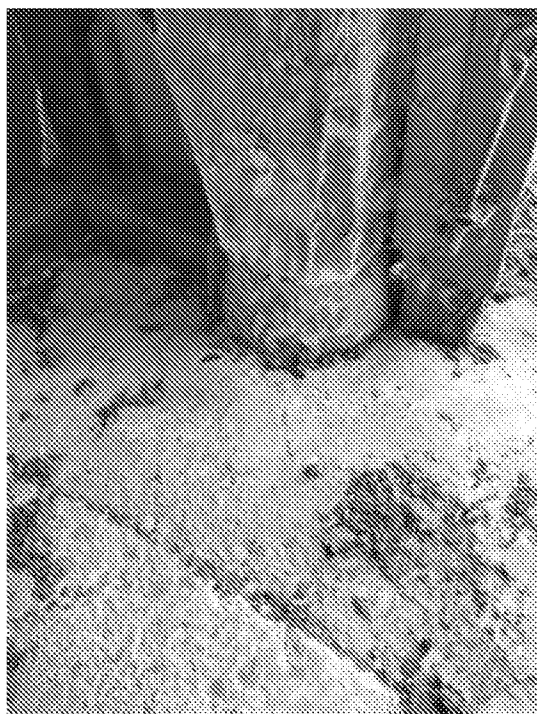
Building 5 – Good condition base of post to room 17 on top of concrete plinth

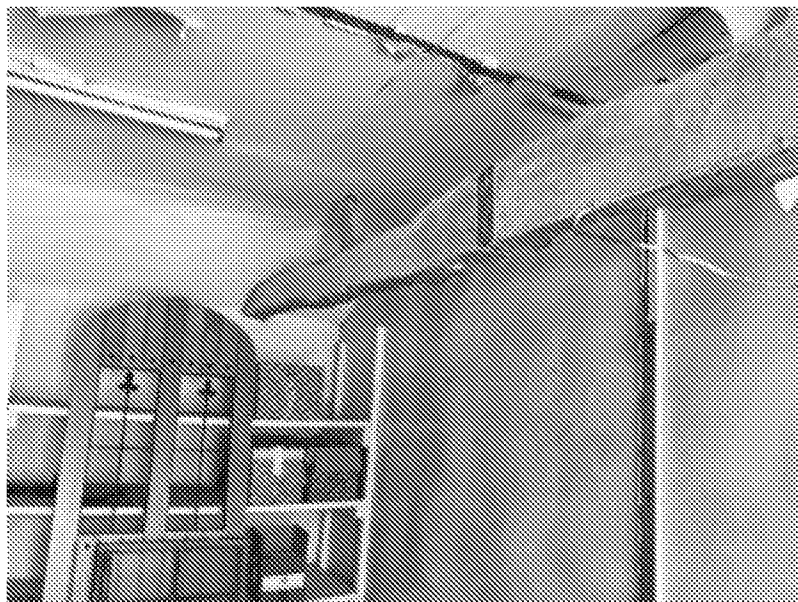
Building 5 – Boarded out room with bottom chord of truss visible

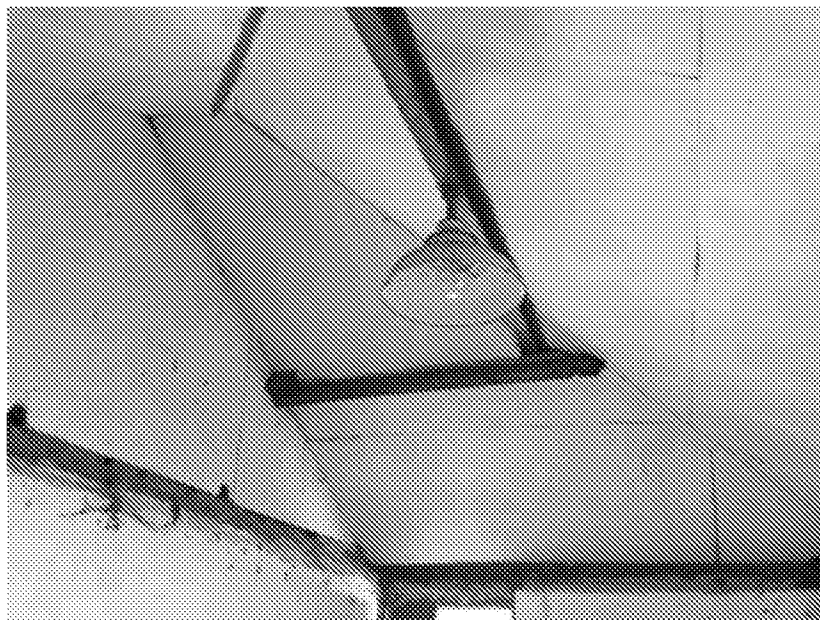
Building 5 – Full roof not visible only a purlins and wall plates
