## **Road Safety Audit Stage 1/2**

### **Temporary Construction Access**

#### **Ford Lane**

Report Title Road Safety Audit Stage 1/2

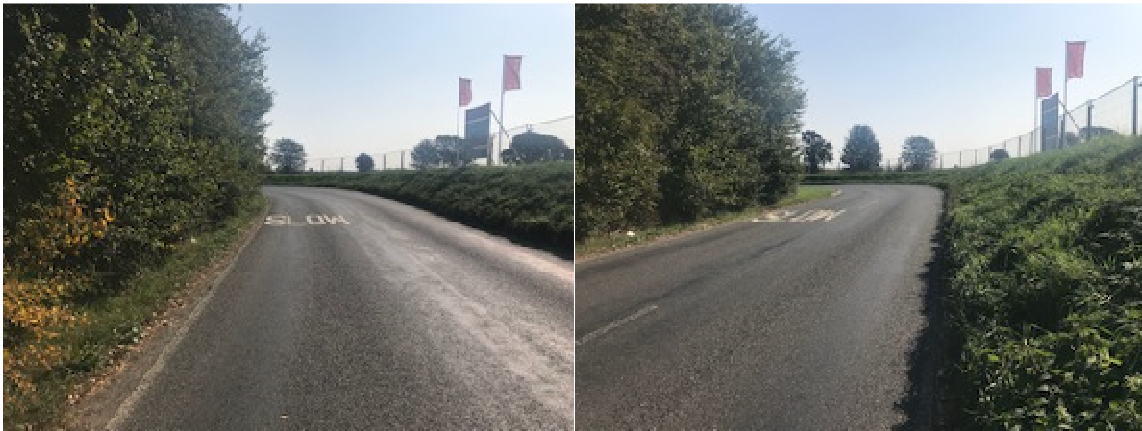
Ford Lane is subject to National speed limit, visibility splays have been provided for 34m and 43m for the proposed access, which may be insufficient for the vehicle approach speeds. Further, no forward visibility splays have been provided for vehicles waiting to turn right into the proposed access where visibility is restricted see figures 1 and 2 below.

Figures 1 and 2: Restricted visibility.

Insufficient visibility splays and forward visibility splays could lead to rear end shunt head on or side impact collisions.

It is recommended that forward and junction visibility splays should be commensurate with traffic speeds. Further that forward visibility splays and traffic speeds should be provided for assessment.
