## TEMPORARY CONSTRUCTION ACCESS, FORD LANE, YAPTON, WEST SUSSEX

### DESIGNER'S RESPONSE TO ROAD SAFETY AUDIT STAGE 1/2

**Project:** 18-344

**Report No.:** 18-344-18

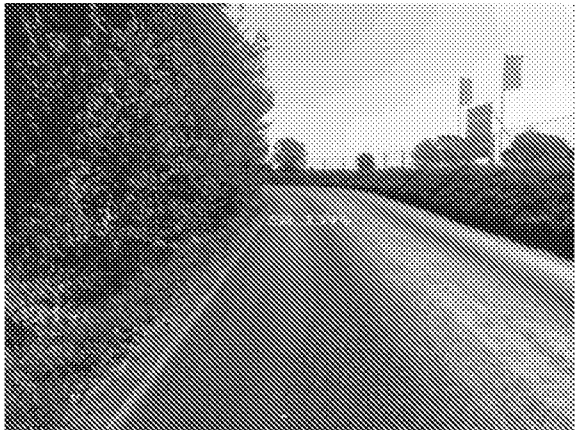
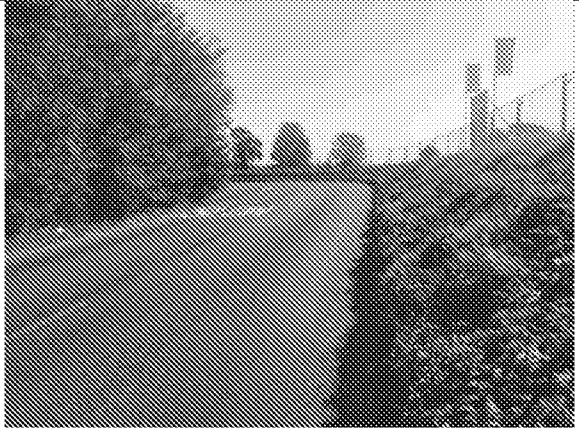
| Audit Item No. | Audit Team Observation | Audit Team Recommendation | Odyssey Designer's Response | Client Comment |
|---|---|---|---|---|
| | <p><b>Location:</b> At the proposed access.</p> <p><b>Summary:</b> Insufficient visibility could lead rear end shunt head on or side impact collisions.</p> | It is recommended that forward and junction visibility splays should be commensurate with traffic speeds. Further that forward | Visibility splays are provided/based on a 30mph speed limit. This will be the revised speed limit as part of the future/final works. | |

| Audit Item No. | Audit Team Observation | Audit Team Recommendation | Odyssey Designer's Response | Client Comment |
|---|---|---|---|---|
| | <p>Ford Lane is subject to National speed limit, visibility splays have been provided for 34m and 43m for the proposed access, which may be insufficient for the vehicle approach speeds. Further, no forward visibility splays have been provided for vehicles waiting to turn right into the proposed access where visibility is restricted see figures 1 and 2 below.</p> <p>Insufficient visibility splays and forward visibility splays could lead to rear end shunt head on or side impact collisions.</p> | <p>visibility splays and traffic speeds should be provided for assessment.</p> | | |

| Audit Item No. | Audit Team Observation | Audit Team Recommendation | Odyssey Designer's Response | Client Comment |
|---|---|---|---|---|
| | <p>Figures 1 and 2: Restricted visibility.</p> | | | |
