## **Road Safety Audit Stage 1/2**

### **Temporary Construction Access**

#### **Ford Lane**

**Date: 22<sup>nd</sup> September 2020**

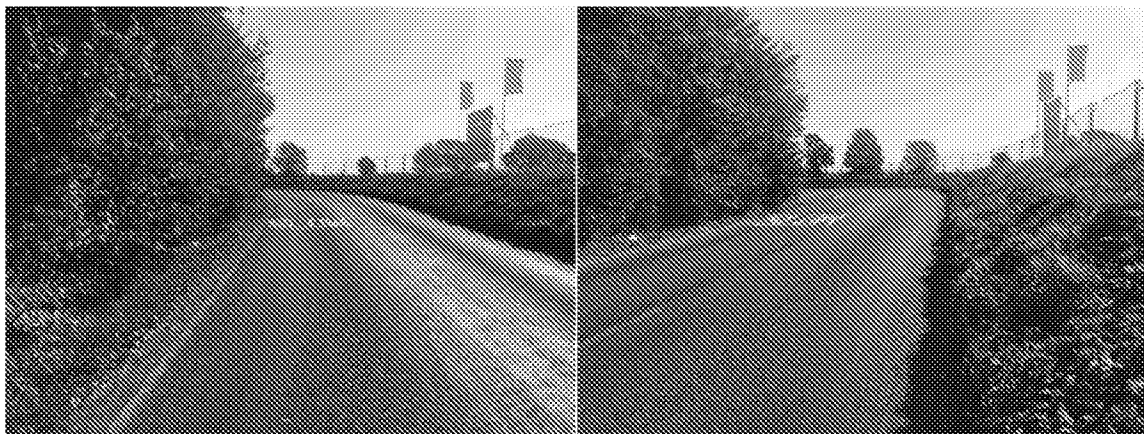
Ford Lane is subject to National speed limit, visibility splays have been provided for 34m and 43m for the proposed access, which may be insufficient for the vehicle approach speeds. Further, no forward visibility splays have been provided for vehicles waiting to turn right into the proposed access where visibility is restricted see figures 1 and 2 below.

Figures 1 and 2: Restricted visibility.

Insufficient visibility splays and forward visibility splays could lead to rear end shunt head on or side impact collisions.

It is recommended that forward and junction visibility splays should be commensurate with traffic speeds. Further that forward visibility splays and traffic speeds should be provided for assessment.
