Project Name: Stakers Farm Barns, Yapton, BN10 0PU

QED Ref: 19-211

Date of Issue: 26 July 2019

Date of Site Visit: 27 June 2019

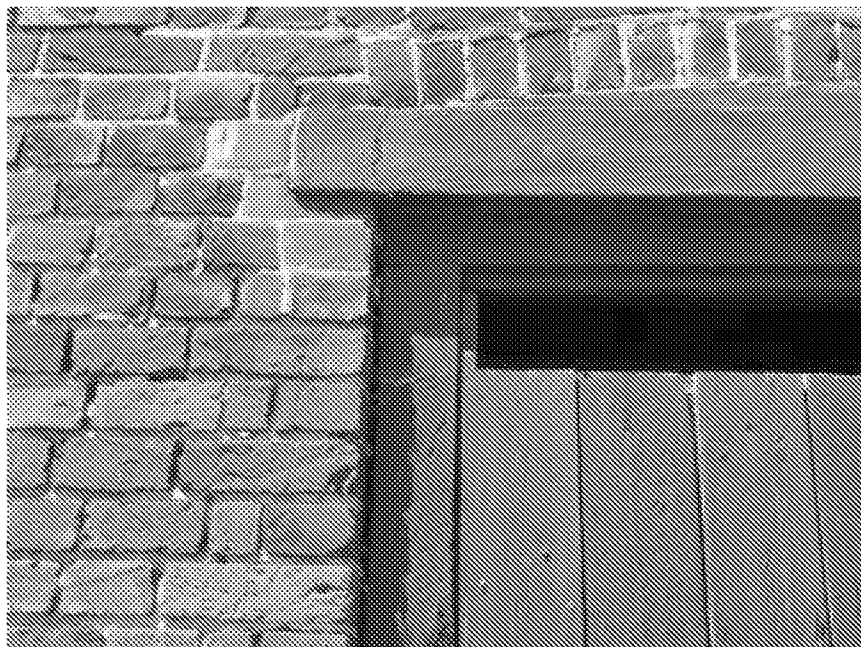
Building 2 – Front elevation showing vertical crack through the lintel above one of the doors

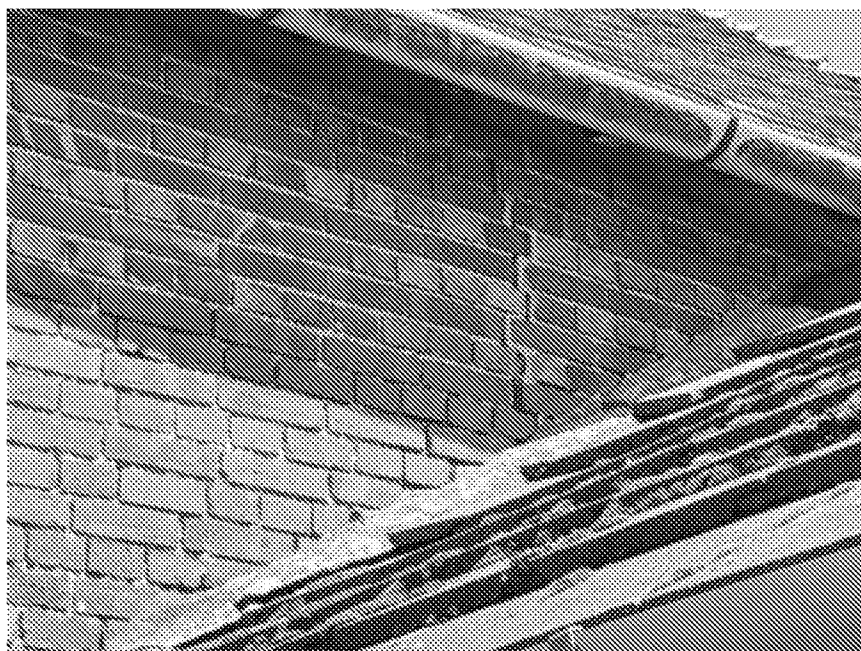
Rear Elevation –The rear elevation was solid brickwork with no openings. There was some vertical cracking on the side wall at high level which abuts Building 3. There is an eaves gutter and downpipe at one corner of the rear elevation.

Building 2 – Side elevation showing vertical cracking in side wall abutting Building 3

End/Side Walls – It is recommended that these walls may require underpinning to provide a good solid foundation to each wall due to the cracking visible. This underpinning may need to be extended around the corners of the front and rear walls to a degree to avoid any hard spots and future cracking. This is however subject to more intrusive investigation works with regards to the existing foundations. It is recommended a series of trial pits be dug to be able to ascertain the depth and profile of the existing foundation and the type of bearing strata. Helifix ties or similar to are to be installed across the cracks together with replacement of any cracked bricks. However, if the front and rear walls require underpinning as described above, it would be prudent and advisable to also underpin these walls to avoid any hard spots and potential long term cracking. The depths of the existing foundation and proposed underpinning or new foundations are all subject the depth requirement for foundations in line with the NHBC Standards in relation to the soil type, plasticity of the soil and proximity and type of trees.

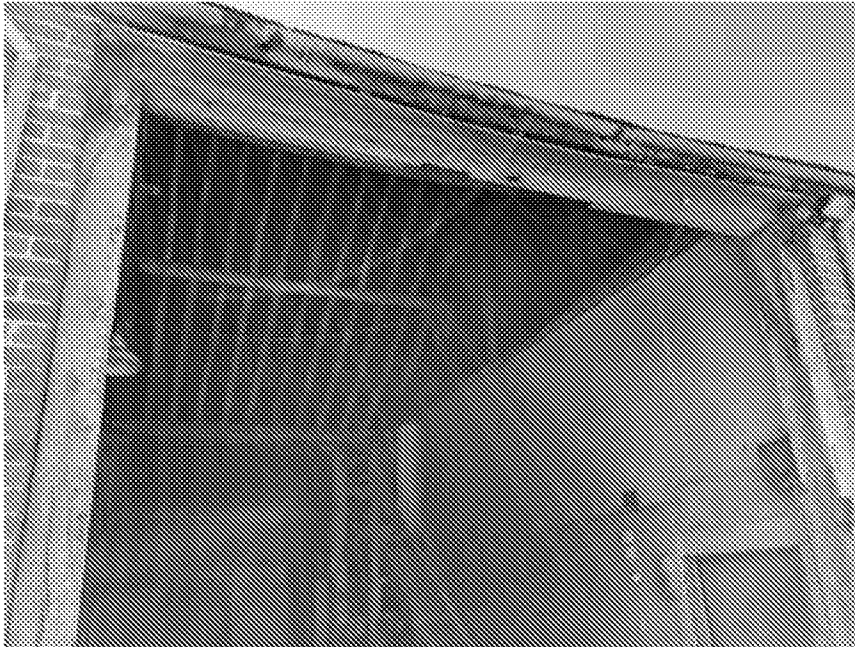
Building 4 – Sagging timber beam at eaves level of door opening

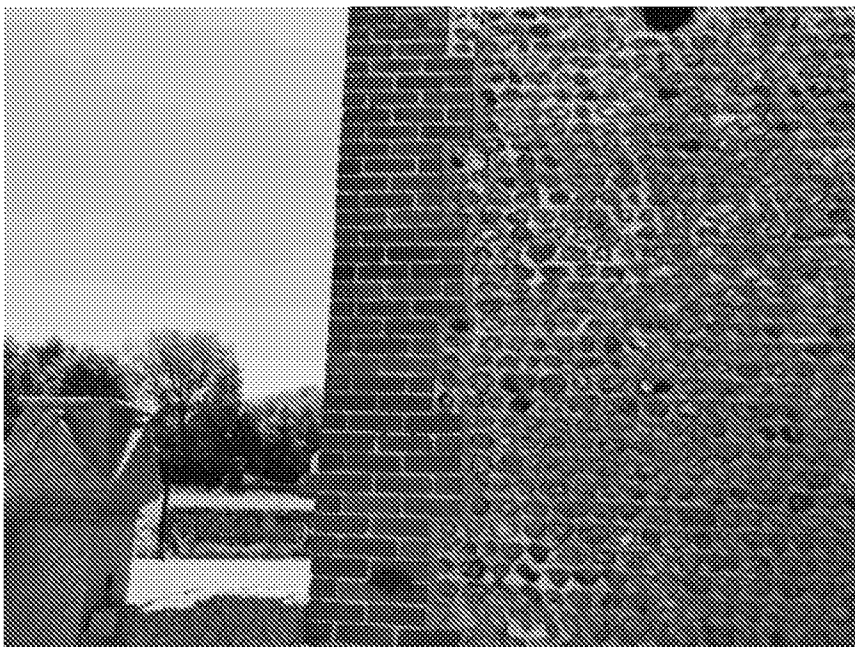
Side Elevation – The side elevation as you enter the courtyard has vertical cracking between the flint and brickwork at the corner of the building.

Building 4 – Cracking between flint and brickwork on corner

Front Wall – The front brickwork wall appeared to be in relatively good condition with only cracking apparent at the junction of the brickwork and flint sections of wall. Helifix ties or similar are to be provided across any cracked joints between brickwork walls and flint walls. It is recommended new Catnic or similar lintels are installed for all openings. The elevation would need to be fully repointed. At this stage it is not considered a requirement to underpin this wall unless the removal of the ground floor and/or introduction of a new slab and insulation and lowering of the slab undermines the existing foundations. The timber frame around the main door opening is to be either strengthened and treated or replaced with a galvanized steel frame. The depths of the existing foundation and proposed underpinning or new foundations are all subject the depth requirement for foundations in line with the NHBC Standards in relation to the soil type, plasticity of the soil and proximity and type of trees.

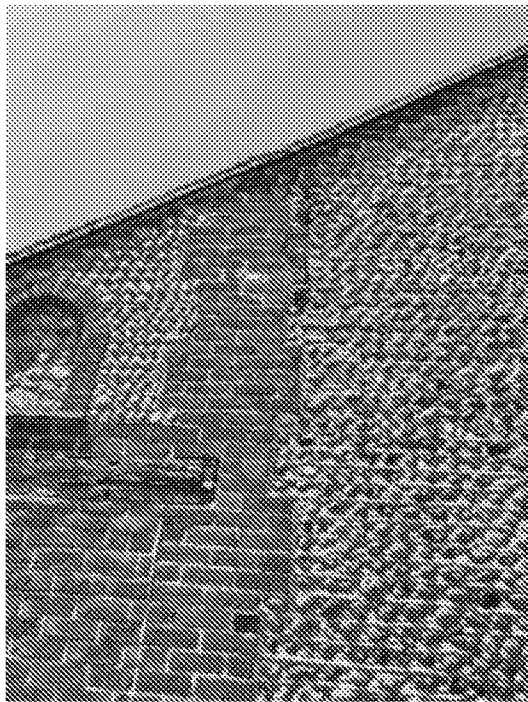
Building 4 – Cracking between flint and brickwork

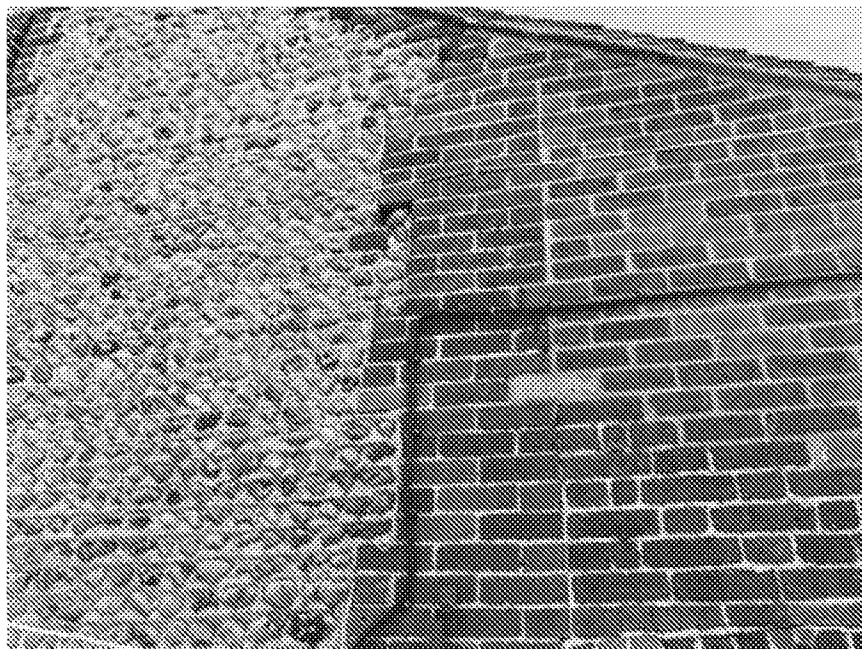
Side Elevation – The side elevation as you walk around the back of the buildings to the rear of building 3 had vertical cracking between the flint and brickwork at the corner of the building.

Building 4 – Side elevation to rear of building 3 showing cracking between flint and brickwork

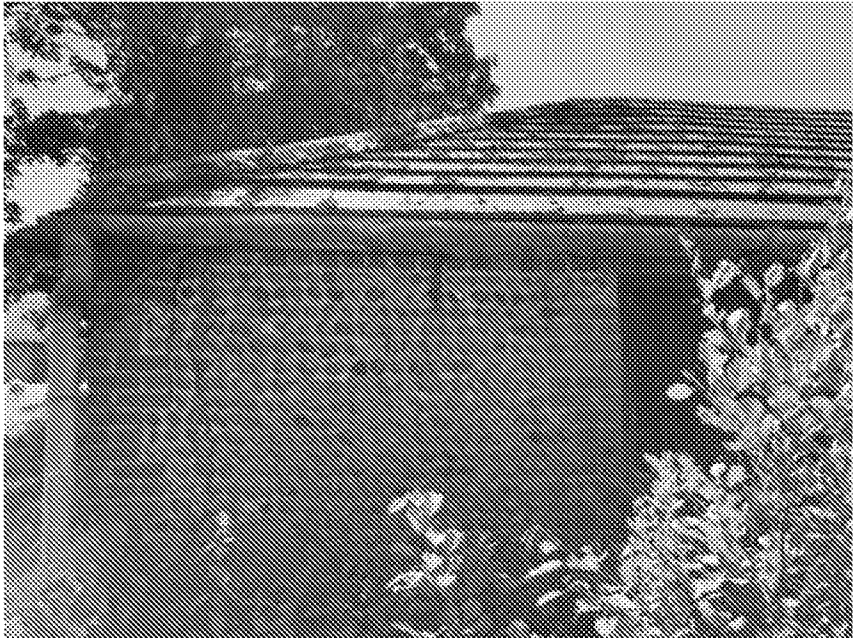
Front Elevation - The front elevation is formed from a series of timber cladding panels with a section of brickwork and flint at one end with 1 number large full height opening into the building at the other end. There was vertical cracking between the flint and brickwork at the corner of the building.

Building 5 – Front elevation showing the flint/brickwork end of the elevation and vertical crack

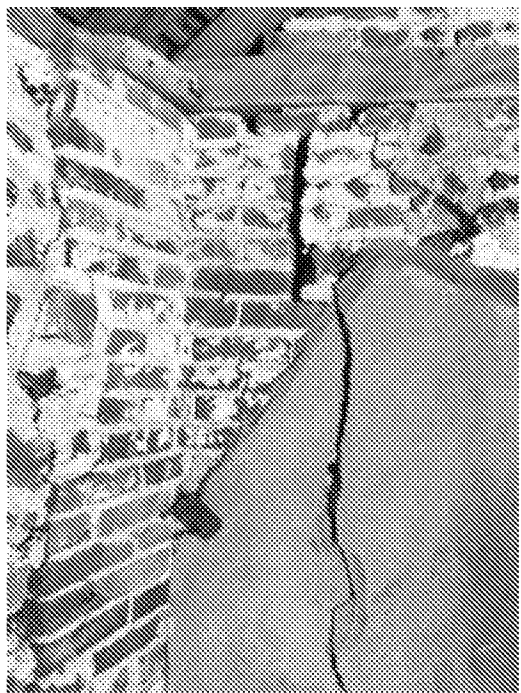
The roof for the building is formed from a series of timber trusses with timber purlins and rafters between. There is evidence of roof spread at the rear wall as the rear wall is clearly leaning outwards. There is also varying degrees of cracking between the rear wall and internal room division walls, which substantiates the suggestion that there has been lateral movement at eaves level. The most significant areas of lateral movement appeared in the areas where there were only a limited number of collars/ties between rafters. In rooms where there were roof trusses present, the lateral movement was less. There are also locations where the truss bearing onto the wall was reduced to approx. 30mm on the rear wall, due to the spreading at eaves level. There is evidence of decaying timbers in areas due to the fact that the rooms are exposed to the elements.

Building 1 – Typical vertical cracking in return wall at junction of rear wall where there has been roof spread

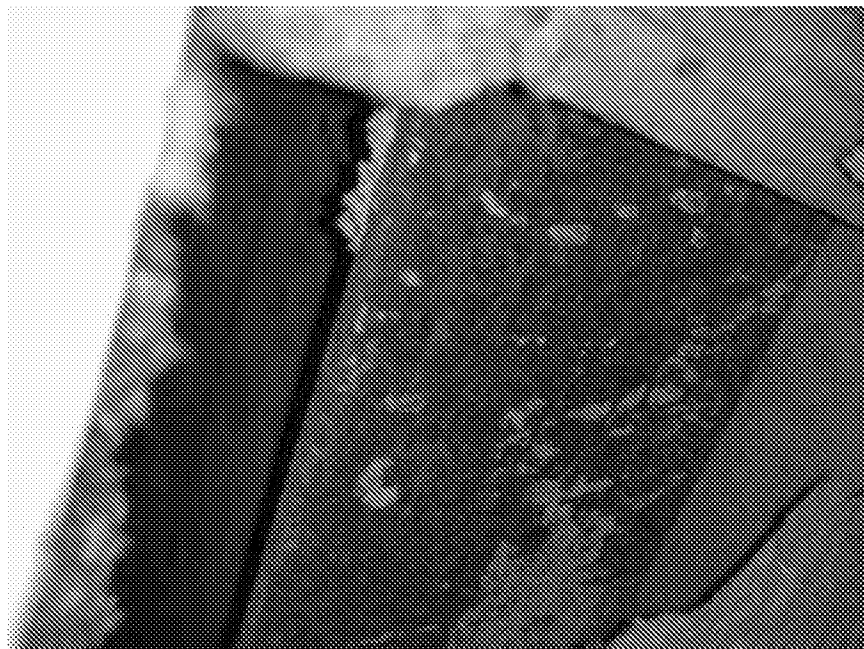
Room 11 – This room has an additional floor added at first floor level, there is a steel beam splitting the span of the timber floor joists, the steel beam is slightly corroded. The steel beam is then supported on masonry piers each end. All walls at ground floor level are boarded or finished therefore it was not possible to see the condition of the brickwork/flint walls. At first floor level the walls are also boarded or finished with some of the timber trusses exposed. The areas of timber truss visible appeared to be in good condition.

Building 4 – Corroded steel beam supporting first floor joists

Existing First Floor – If this section of floor is to be retained, a design check would need to be undertaken on the existing steel beams and joists to ensure they are sufficient for proposed dead and live load requirements. If they are deemed to be insufficient, they can either be strengthened or replaced to suit. The first floor structure would then be fixed back to the existing walls to provide lateral support to the existing walls with slotted holes, so that it only provide lateral restraint and not transfer any vertical load.

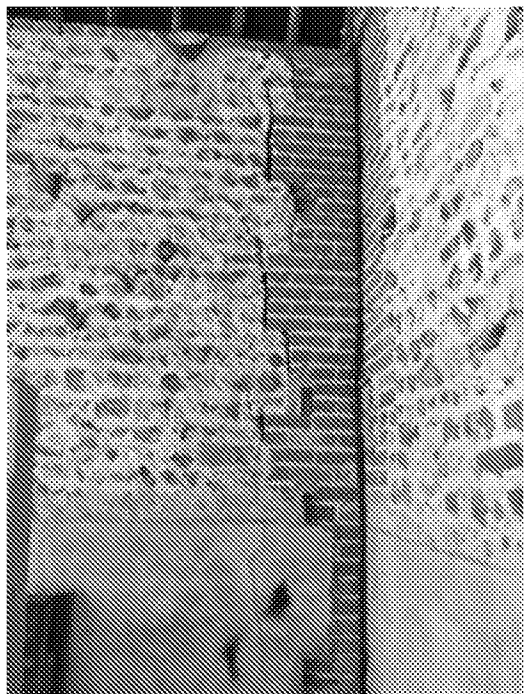
Room 13 – This is the main space to the building with 4 main trusses within the space spanning front to back with purlins and rafters. There is general vertical cracking between the flint and brickwork wall section. The ground floor is concrete.

Building 4 – Typical vertical cracking between brickwork and flint
