**Project Name:** NRS - Yapton 150 Repair

**Project Date:** 26/10/2024

**Inspection Standard:** MSCC5 Sewers & Drainage GB (SRM5 Scoring)

Section Inspection - 26/10/2024 - S63X

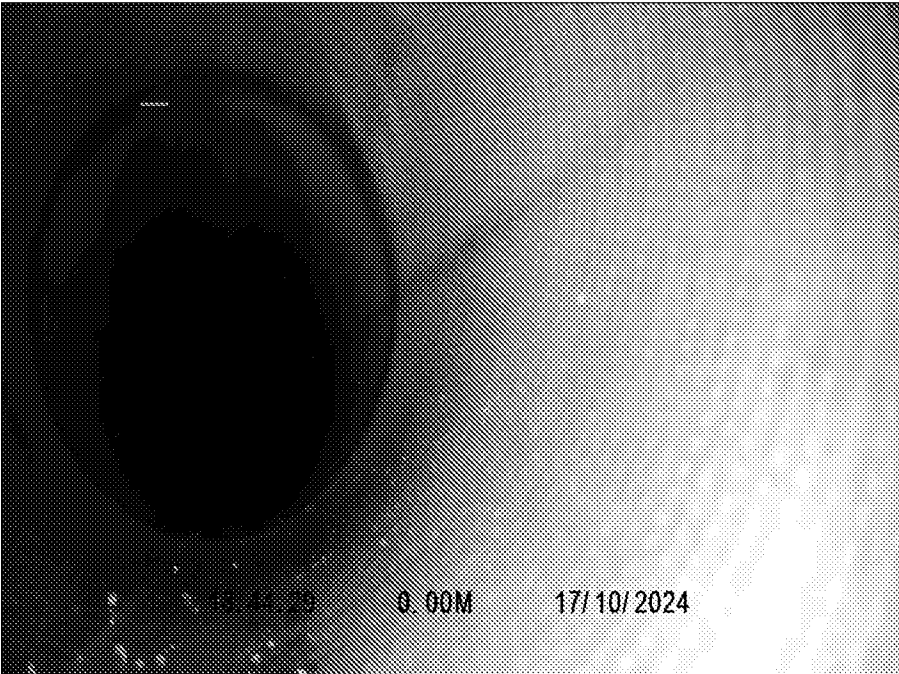
| Scale: | 1:108 | Position [m] | Code | Observation | MPEG | Photo | Grade |
|---|---|---|---|---|---|---|---|
| | | 0.00 | S01 RPL | Point repair, localised lining from 12 o'clock to 11 o'clock, start | 00:00:01 | S63X_f38e<br>e997-3b44<br>-406a-b7ef | |

S63X\_f38ee997-3b44-406a-b7ef-44aa1784214f\_20241026\_135059\_033.jpg, 00:00:01, 0.00 m  
Point repair, localised lining from 12 o'clock to 11 o'clock, start
