**Project Name:** NRS - Yapton 225 Repair Survey

**Project Date:** 26/10/2024

**Inspection Standard:** MSCC5 Sewers & Drainage GB (SRM5 Scoring)

Section Inspection - 25/10/2024 - S65X

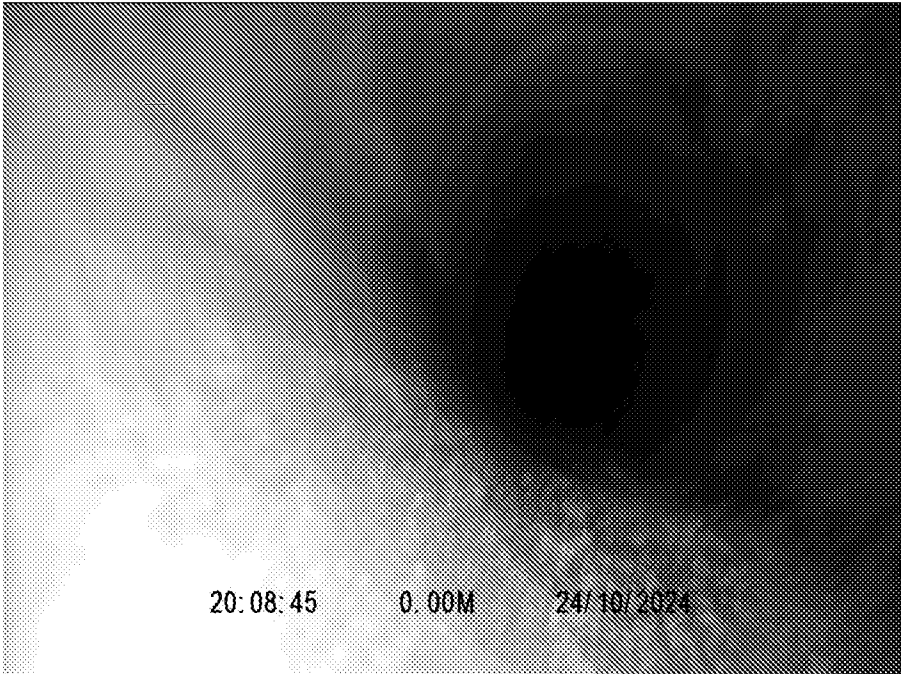
| Scale: | 1:285 | Position [m] | Code | Observation | MPEG | Photo | Grade |
|---|---|---|---|---|---|---|---|
| | | 0.00 | S01 RPL | Point repair, localised lining from 12 o'clock to 11 o'clock, start | 00:00:05 | S65X_ab0<br>00ad8-c28<br>8-4fb3-8c1 | |

S65X\_ab000ad8-c288-4fb3-8c17-a56ce29b19f5\_20241026\_140202\_184.jpg, 00:00:05, 0.00 m  
Point repair, localised lining from 12 o'clock to 11 o'clock, start
