**Project Name:** NRS - Yapton 150 Repair

**Project Date:** 26/10/2024

**Inspection Standard:** MSCC5 Sewers & Drainage GB (SRM5 Scoring)

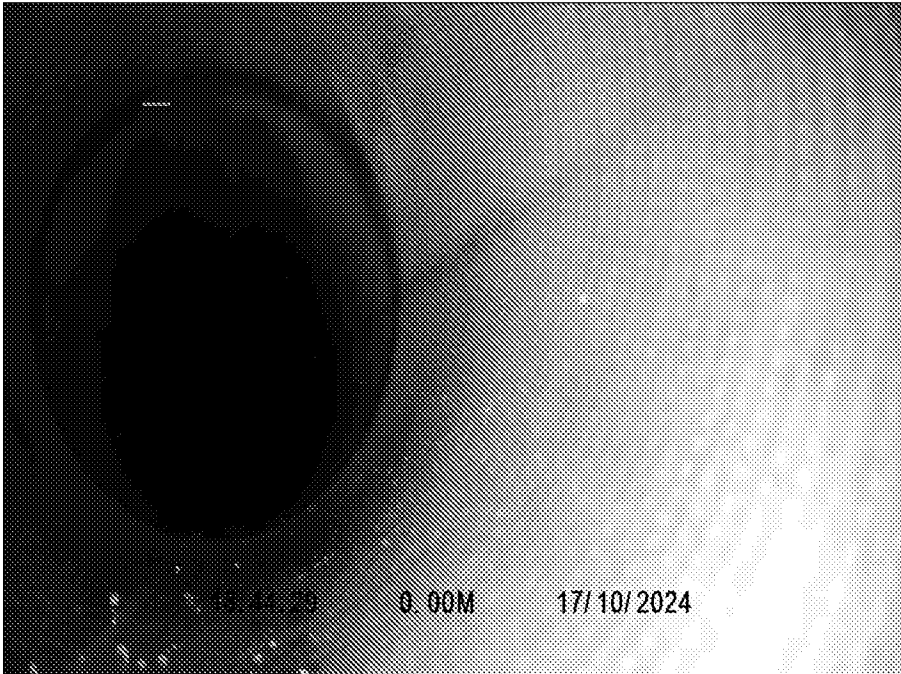
S63X\_f38ee997-3b44-406a-b7ef-44aa1784214f\_20241026\_135059\_033.jpg, 00:00:01, 0.00 m  
Point repair, localised lining from 12 o'clock to 11 o'clock, start

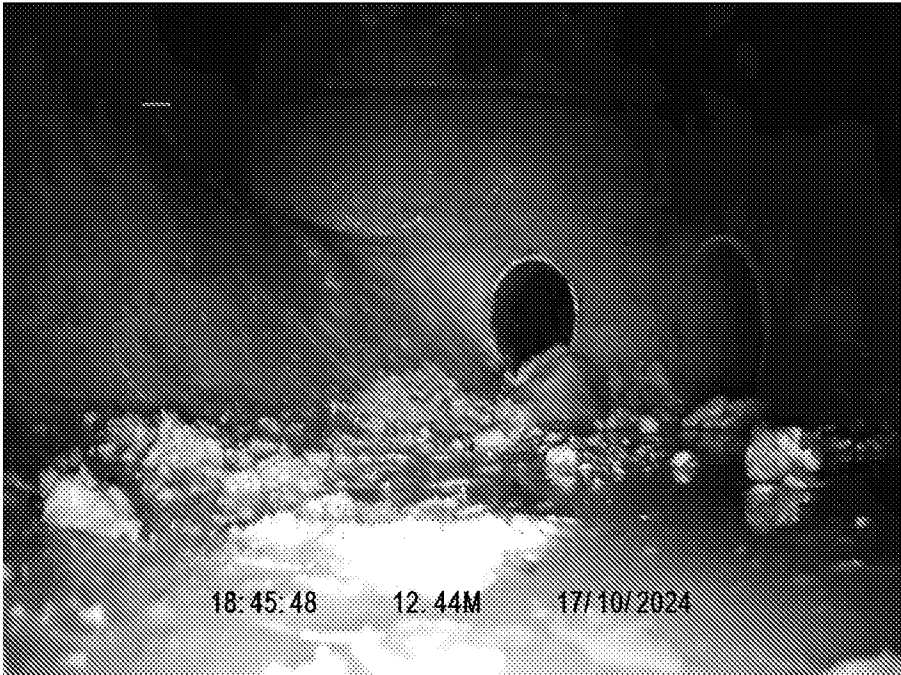
S63X\_875222c7-28ab-42d3-8dc0-d5bee012671a\_20241026\_135131\_327.jpg, 00:01:23, 12.44  
m  
Finish node, manhole, reference: S63

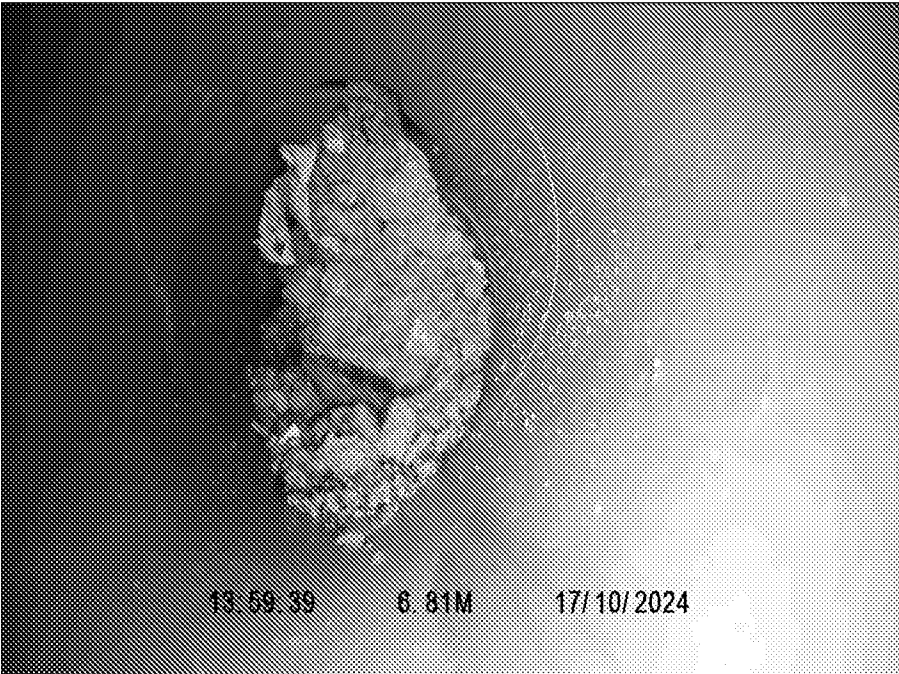
| Section | PLR | Grade | Description |
|---|---|---|---|
| 2 | S63X | 5 | Collapsed drain or sewer |

| Scale: | 1:59 | Position [m] | Code | Observation | MPEG | Photo | Grade |
|---|---|---|---|---|---|---|---|
| | | 6.81 | XP | Collapsed drain or sewer | 00:00:25 | S63X_547<br>43745-695<br>6-4ae3-92c<br>1f65-672f-<br>4fc8-59ee- | 5 |

S63X\_54743745-6956-4ae3-92c5-5050ab27cf3e\_20241026\_135333\_545.jpg, 00:00:25, 6.81 m  
Collapsed drain or sewer

- Grade 3: Best practice suggests consideration should be given to repairs in the medium term.
- Grade 4: Best practice suggests consideration should be given to repairs to avoid a potential collapse.
- Grade 5: Best practice suggests that this pipe is at risk of collapse at any time. Urgent consideration should be given to repairs to avoid total failure.

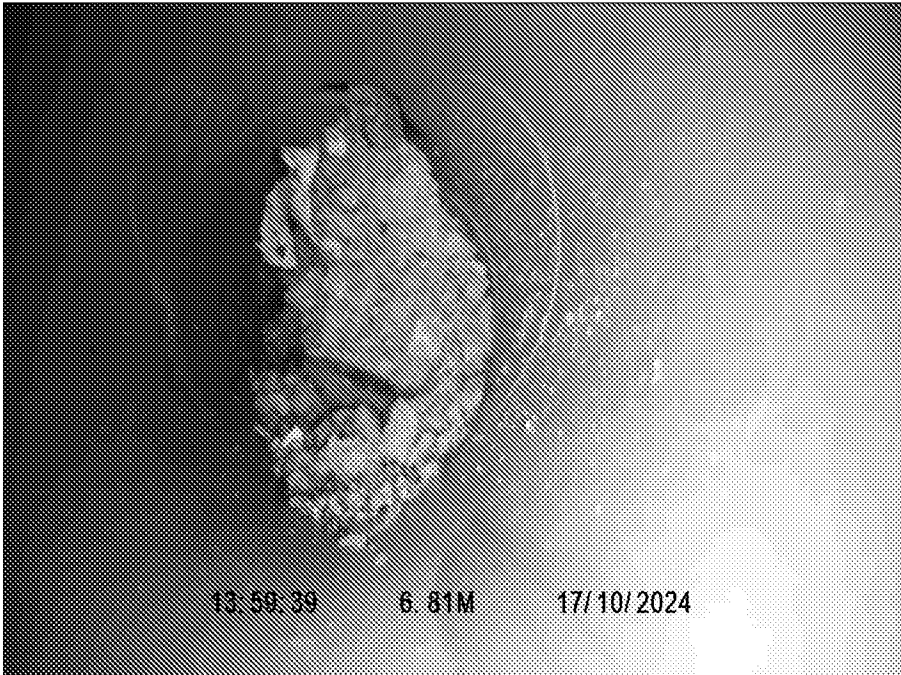
| Scale: | 1:59 | Position [m] | Code | Observation | MPEG | Photo | Grade |
|---|---|---|---|---|---|---|---|
| | | 6.81 | CM | Cracks, multiple from 12 o'clock to 11 o'clock | 00:00:25 | S63X_7afb<br>1f65-672f-<br>4fc8-59ee- | 3 / 2 |

S63X\_7efb1fa8-a72f-4fc9-89ee-02cd8aeeef017\_20241026\_135335\_494.jpg, 00:00:25, 6.81 m  
Cracks, multiple from 12 o'clock to 11 o'clock

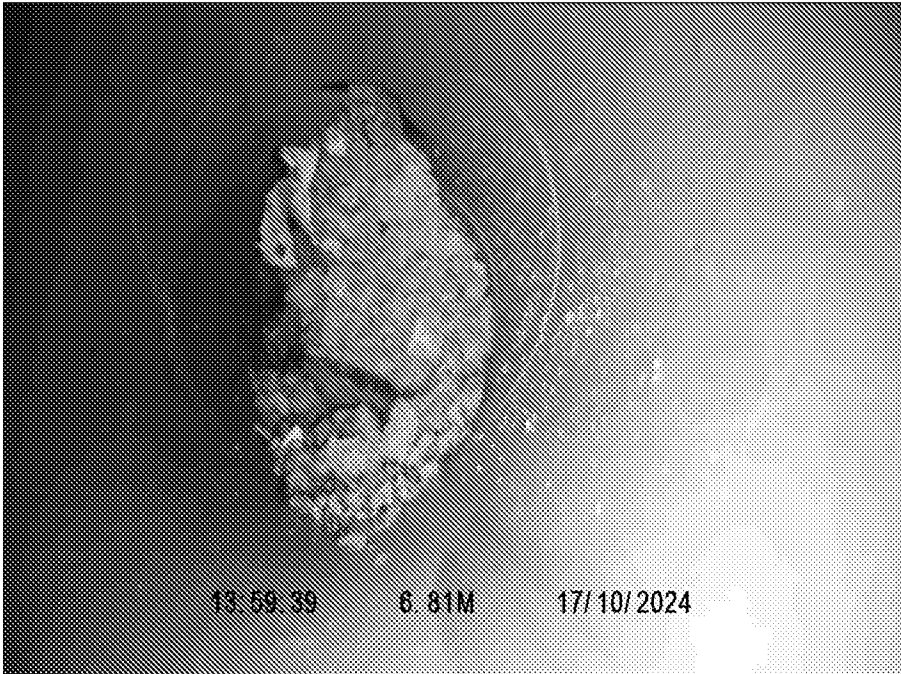
| Scale: | 1:59 | Position [m] | Code | Observation | MPEG | Photo | Grade |
|---|---|---|---|---|---|---|---|
| | | 6.81 | SA | Survey abandoned: COLLAPSED PIPE | 00:00:25 | S63X_55d<br>30e22-376<br>e-4629-af0 | |

S63X\_55d30e22-376e-4829-af0b-162fa7defaf8\_20241026\_135346\_453.jpg, 00:00:25, 6.81 m  
Survey abandoned
