| <b>Project Name:</b> | Cinders Nursery, Yapton |
| <b>Document Reference:</b> | 125.5005/SVR |
| <b>Document Name:</b> | SuDS Verification Report |

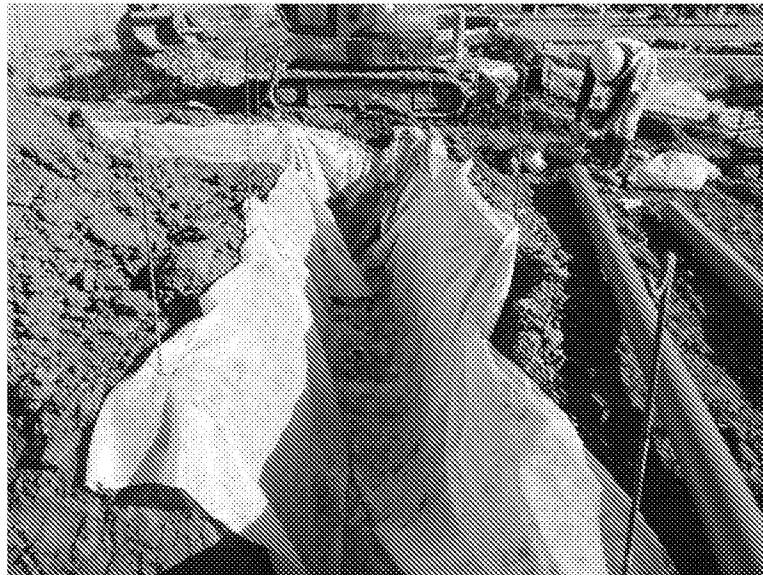
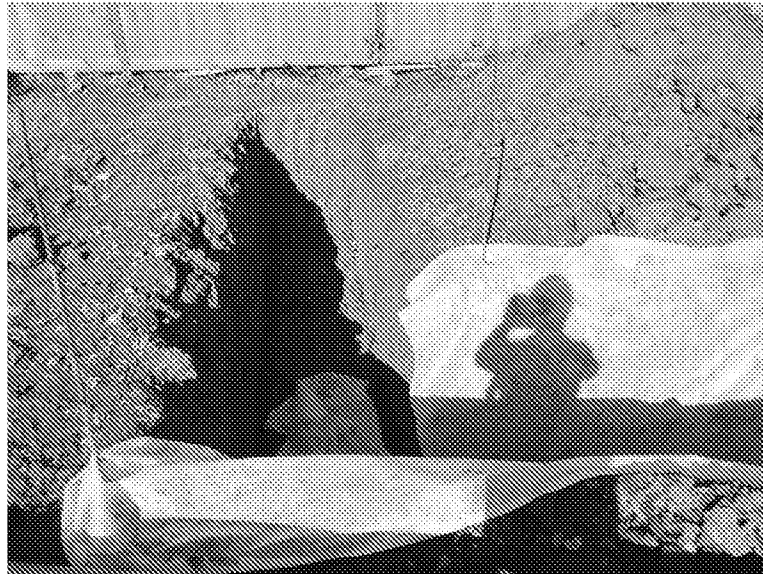
Associates to gain access to the trenches. However, Crayfern homes have provided Paul Basham Associates with photographs which show the excavated trench prior to it being backfilled with material for the Trench Soakaway. They show that the trench was laid with a geomembrane prior to it being backfilled. See **Figure 2** and **Figure 3**.

**Figure 2:** Excavation for Trench Soakaway Lined with Geomembrane.

**Figure 3:** Excavation for Trench Soakaway Lined with Geomembrane.

- 3.1 As Paul Basham Associates were not present at the time of installation, this report cannot confirm if the trenches were constructed in accordance with the agreed design. However, the site was attended shortly after a rain event and showed no signs of flooding in or around dwellings drained by Infiltration Trench Soakaways. No trees were noted in or around areas that would be detrimental to the infiltration soakaways.

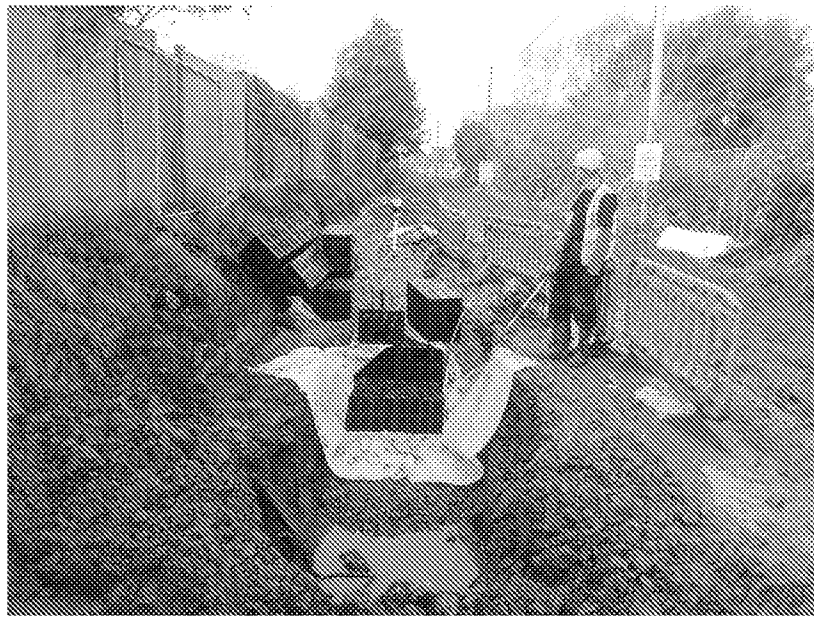
- 3.2 The 'as built' drawing indicates that a geocellular infiltration crate system is to be installed along Cinder's Lane. See **Figure 5** and **Figure 5**. Paul Basham Associates were not present during installation of the crates but were provided with photographs from Crayfern homes which show that the excavated trenches were laid with small stone aggregate, the crates were then laid and wrapped in a geomembrane. Pictures provided also show that the crates were then overlaid with small stone aggregate. See **Figure 6** and **Figure 7**.

**Figure 6:** Photograph Showing the Geocellular Crates Underlain by Small Stone Aggregate

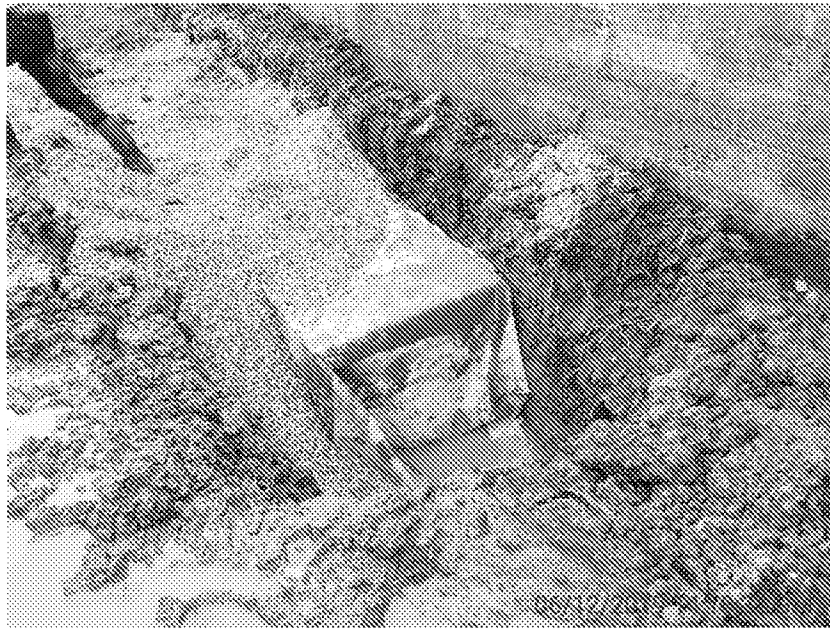
**Figure 7:** Photograph Showing Geocellular Crates Overlain with Small Stone Aggregate

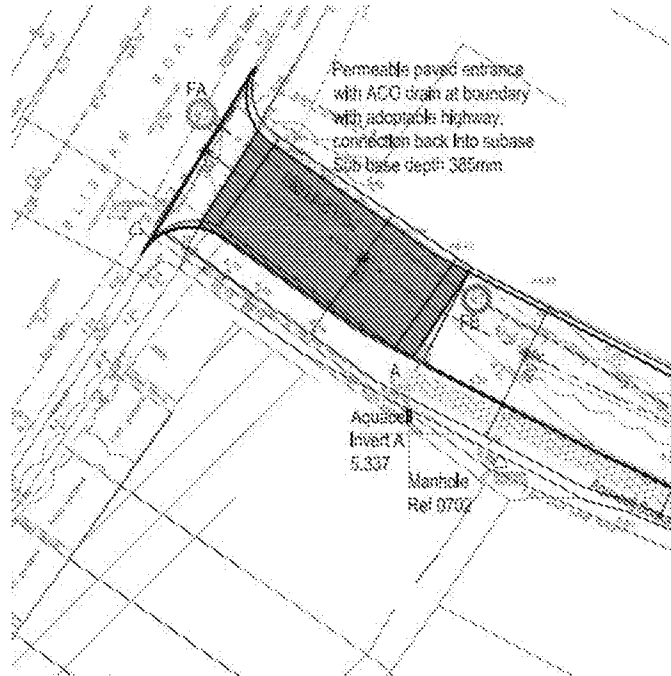
**Figure 8:** Snip of the As Built Drawing showing the Proposed Position of the Permeable Block Paving.

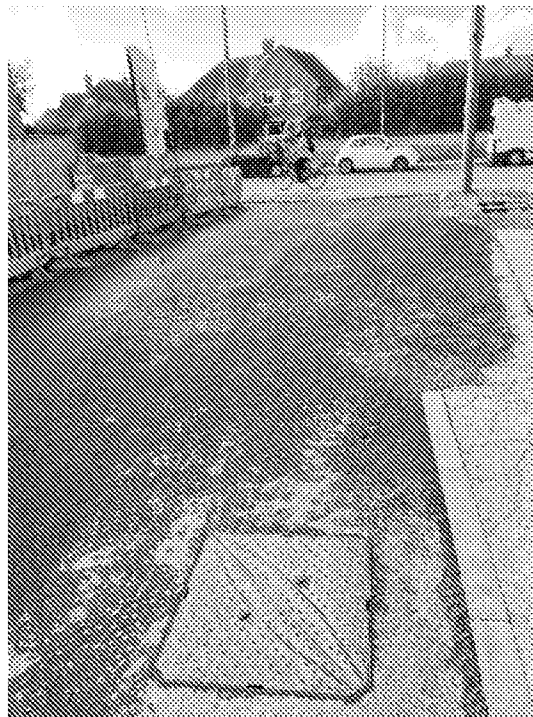
proposed position of the permeable block paving at the site access. **Figure 9** shows that upon site visit the permeable block paving has not been installed as per the As Built drawing.

**Figure 9:** Image of the Proposed Position of the Permeable Block Paving at Site Access.

- 5.3 All but one of the specified permeable block paving sets could be observed upon site visit. The missing block paving set was that at the site entrance.

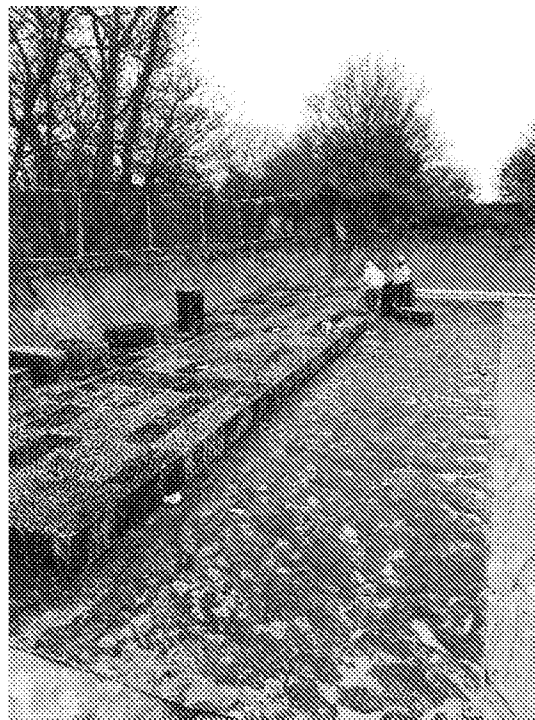
- 3.4 The as built drawings show that there is a set of Geocellular Attenuation Crates installed in the southeast corner of the site. See **Figure 10**. Paul Basham Associates did not attend the site during the installation of the crates however photographs taken during construction provided to Paul Basham Associates by Crayfern Homes show that the crates were underlain by an impermeable geomembrane. They also show that after being laid, the crates were then covered with an impermeable geomembrane and then a small stone aggregate. See **Figure 11**, **Figure 12**, and **Figure 13**.

**Figure 11:** Photograph Showing the Geocellular Crates Underlain with Impermeable Geomembrane

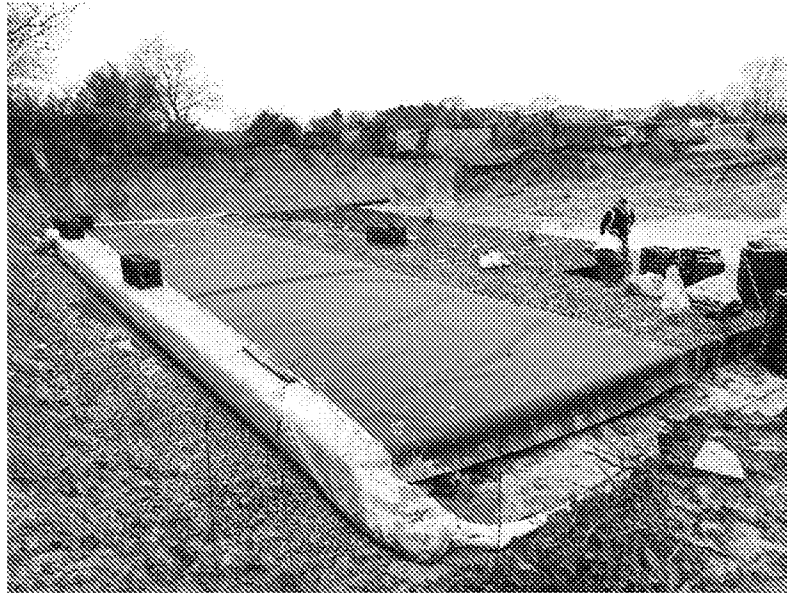
**Figure 12:** Photograph Showing the Geocellular Crates Wrapped in Impermeable Geomembrane

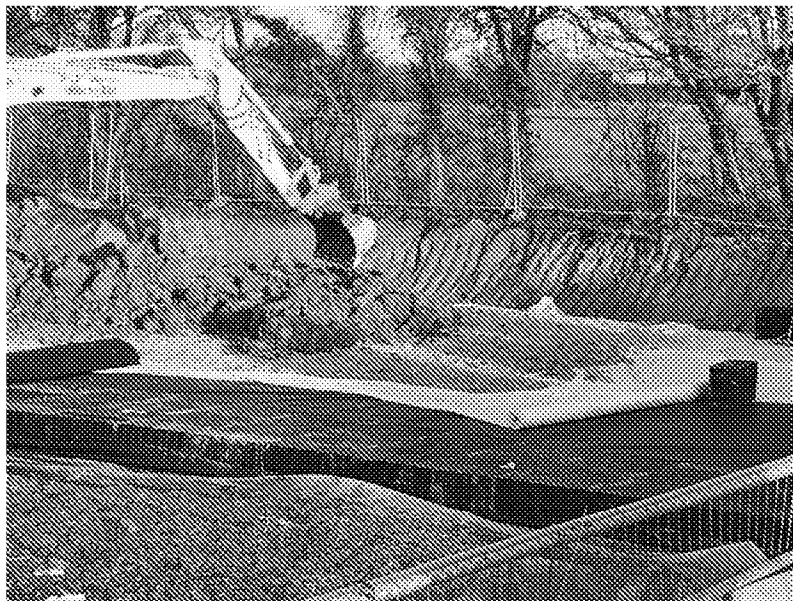
**Figure 13:** Photograph Showing the Crates Overlaid with Small Stone Aggregate

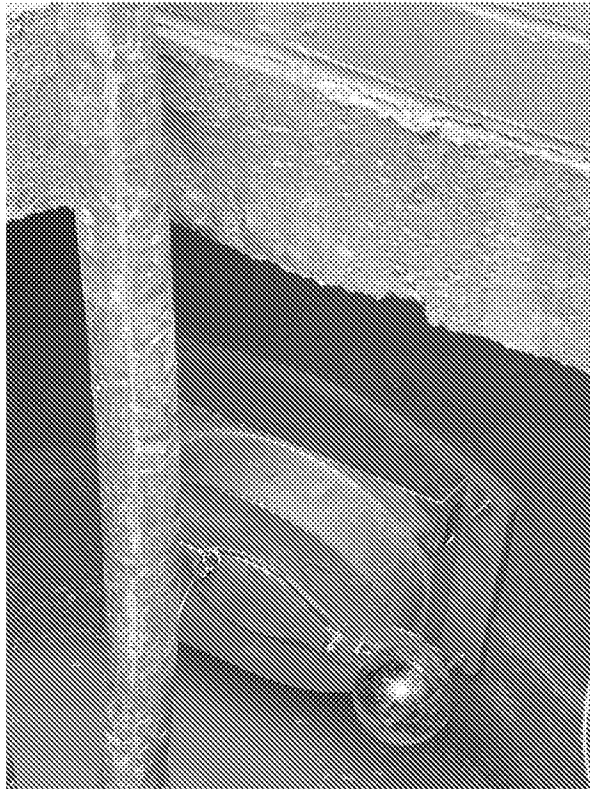
- 3.6 It was not possible to gain access to the Hydrobrake during the site visit. However, a photograph provided by Crayfern Homes (**Figure 14**) shows that a Hydrobrake was installed. A photocopy of the invoice for the device is contained in **Appendix C**.

**Figure 14:** Photograph of Hydrobrake Flow Control Device

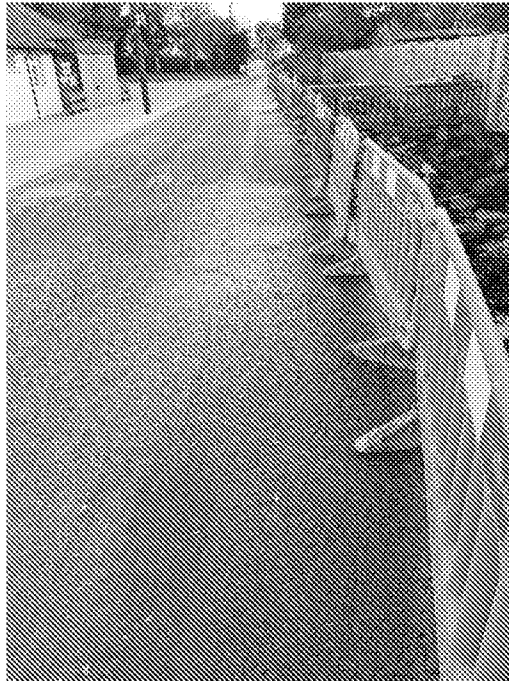
1. **Missing Gully A:** **Figure 15** shows the proposed position of the gully. **Figure 16** shows a photograph taken on site of the proposed position of the gully. It shows that no gully has been installed at the time of the site visit.

**Figure 16:** Image of the Proposed Position of the Gully taken.

- 4.1 **Missing Gully A:** **Figure 27** below shows a stoned-up excavation for a gully in the proposed position of Missing gully A.

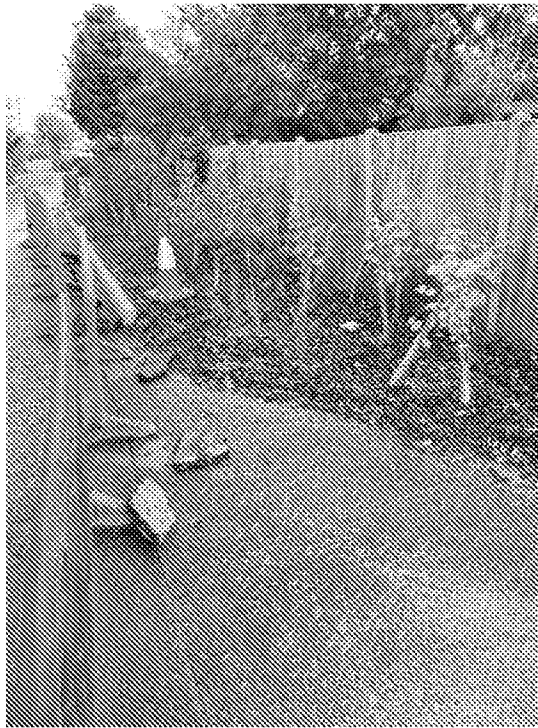
2. **Missing Gully B:** **Figure 17** shows the proposed position of the gully. **Figure 18** is a photograph of the proposed position of the gully. No gully could be observed at the time of site visit.

**Figure 18:** Image of the Proposed Position of Gully

- 4.2 **Missing Gully B:** Figure 28 below shows a stoned-up excavation for a gully in the proposed position of Missing gully B.

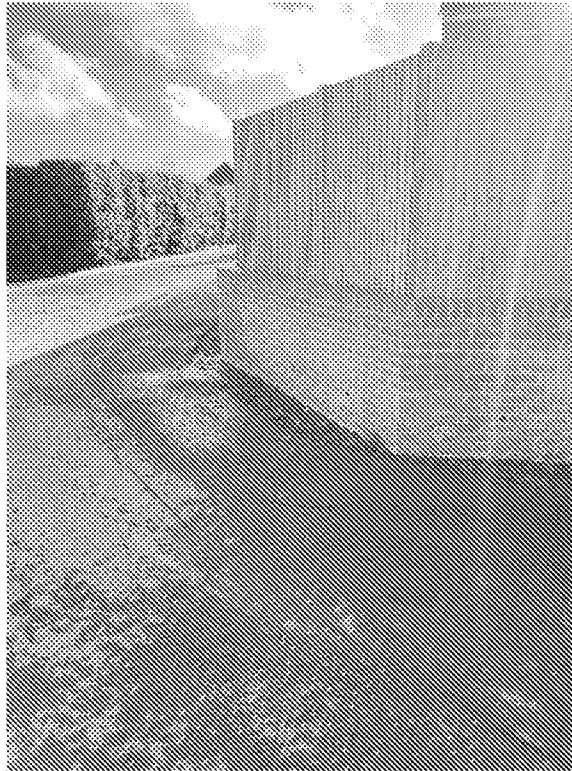
3. **Missing Gully C:** **Figure 19** shows the proposed position of the gully. **Figure 20** is a photograph of the proposed position of the gully. No gully could be observed at the time of site visit.

**Figure 20:** Photograph of the Proposed Position of Gully

- 4.3 **Missing Gully C:** Figure 29 below shows a gully installed in the proposed position of Missing gully C.

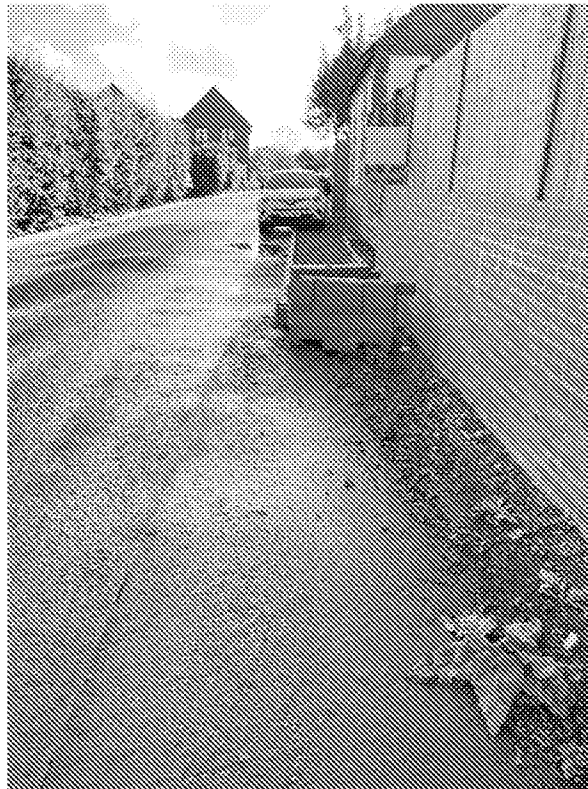
4. **Missing Gully D:** **Figure 21** shows the proposed position of the gully. **Figure 22** is a photograph the proposed position of the gully. No gully could be observed at the time of site visit.

**Figure 22:** Photograph of the Proposed Position of the Gully

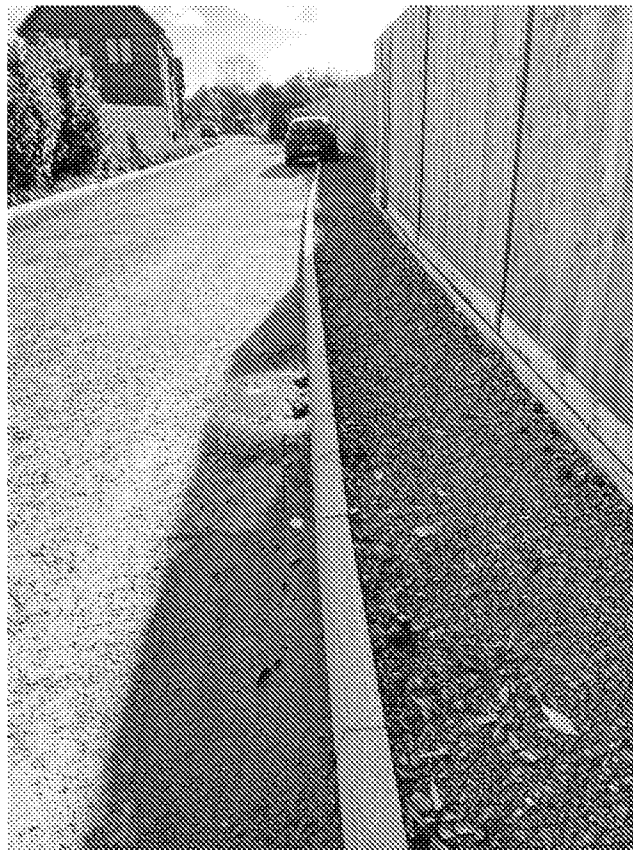
5. **Missing Gully E:** **Figure 23** shows that the proposed position of the gully. **Figure 24** is a photograph of the proposed position of the gully. No gully could be observed at the time of site visit.

**Figure 24:** Photograph of the Proposed Position of the Gully

- 4.4 **Missing Gully E:** **Figure 30** below shows a stoned-up excavation for a gully in the proposed position of Missing gully E.

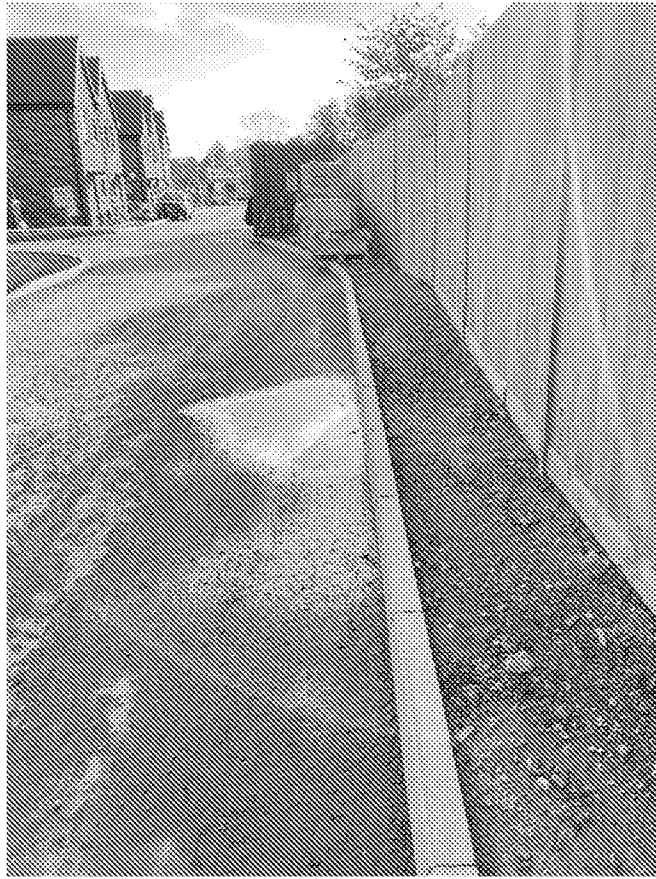
6. **Missing Gully F:** **Figure 25** shows the proposed position of the gully. **Figure 26** is a photograph of the proposed position of the gully. No gully could be observed at the time of site visit.

**Figure 26:** Photograph of Proposed Position of Gully

- 4.5 **Missing Gully F:** Figure 31 below shows a stoned-up excavation for a gully in the proposed position of Missing gully F.
