BMC/BMC/MS03636

**Boundary wall, Stakers Farm, North End Road, Yapton.**

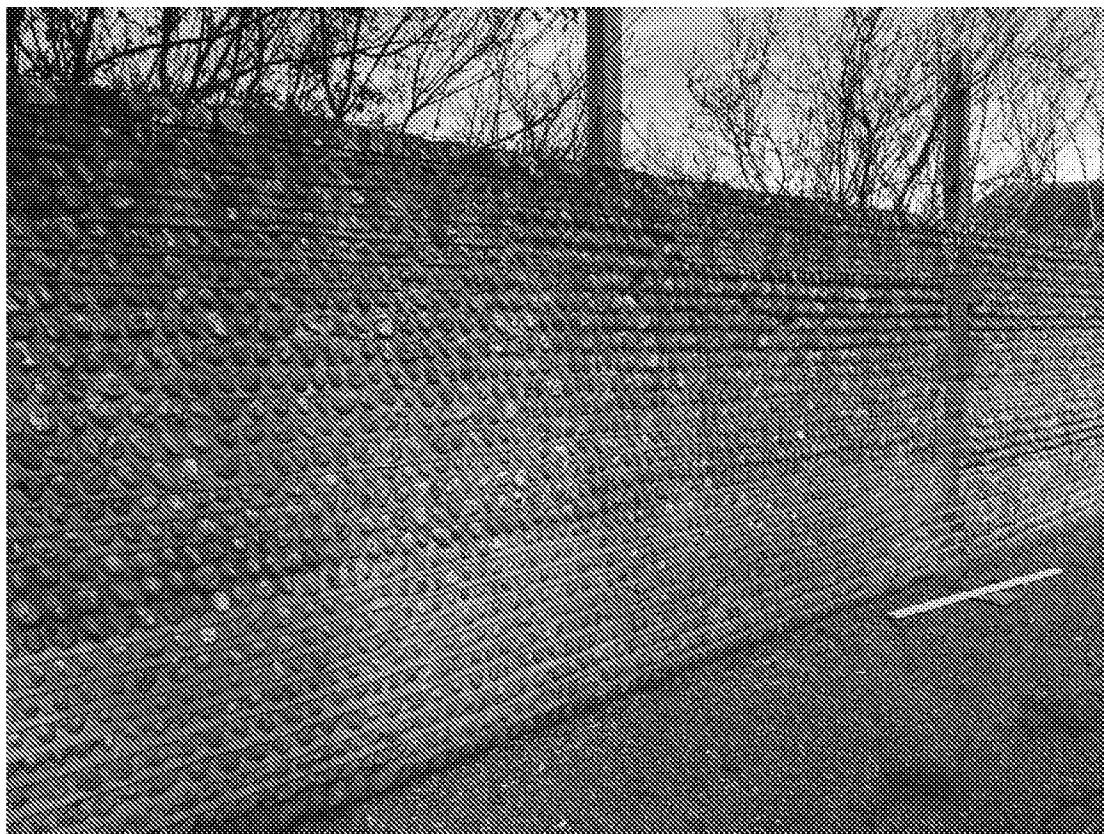
- 4.7 The lower half metre of wall, on the east face, appeared to have been repointed more recently along the majority of its length.
- 4.8 The upper section of wall, on the east face, had similarly been repointed, but to a slightly lesser extent.

- 4.10 Slight vertical cracks were noted at approximately 600-700mm vertical centres along the length of the wall extending up from ground level a height of approximately 500mm.

*View on east face of eastern boundary wall*

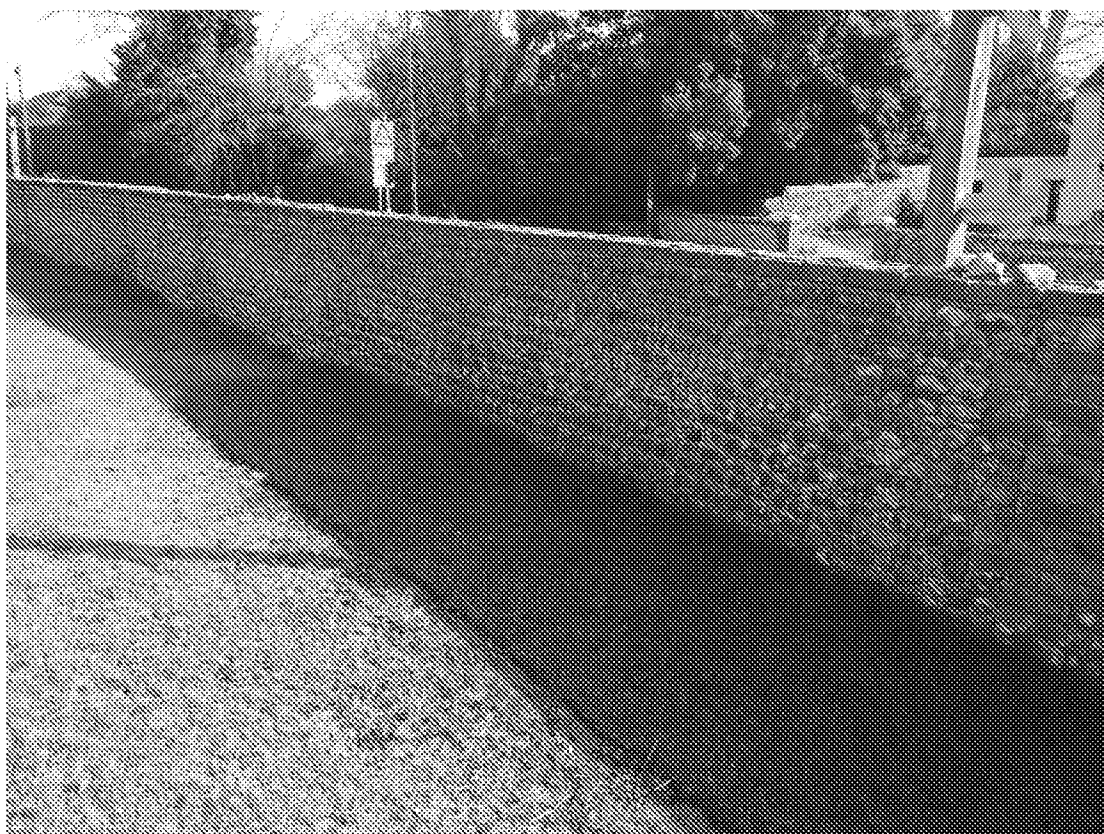
*View on west face of eastern boundary wall*

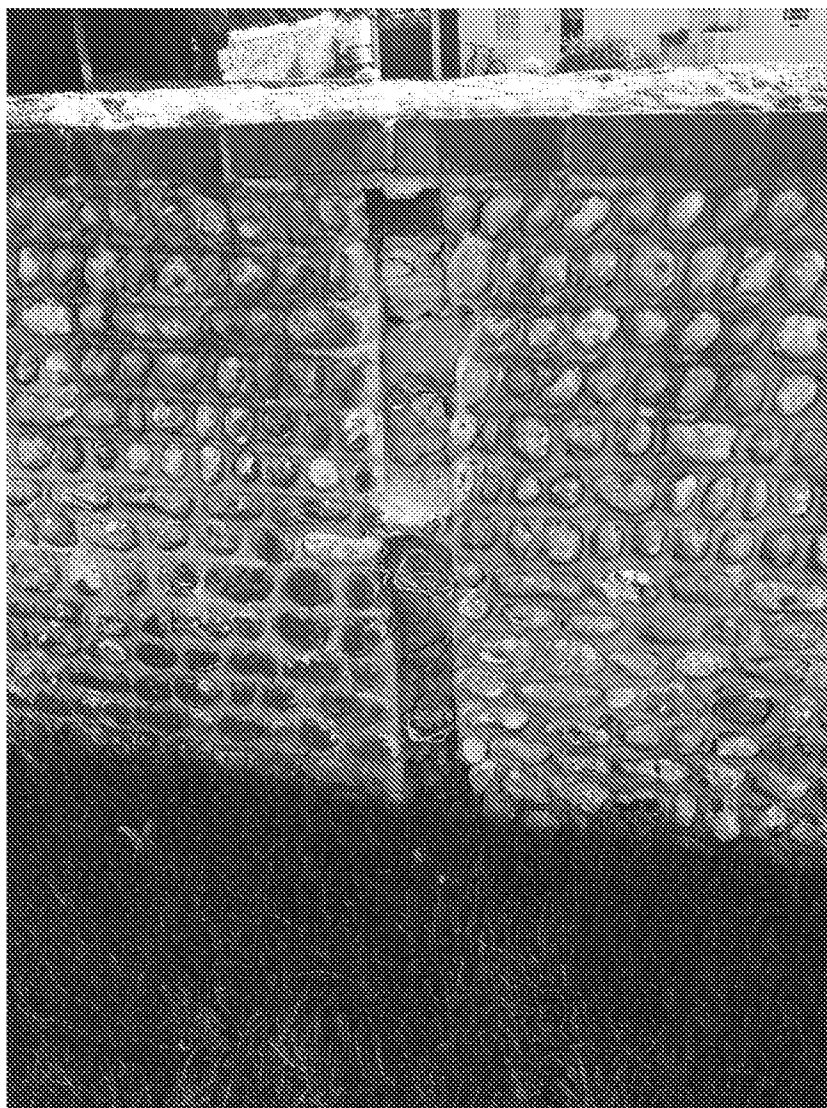
***View on west face of eastern boundary wall***

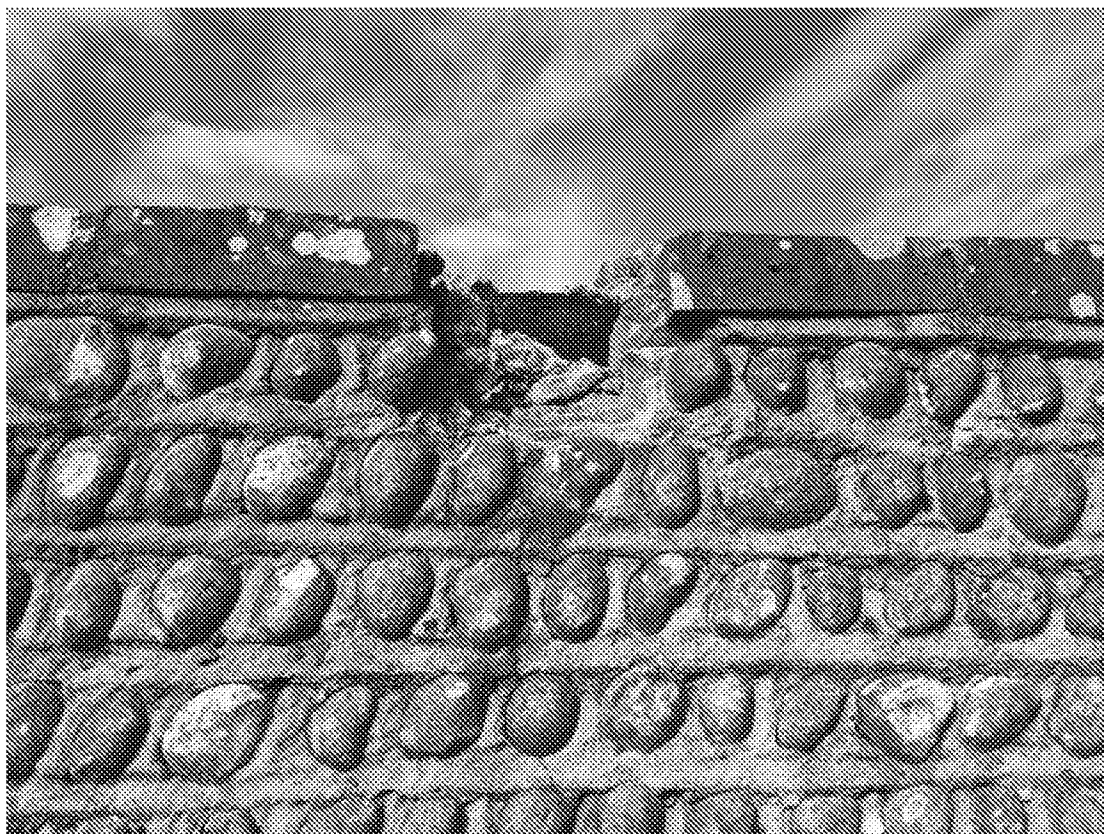
- 4.1 In a localised area, the brick and mortar coping at the head of the wall was missing, allowing the core of the wall to be viewed.
- 4.2 The wall appeared to be 315 mm in thickness, formed of a central single brick skin and faced on both sides with flints, bedded in defined rows, in mortar.

*View on top of eastern boundary wall with central brick core visible*

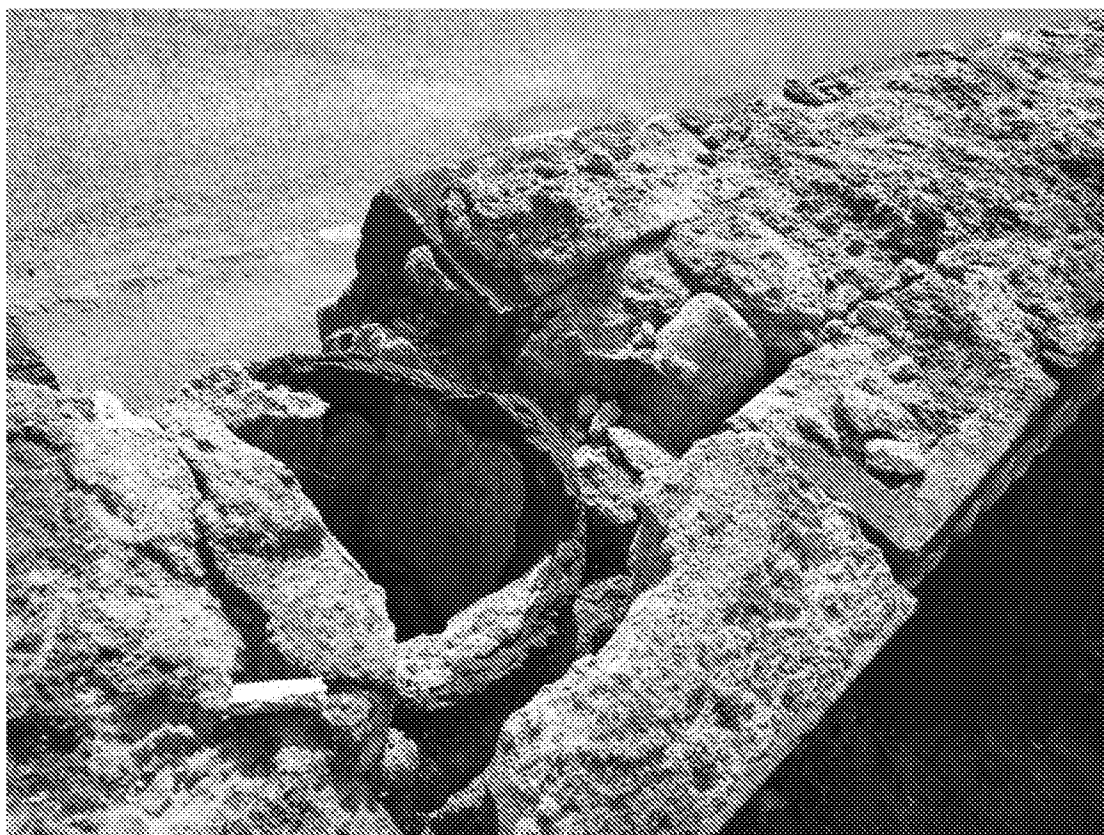
*View on top of eastern boundary wall*

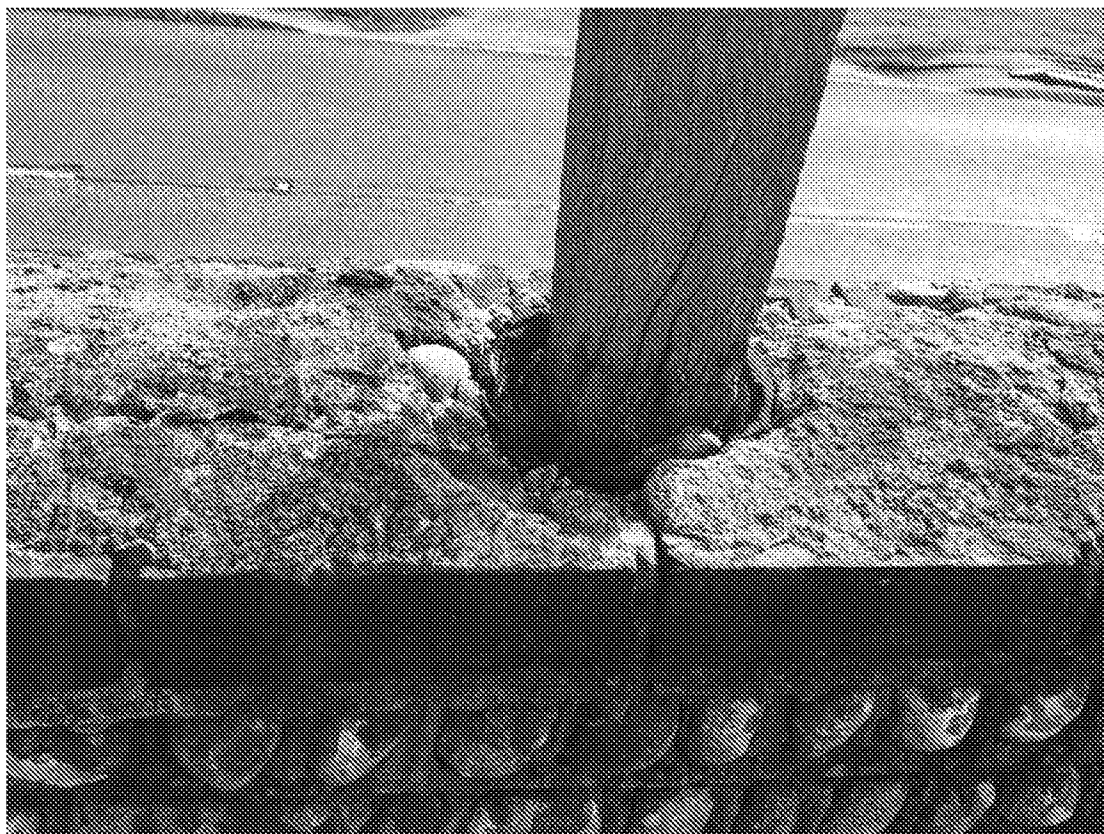
*View on top of eastern boundary wall*
