## Project-Information

| Project Name:<br>386 Yapton | Contract Number: | Contact: | Date:<br>01/05/25 |

| <b>Client:</b> | <b>Parchow Groundworks Limited</b> |
| <b>Contractor:</b> | <b>All Hours Plumbing Ltd</b> |

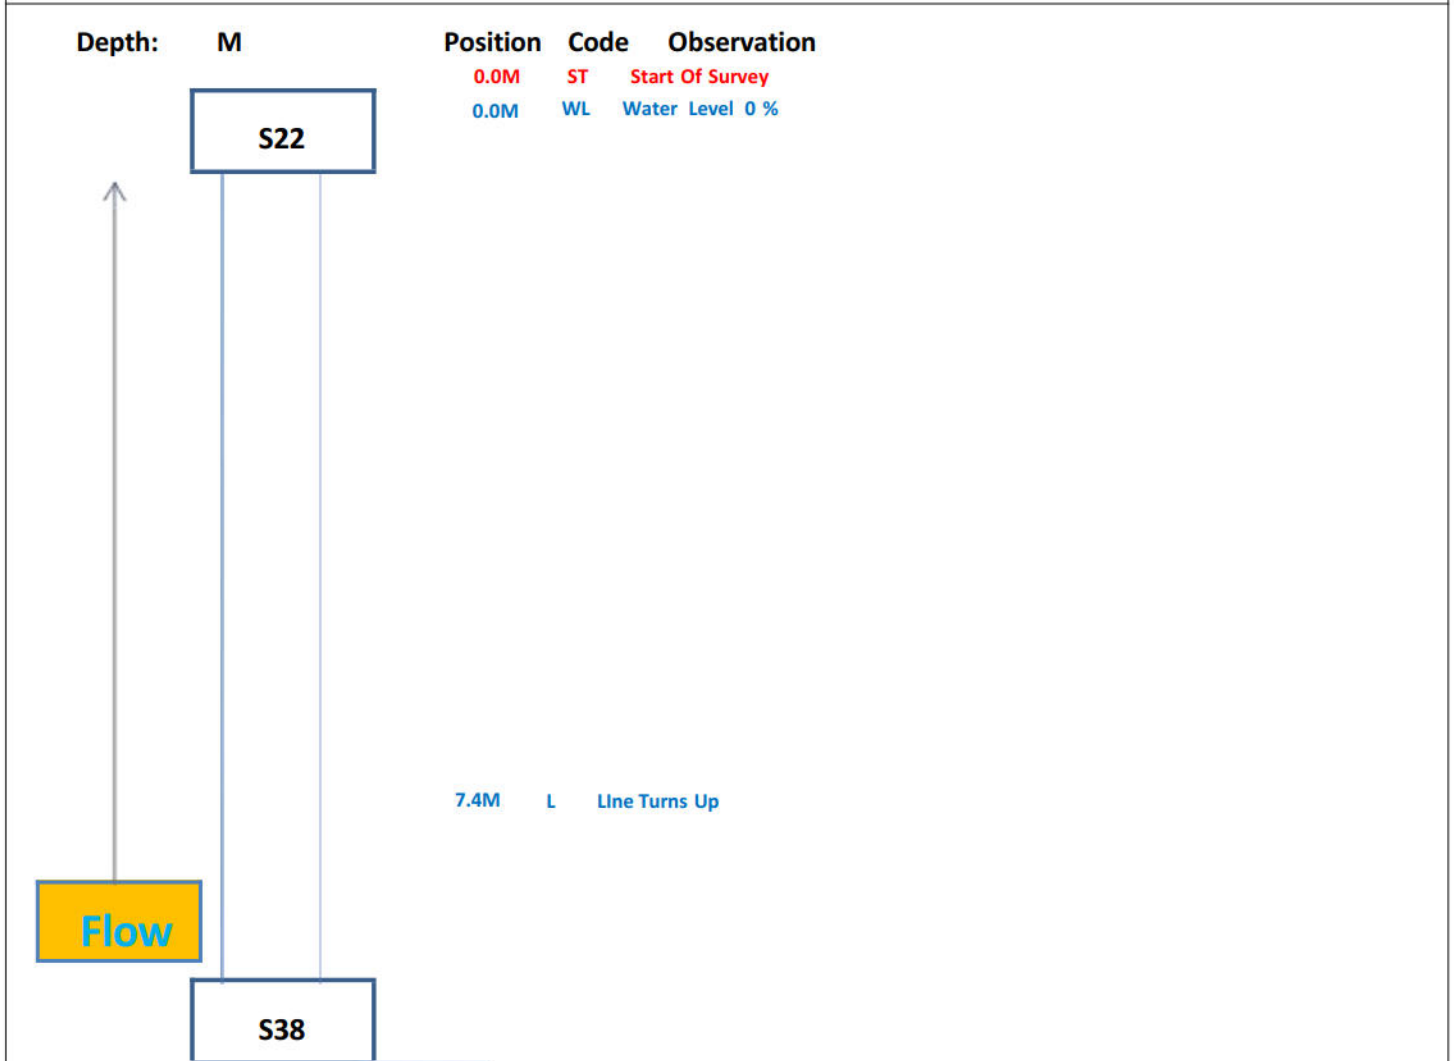
REM, THERE ARE NO PROBLEMS WITH THIS SECTION OF PIPEWORK. MANHOLE S 38 WAS NOT INSTALLED AND LINE TURNS UP TO DOWNPIPE

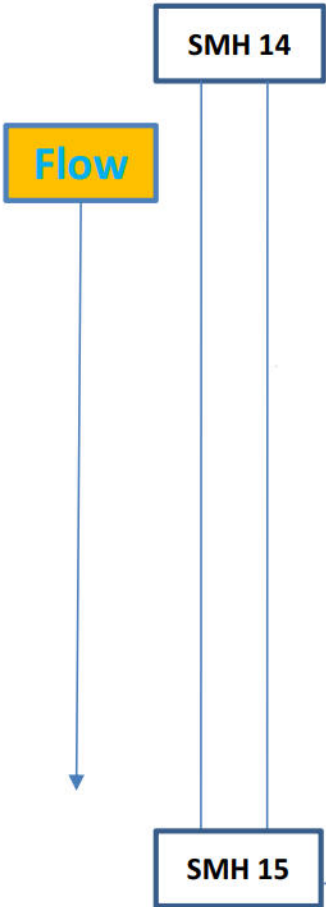
5.4M PR Start Of Patch Repair  
6.0M PR End Of Patch

REM ; THERE ARE NO DEFECTS WITH THIS SECTION OF PIPE
