# **BOGNOR NORTHERN RELIEF ROAD, PHASE 1**

## **“PROPOSED PLAYING FIELD ACCESS” (Version 2.0)**

### **Road Safety Audit Combined Stage 1 & Stage 2 – Detailed Design**

**March 2015**

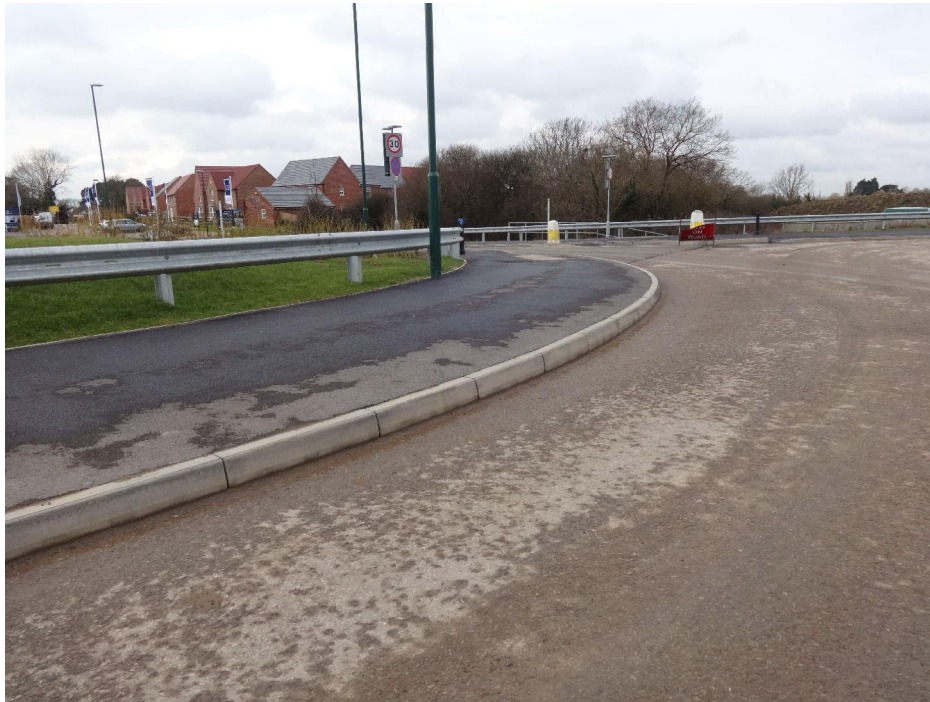
At the existing westbound carriageway of the Northern Relief Road approaching the Stanover Lane Roundabout, the proposed Playing Field Access within the Southern Arm will be hidden from view of westbound drivers by the combination of current Vehicle Restraint Barriers on the inner radius of the horizontal exit curvature and the adverse vertical down gradient of the carriageway into the housing Development, thus creating lack of sufficient clear forward visibility for westbound drivers turning left towards the location of the proposed access to the Playing Fields and Potential School Premises. These conditions are also likely to be exacerbated by the future growth of the planting currently located behind the VR barriers.

NRR westbound lane approaching the Southern Arm of the Stanover Lane Roundabout.

Owing to these conditions and the close proximity of the proposed new access on the existing carriageway, if/whenever also combined with potential fast speeds at which some vehicles may be exiting the roundabout (40mph speed limit on the roundabout), some drivers when turning left on the clear sweeping radius into the 30mph section of Development Access Road may fail to slow sufficiently to perceive the risk of a leading vehicle suddenly braking in order to turn right into the Playing Field Access Road or even see a stationary vehicle waiting to turn right. Consequently, there appears a high risk of rear end collisions between such vehicles.

The proposed access arrangements should be revisited with a view to re-assessing the potential traffic flows at the junction and of sufficiently widening the carriageway locally to provide a segregated area at the centre of carriageway for right turning vehicle to move into and potentially wait for suitable gap if required to do so, whilst the current planting at the rear of the Vehicle Restraint System on the inner radius curvature should be removed.

The proposed access arrangements have be revisited with the inclusion of right hand ghost island with adequate storage for a bus.

Vehicle Restraint System shall be altered to provide for the access.
