# **BOGNOR NORTHERN RELIEF ROAD, PHASE 1**

## **“PROPOSED PLAYING FIELD ACCESS” (Version 2.0)**

### **Road Safety Audit Combined Stage 1 & Stage 2 – Detailed Design**

**March 2015**

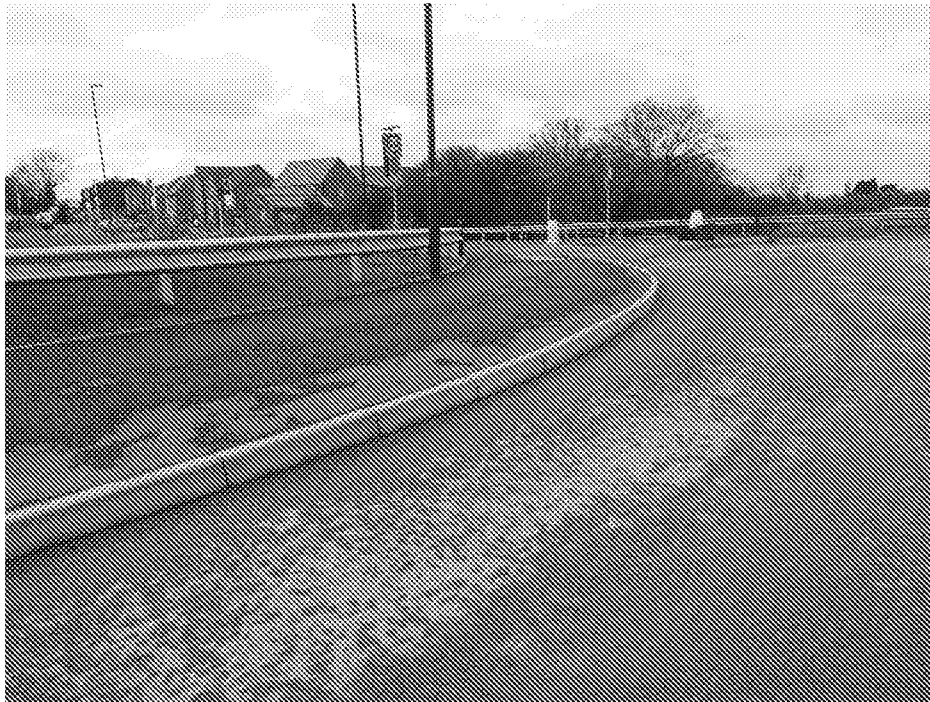
At the existing westbound carriageway of the Northern Relief Road approaching the Stanover Lane Roundabout, the proposed Playing Field Access within the Southern Arm will be hidden from view of westbound drivers by the combination of current Vehicle Restraint Barriers on the inner radius of the horizontal exit curvature and the adverse vertical down gradient of the carriageway into the housing Development, thus creating lack of sufficient clear forward visibility for westbound drivers turning left towards the location of the proposed access to the Playing Fields and Potential School Premises. These conditions are also likely to be exacerbated by the future growth of the planting currently located behind the VR barriers.

NRR westbound lane approaching the Southern Arm of the Stanover Lane Roundabout.

Owing to these conditions and the close proximity of the proposed new access on the existing carriageway, if/whenever also combined with potential fast speeds at which some vehicles may be exiting the roundabout (40mph speed limit on the roundabout), some drivers when turning left on the clear sweeping radius into the 30mph section of Development Access Road may fail to slow sufficiently to perceive the risk of a leading vehicle suddenly braking in order to turn right into the Playing Field Access Road or even see a stationary vehicle waiting to turn right. Consequently, there appears a high risk of rear end collisions between such vehicles.

Whereas no details of any predicted traffic flows appear to been included within The Design & Access Statement and as the Playing Field is shown with a full sized football pitch, it seems likely to be often used by local teams and also by visiting teams travelling in buses/coaches and other various types of 'people carriers'. Consequently, there may be increased risk of slower moving vehicles being within the centre of carriageway for longer times. The identified risk of rear-end collisions seems likely to further increase with the proposal for locating 'Future Primary School Development' within the access road.

The proposed access arrangements should be revisited with a view to re-assessing the potential traffic flows at the junction and of sufficiently widening the carriageway locally to provide a segregated area at the centre of carriageway for right turning vehicle to move into and potentially wait for suitable gap if required to do so, whilst the current planting at the rear of the Vehicle Restraint System on the inner radius curvature should be removed.

The proposed access arrangements have be revisited with the inclusion of right hand ghost island with adequate storage for a bus.

Vehicle Restraint System shall be altered to provide for the access.
