Our Ref: 211378 - Let 1 - Yapton

16 June 2021

**Re: Tree issues at land adjacent to Orchard Business Park, North End Road, Yapton, BN18 0GA**

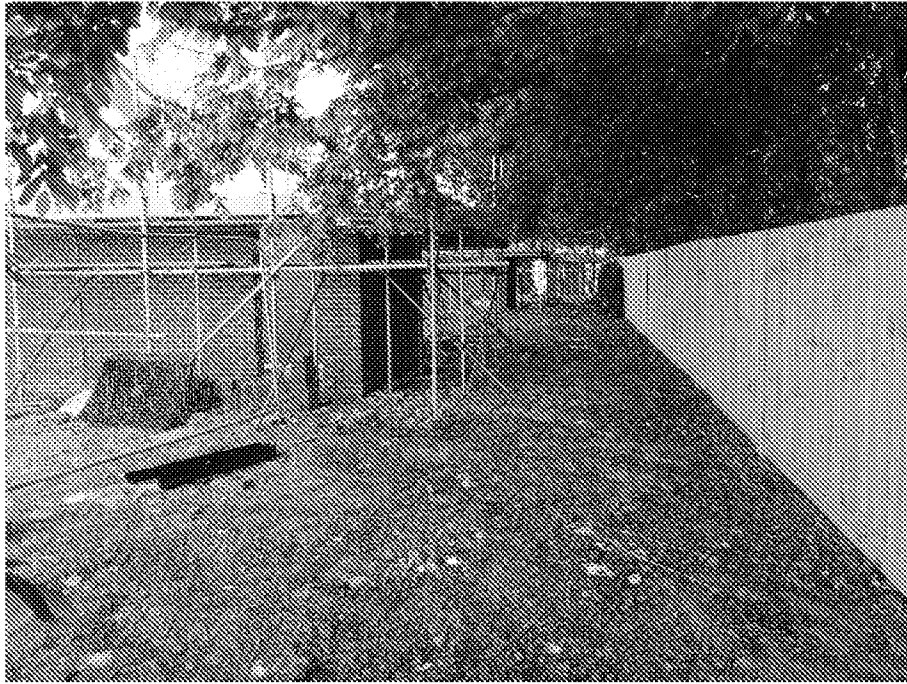
The tree protection barriers appeared to be generally in the positions shown on the Vivid Design Studio Proposed Hedgerow Protection Plan (photographs 1, 2 and 3). However, I did note that a couple of weld mesh panels had been displaced. Nonetheless, I thought that the positioning was generally acceptable in terms of providing a suitably distanced tree protection regime during the remainder of the construction phase.

During my visit I did note that there was a lack of bracing of the weld mesh panels and this (along with the displaced panels) needs attention, as I share the Tree Officers concerns regarding robustness. I noted that pins had been placed through the rubber block trays in order to deter movement, but my experience is that such a measure in isolation is likely to be insufficient to deter accidental displacement. I therefore advised that additional strut bracing should be considered at the same time as the repositioning of the errant panels.

**Photograph 1** – Tree protection rear of plots 1 and 2 on 07.06.21

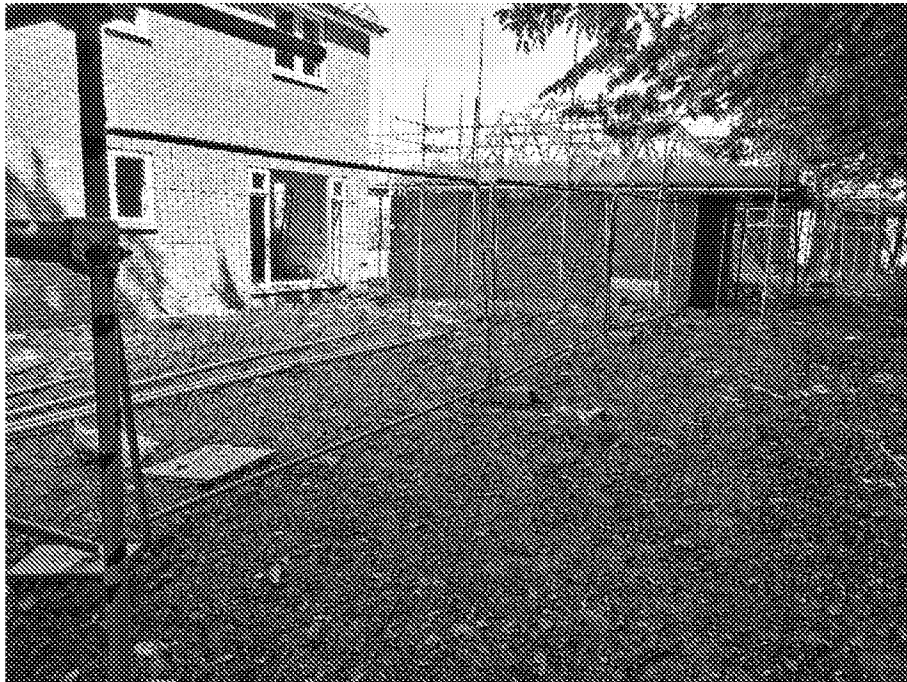
**Photograph 2** – Tree protection rear of plots 1 and 2 on 07.06.21

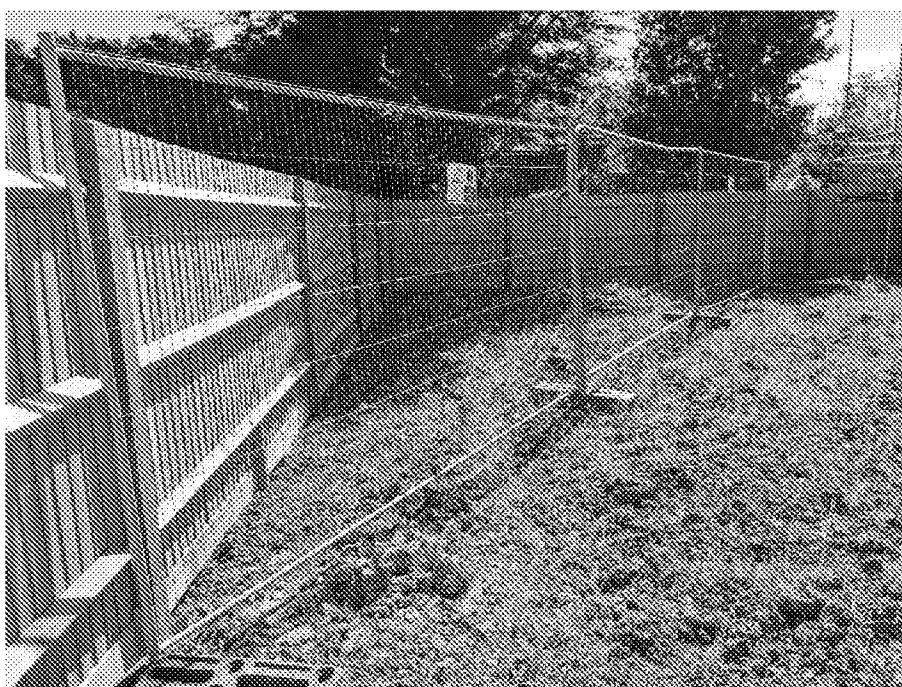
**Photograph 3** – Tree protection rear of plot 6 on 07.06.21

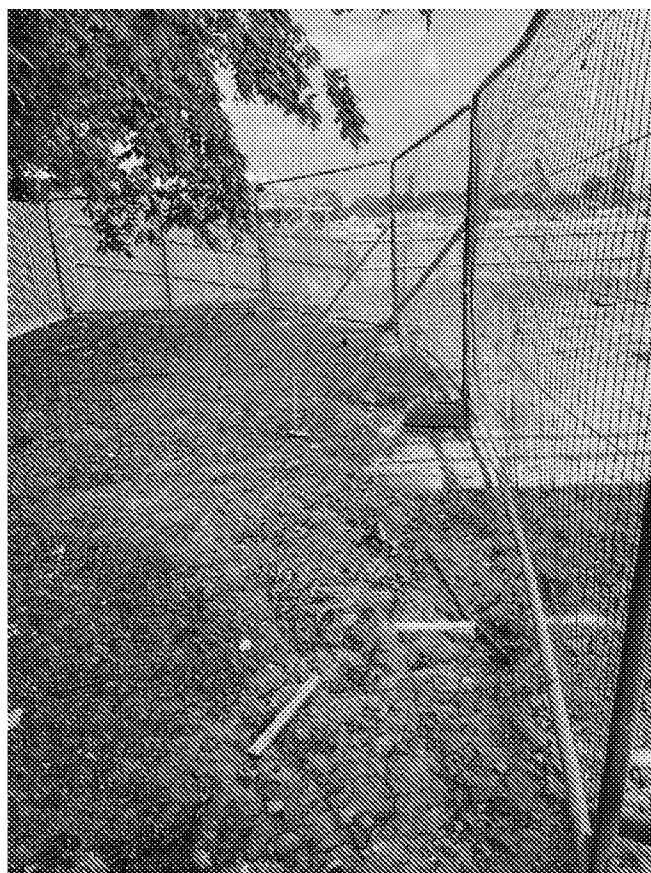
**Photograph 4** – Updated and current tree protection rear of plots 1 and 2

I understand from our subsequent telephone conversation that the tree protection barriers have now been braced more securely using rear facing struts pinned to the ground and that the displaced panels are now in position. You sent me images (photographs 4, 5 and 6) showing the revised more securely braced and pinned tree protection. In my view, this is a significant improvement over the tree protection I noted during my visit and I would now suggest that this is generally in accordance with Figure 3 of *BS 5837:2012 Trees in relation to design, demolition and construction – Recommendations*. This diagram shows weld mesh panels with stabiliser struts mounted on their block trays and is not dissimilar to that shown in your photographs.

In summary, I feel that the updated tree protection indicated in your photographs is probably adequate now in terms of protecting the trees during the construction phase. However, the adequacy of the measures needs to be monitored during the remainder of the build phase and steps taken to rectify any deficiencies. My advice would be to now contact the councils Tree Officer, send him a copy of this report and seek his views on whether he is now content with the tree protection measures currently shown.

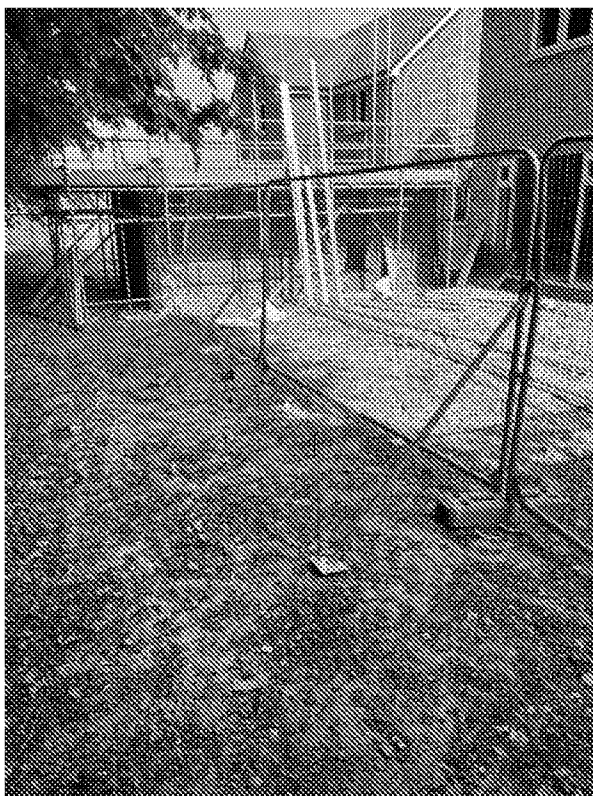
**Photograph 5** – Updated and current tree protection rear of plots 1 and 2

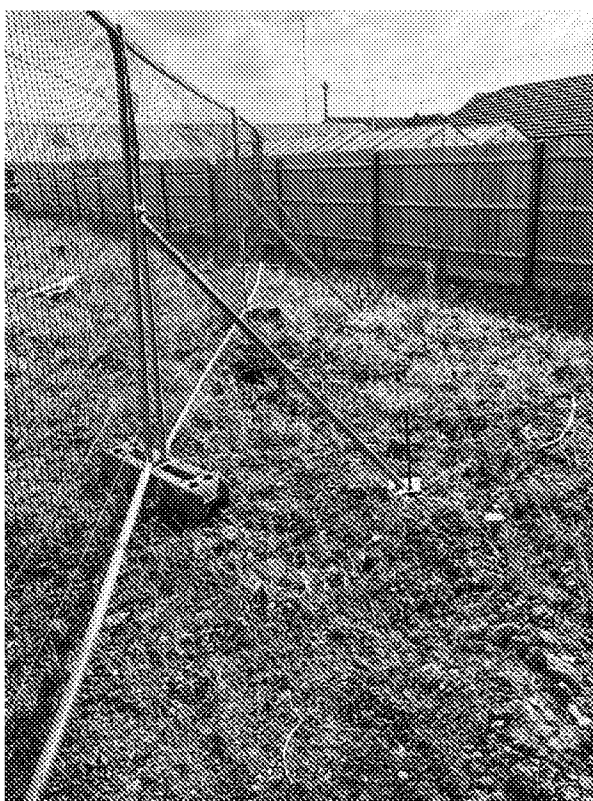
**Photograph 6** – Updated and current tree protection rear of plot 6
