St Mary's Hall, London Road  
Arundel, West Sussex, BN18 9BA

# Heritage Statement

*To accompany the revised Listed Building Application for  
modifications to the original approval*

November 2011

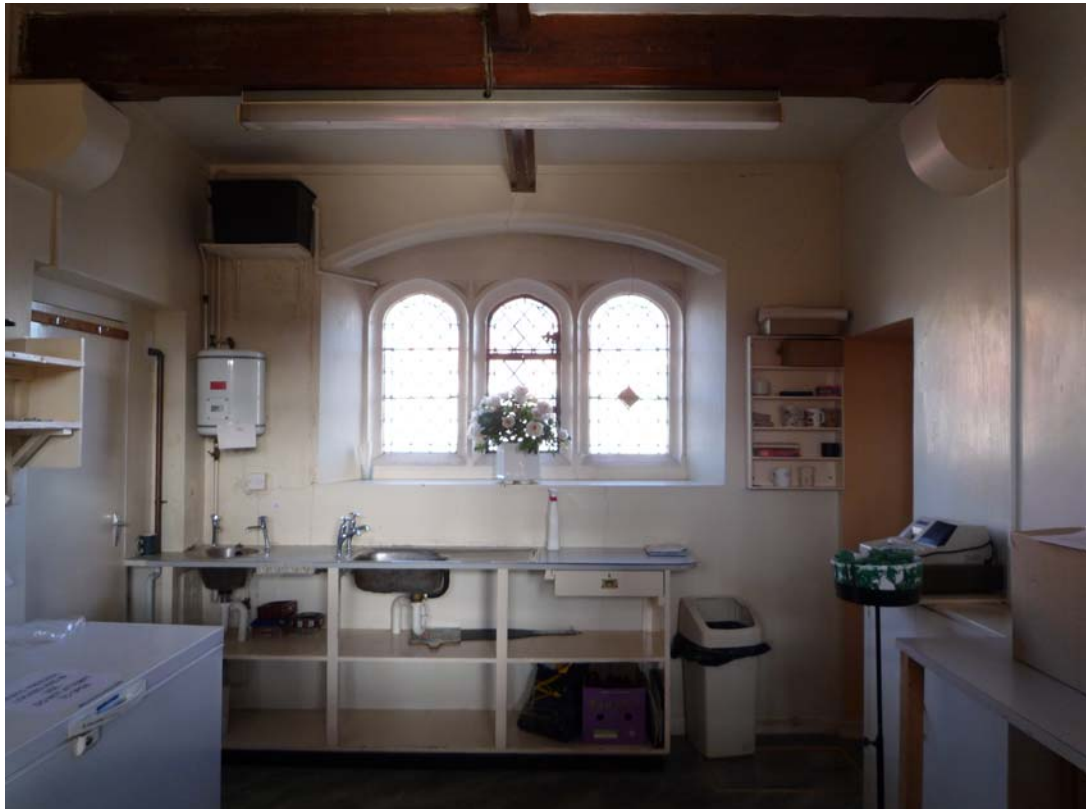
- f) Detrimental impact on fabric resulting from the changes:  
At the upper level, the new layout does require a new door opening to be made within a wall to give access to the meeting room where no previous opening exists. Whilst this is an alteration and has impact on the historic fabric, it is felt that it would be replacing the existing opening within this wall which will be blocking up in brickwork and have no greater resulting impact than the original opening had. The original opening is shown here in the photograph (right hand side of room in the image) below and is considered to be of no particular historic merit.

*This opening is considered to be of low historic merit in the overall context of the building, given that it is a simple flat headed lintel of later insertion.*

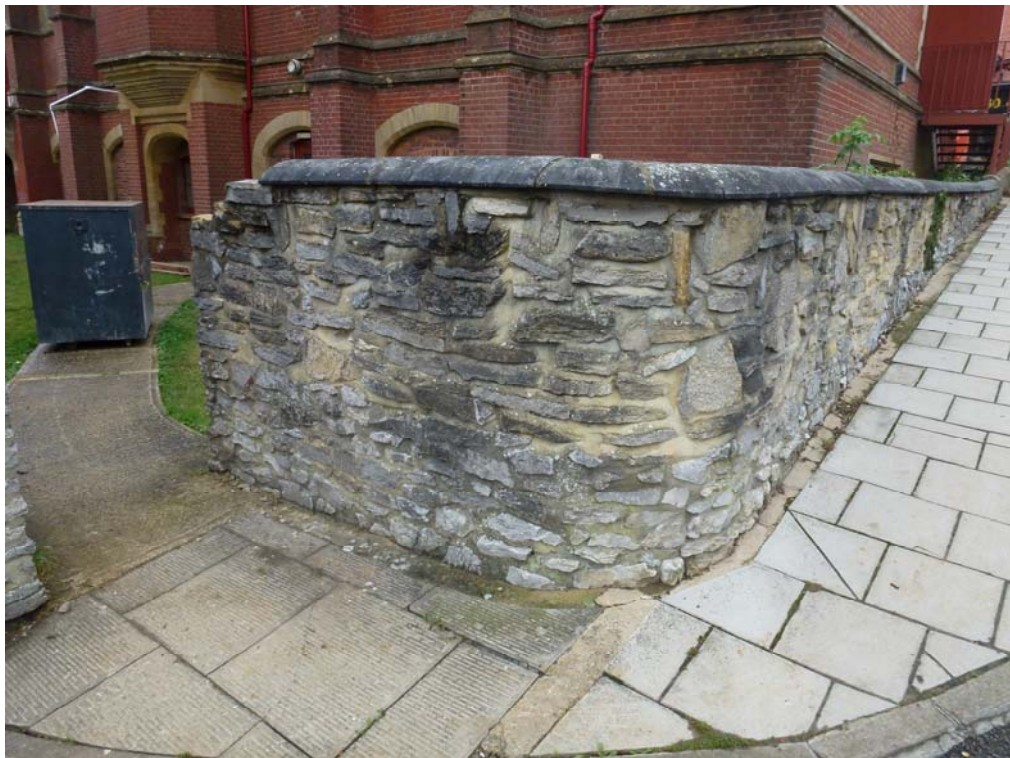
- e) Overall, it is felt that this approach will best retain and reuse the historic fabric of the boundary wall in a more positive manner by use to rebuild the lower boundary below the railings and continued onto the facing the new ramped access to the building on Mount Pleasant side. A photograph of the existing stone wall is here below:

- d) The proposal is to reuse the existing copings and stonework of the existing wall in the newly built sections for the ramp, and top this with new wrought iron railings of a traditional design as shown on the elevational drawings.

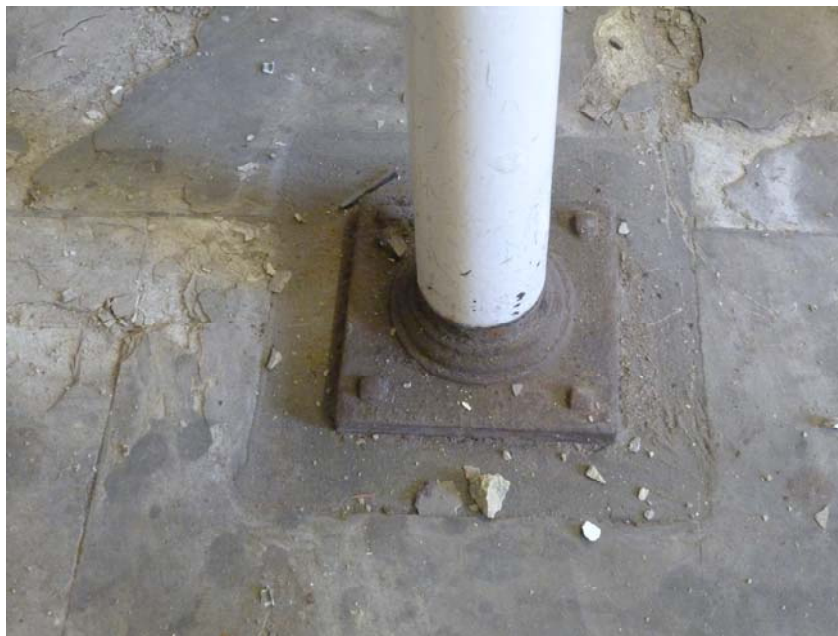
- d) The stones now discovered are cracking and there is considerable face deterioration due to having been covered up for a significant amount of time. The image below shows the flooring around the base of one of the steel columns.

- i) The stones are not intact, and have already been damaged or are removed in places, so their heritage significance is felt to be lessened.
- j) Lifting the stones and re-using them in situ has been considered, but the function room is to have a wide variety of uses, with anything from yoga classes to conference use. It is felt that the activities would not be best served by an uneven external quality solid stone floor.

- k) The application here therefore seeks to remove the slabs for alternative use where possible.
- l) Until the stones are lifted, there is no way to establish how much of the material can be salvaged, but it is hoped that they can be re-incorporated into the external landscaping in the rear courtyard with some minor re-working.
