St Mary's Hall, London Road  
Arundel, West Sussex, BN18 9BA

# Heritage Statement

*For alterations to the existing building*

*To accompany the revised Listed Building Application for  
modifications to the original approval*

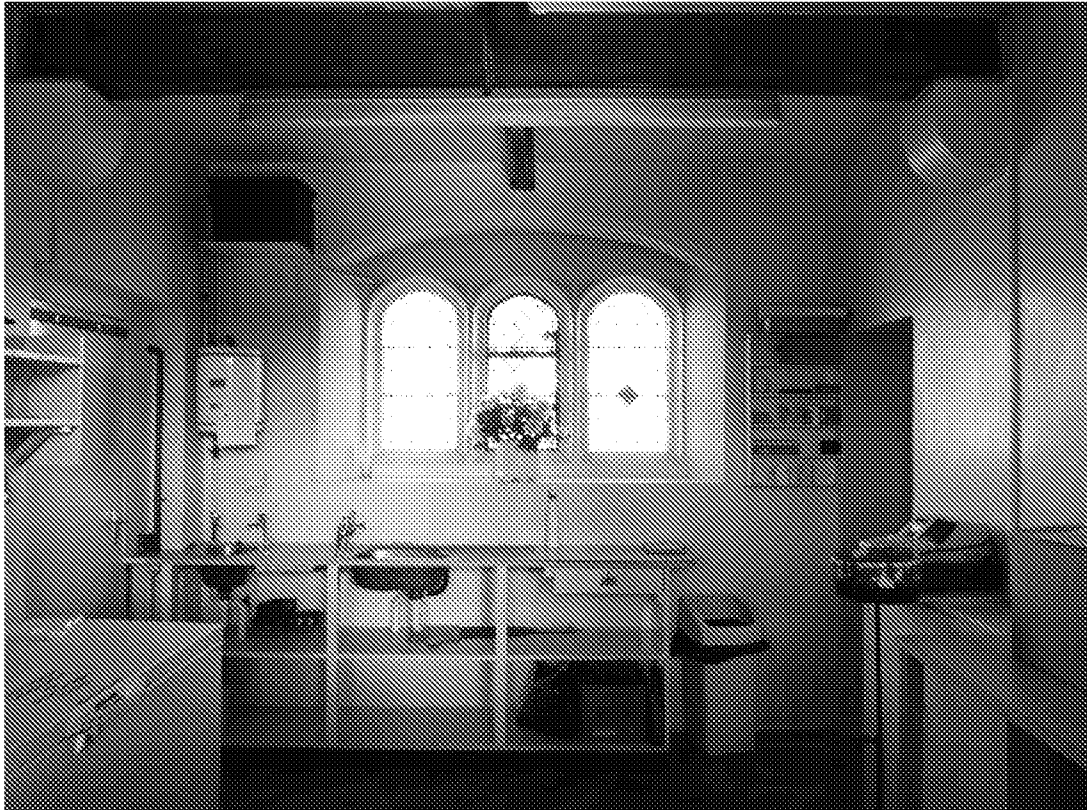
- f) Detrimental impact on fabric resulting from the changes:  
At the upper level, the new layout does require a new door opening to be made within a wall to give access to the meeting room where no previous opening exists. Whilst this is an alteration and has impact on the historic fabric, it is felt that it would be replacing the existing opening within this wall which will be blocking up in brickwork and have no greater resulting impact than the original opening had. The original opening is shown here in the photograph (right hand side of room in the image) below and is considered to be of no particular historic merit.

*This opening is considered to be of low historic merit in the overall context of the building, given that it is a simple flat headed lintel of later insertion.*

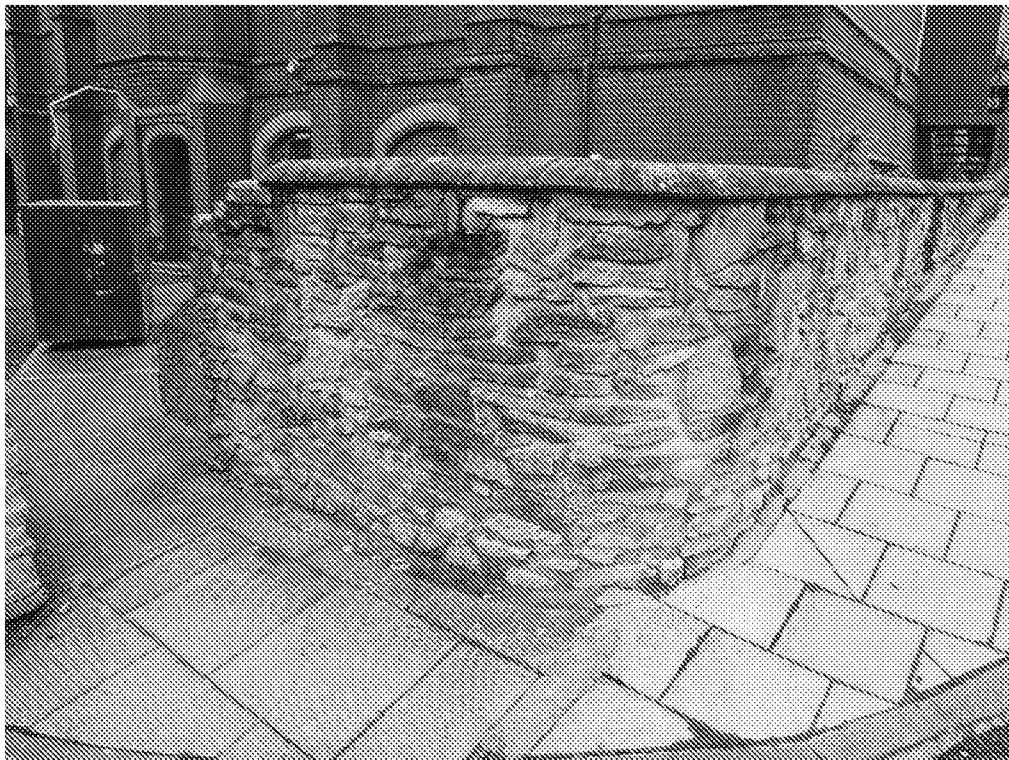
- e) Overall, it is felt that this approach will best retain and reuse the historic fabric of the boundary wall in a more positive manner by use to rebuilt the lower boundary below the railings and continued onto the facing the new ramped access to the building on Mount Pleasant side. A photograph of the existing stone wall is here below:

- d) The proposal is to reuse the existing copings and stonework of the existing wall in the newly built sections for the ramp, and top this with new wrought iron railings of a traditional design as shown on the elevational drawings.

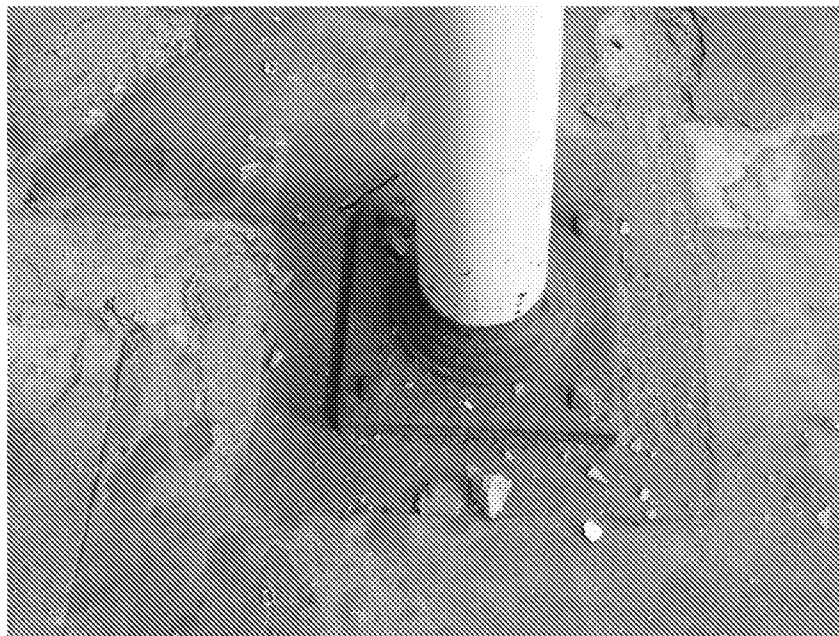
- d) The stones now discovered are cracking and there is considerable face deterioration due to having been covered up for a significant amount of time. The image below shows the flooring around the base of one of the steel columns.

- i) The stones are not intact, and have already been damaged or are removed in places, so their heritage significance is felt to be lessened.
- j) Lifting the stones and re-using them in situ has been considered, but the function room is to have a wide variety of uses, with anything from yoga classes to conference use. It is felt that the activities would not be best served by an uneven external quality solid stone floor.

- k) The application here therefore seeks to remove the slabs for alternative use where possible.
- l) Until the stones are lifted, there is no way to establish how much of the material can be salvaged, but it is hoped that they can be re-incorporated into the external landscaping in the rear courtyard with some minor re-working.
