**DALLOWAY ROAD, ARUNDEL,  
WEST SUSSEX**

**PRE-DEVELOPMENT  
ARBORICULTURAL SURVEY**

Report No: RT-MME-124814-02

Date: April 2017

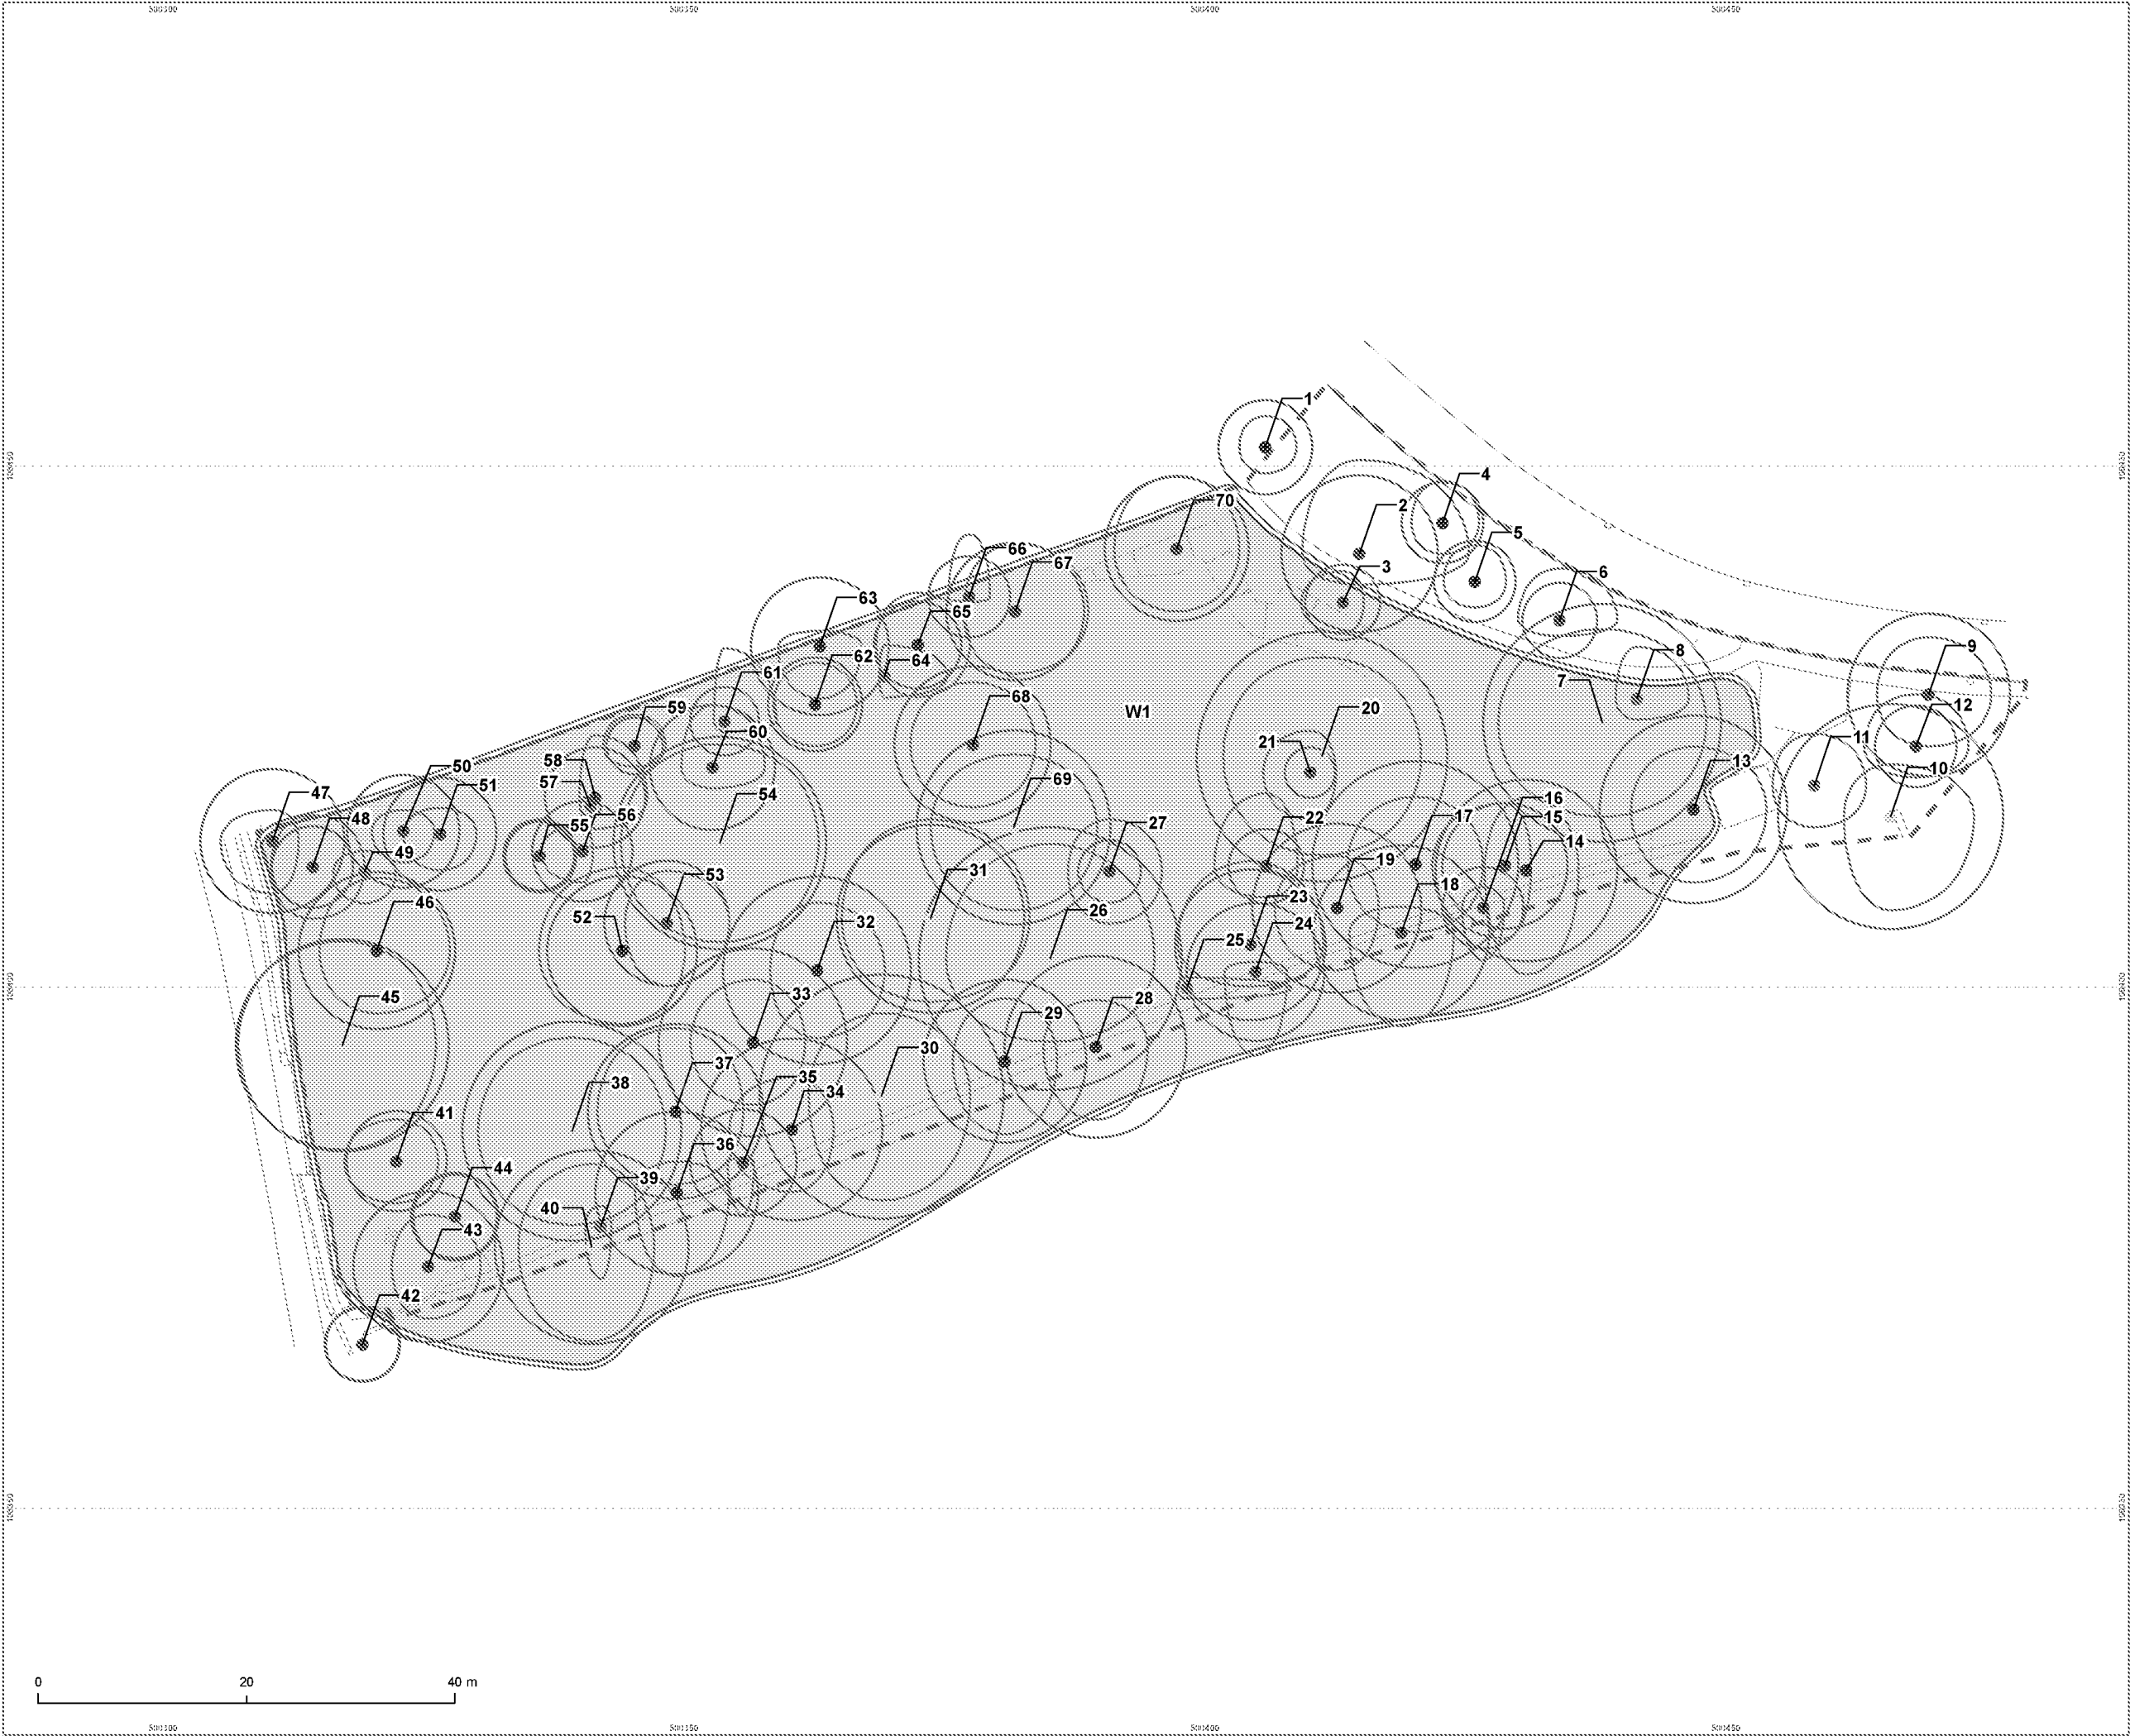
C124814-02-01

A total of seventy individual trees within an area of woodland were recorded during the survey. The location of the trees surveyed can be found on Middlemarch Environmental Ltd Drawing Number C124814-02-01, contained within Section 7 of this report.

The Tree Constraints Plan (Drawing Number C124814-02-01, contained within Section 7 of this report) is designed to show the influence that the trees have upon the site by virtue of their size and position. The plan seeks to act as a design tool that shows both the above and below ground constraints presented by the trees. The plan shows the initial RPA which may be modified dependent on site conditions.
