## **Listed Building Consent**

### **Design and Access Statement & Heritage Statement**

**Walker House  
14 Tarrant Street  
Arundel  
BN18 9DN**

**January 2021**

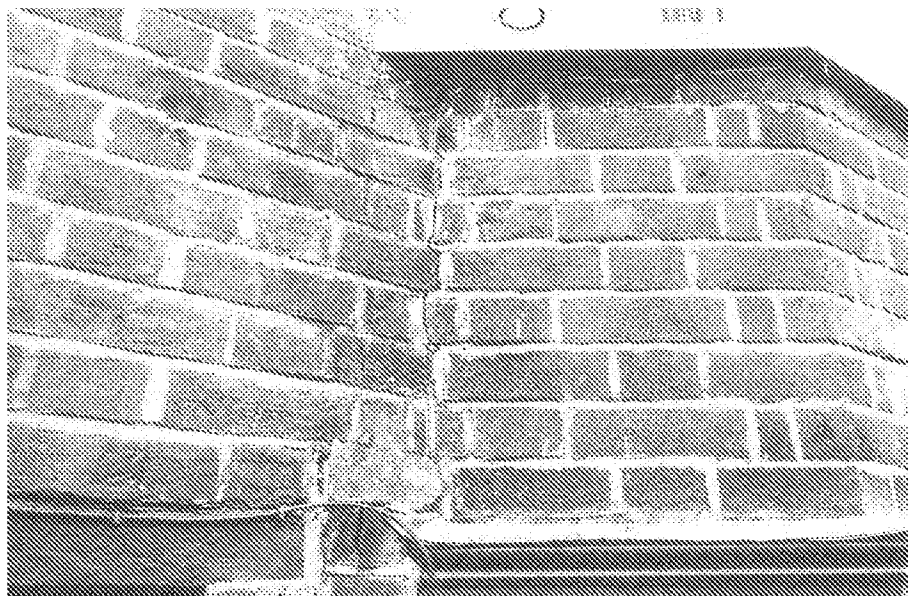
The existing window frames are in poor condition. Finishes appear to have been affected by the exposure to weather and paint has begun to peel. There is also evidence that the two-storey bay had rotated outwards, with a lean at the top towards the South. As a result, some cracking has occurred at the bay junctions.

Fig. 1 . Cracking of bay at junctions – Photo taken March 2019.

Therefore to maintain and restore the primary elevation which sits prominently on Tarrant Street, it should be understood that replacing the existing window frames, like for like, and stabilising the bay would not have a negative impact on the Listed property or surrounding buildings. Repointing in lime mortar and replacing elements of the brickwork will also be necessary in certain areas, particularly Helibar reinforcement is required.

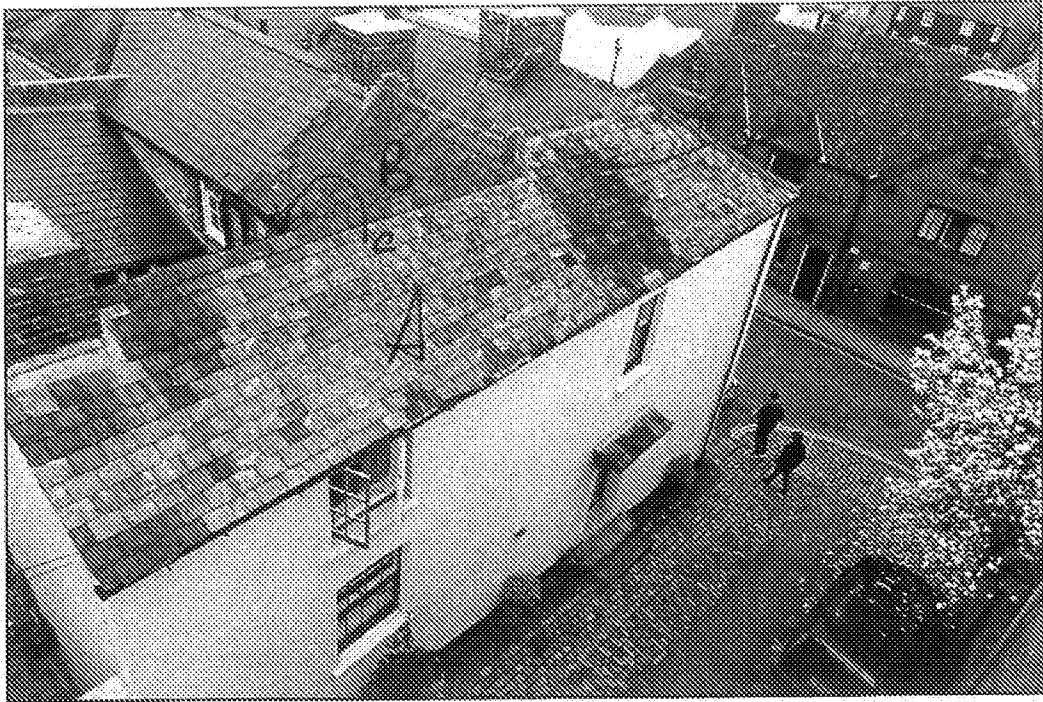
Additionally, the existing roof undulation is likely to have caused a number of slate tiles to have slipped which can now be seen sitting in the gutter. The intention is to stop this reoccurring and to allowing replacement of the roofing felt below which could also be damaged. This also provides an opportunity for straightening of the undulating roof. The roof replacement is therefore necessary and should be carried out with the interest of maintaining a durable building envelope. Additionally, straighten of the roof will reduce the risk of tiles slipping in the future, which can cause damage to the gutters or harm pedestrians below.

West roof slope—slipped slates lying in gutter ...

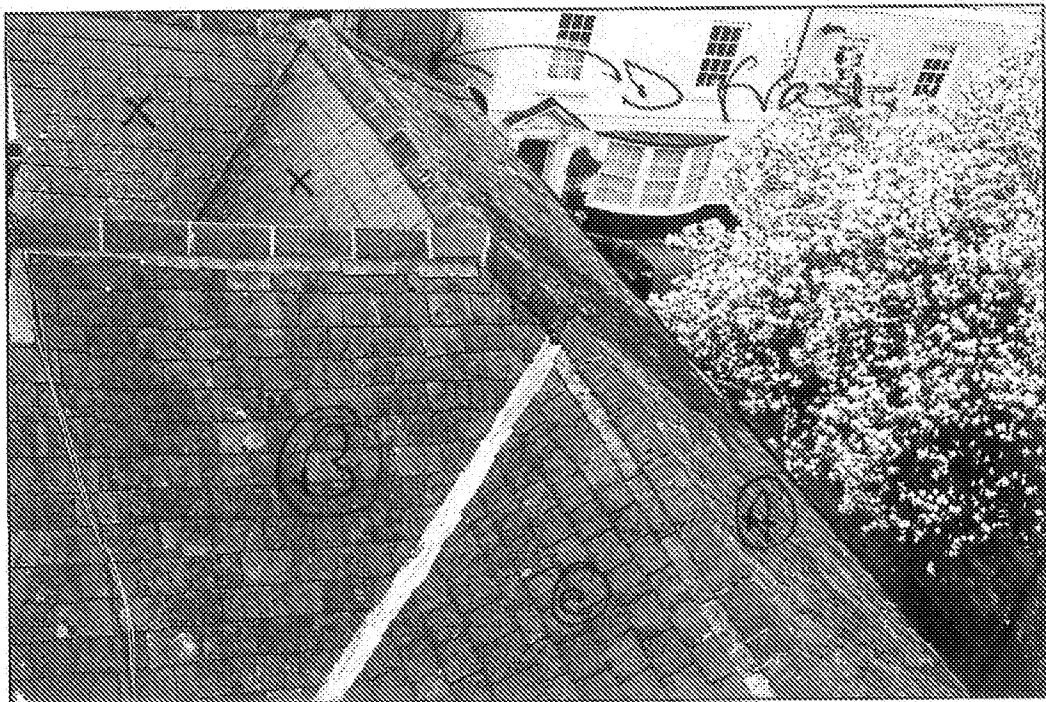
Old slates and clay ridge and hip tiles. Inner roof slopes (tp left) re-slatted

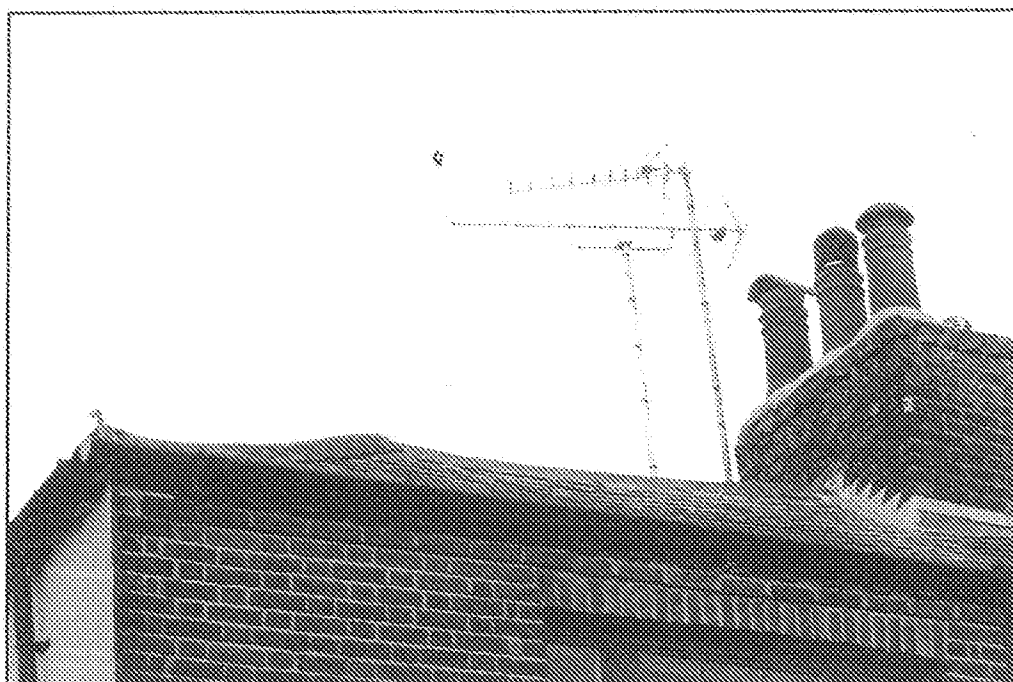
Undulating roof coverings

- Undulation to roof rafters to be made good where possible with treated timber to 'pack out' rafters to allow for straighter runs for the battens. We may not be able to achieve 100% equal levels to the roof but will do the best possible job without re-building rafters.

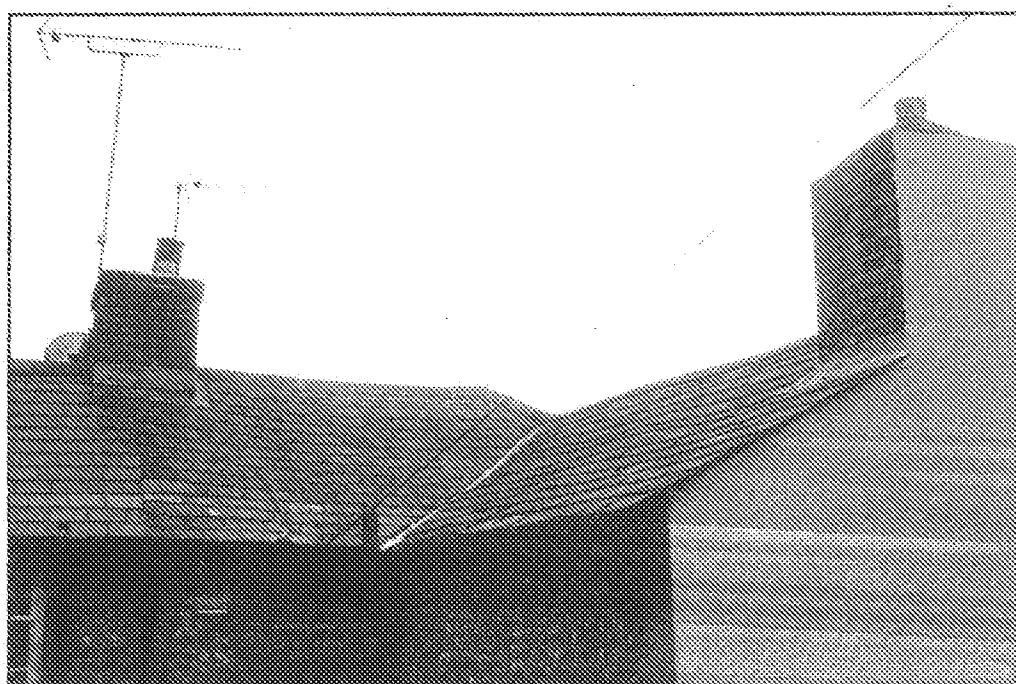
Undulating roof coverings (and lead valley lining)
