# **DESIGN AND ACCESS STATEMENT & HERITAGE STATEMENT**

**61 MALTRAVERS STREET  
ARUNDEL  
BN18 9BQ**

**LISTED BUILDING CONSENT APPLICATION**

**APRIL 2021**

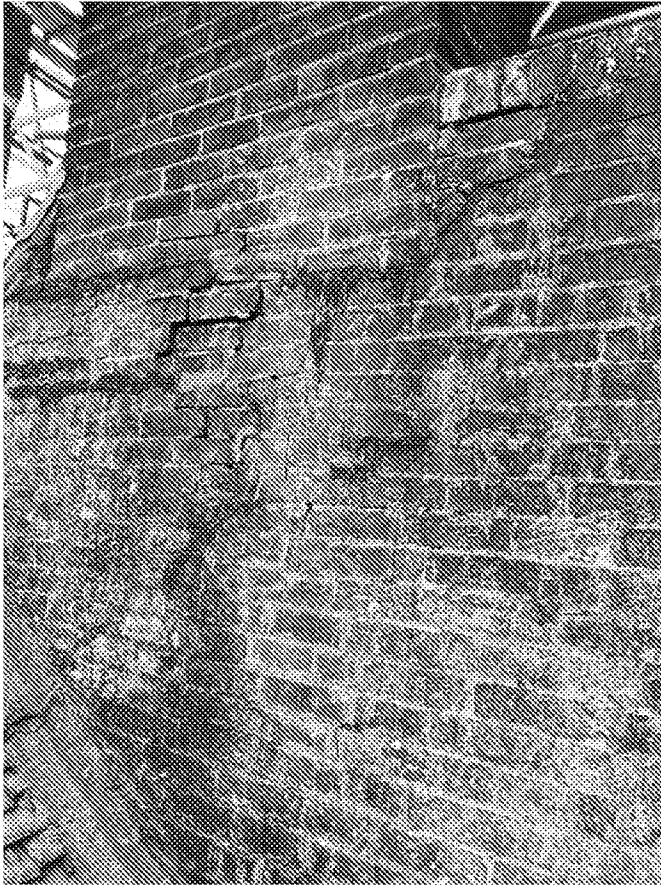
It has recently been discovered that the North West chimney is unstable with evident cracking along the base of the chimney.

According to the guidelines set out in **Section 2D: Proportions for masonry chimney above the roof surface, noted in part A – Structure of the UK Approved Building Regulations**, the current chimney does not meet the recommended proportions which may have contributed to its instability. There is also evidence the rear party wall chimney was reduced in height, perhaps for similar reasons.

*Fig. 1, Base of existing chimney.*

It is therefore proposed to reduce the height of the current chimney. The existing bricks will be reclaimed and reused. The supporting brickwork below the chimney is to be repaired where necessary.

The new chimney will remain the same width and only will be reduced in height to 1950mm from the existing parapet wall on the south west elevation. The chimney will be repointed in hydraulic lime mortar to match the original pointing.
