## **Arboricultural Survey and Impact Assessment**

**Land East of Woodgate Lane, Westergate**

**August 2021**

**BS5837:2012 'TREES IN RELATION TO DESIGN, DEMOLITION AND CONSTRUCTION – RECOMMENDATIONS'**

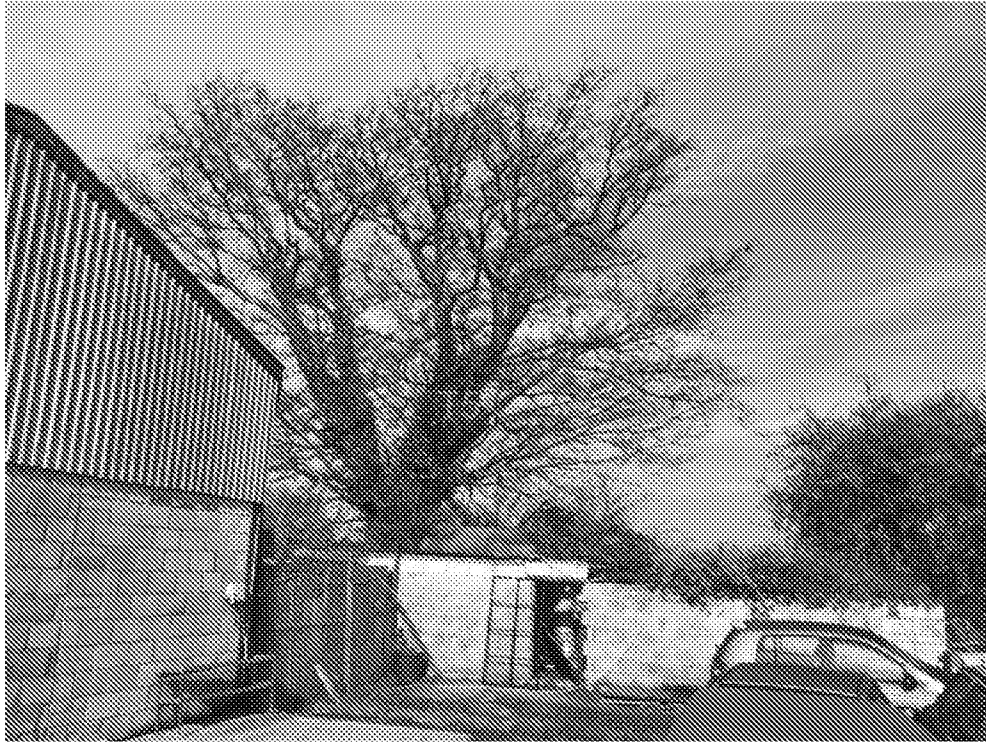
Photoview 3: View looking north towards T5.

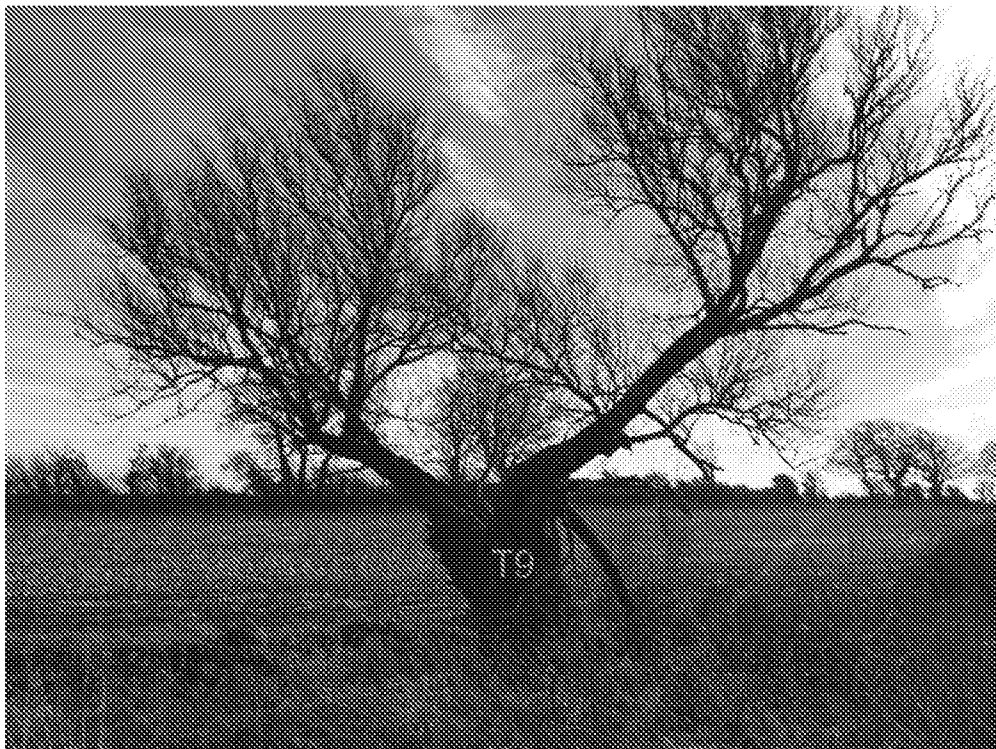
Photoview 6: View looking east towards T9.

| Ref no. | Species | Ht. (m) | | | | Category Grading | Crown Spread (m) | | | | | | | | Life stage | ULE | Physiological Condition | Structural Condition | General observations and Notes |
|---|---|---|---|---|---|---|---|---|---|---|---|---|---|---|---|---|---|---|---|
| T9 | Willow | 11.5 | 1200 | 14.4 | 652 | C1 | 4.0 | 8.5 | 4.5 | 6.0 | N/A | - | N/A | 2.5 | OM | 10+ | Fair | Poor | Large willow, stem split and hollowing, canopy formed from two limbs east and west sides, western has moderate deadwood, eastern limb has dense canopy but upper side of limb is split and decaying and hollow. Past branch failures evident |

- T8 and T9 – re-pollard to reduce risk of future failure
  - Crown clean tree canopies to remove deadwood, especially for trees overhanging new gardens and public open space. Removed deadwood should be retained on site to form habitat piles in location directed by ecologist.

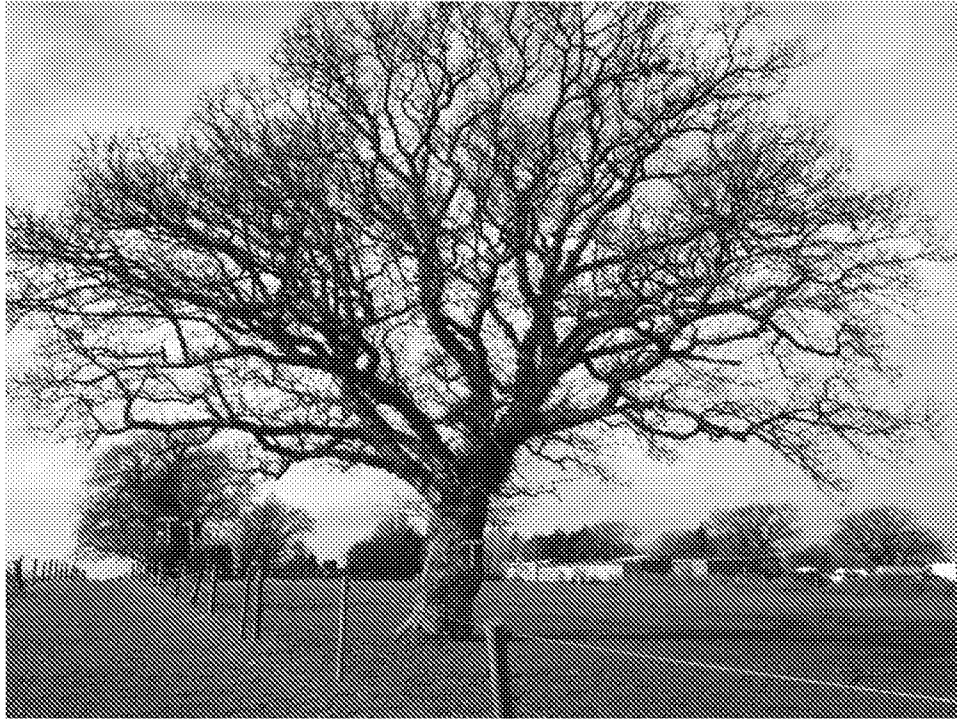
Photoview 7: View looking west towards T13 and T16.

| Ref no. | Species | Ht. (m) | | | | Category Grading | Crown Spread (m) | | | | | | | | Life stage | ULE | Physiological Condition | Structural Condition | General observations and Notes |
|---|---|---|---|---|---|---|---|---|---|---|---|---|---|---|---|---|---|---|---|
| T16 | Oak | 16.0 | 1200 | 14.4 | 652 | B1 | 5.5 | 7.0 | 7.0 | 5.0 | N/A | - | N/A | 2.5 | M | 20+ | Fair | Fair | Very dense ivy on stem and into canopy obstructing view, northern limb failed in past but loss point obscured, kinked stem and limbs, dense canopy structure |

- T13, T16, T22 and T23 – Proposed footpath through the central open space encroaches their RPAs. In these areas it is recommended that footpaths are constructed using a no dig methodology using an above ground cellular confinement system.

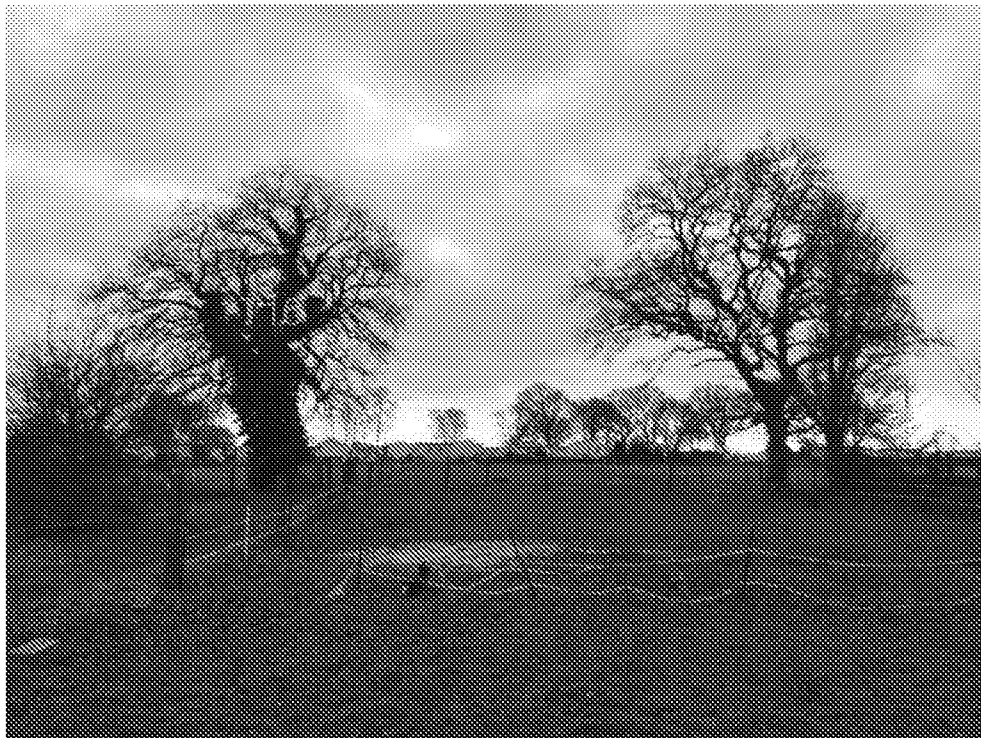
Photoview 10: View south towards T16 and T22.

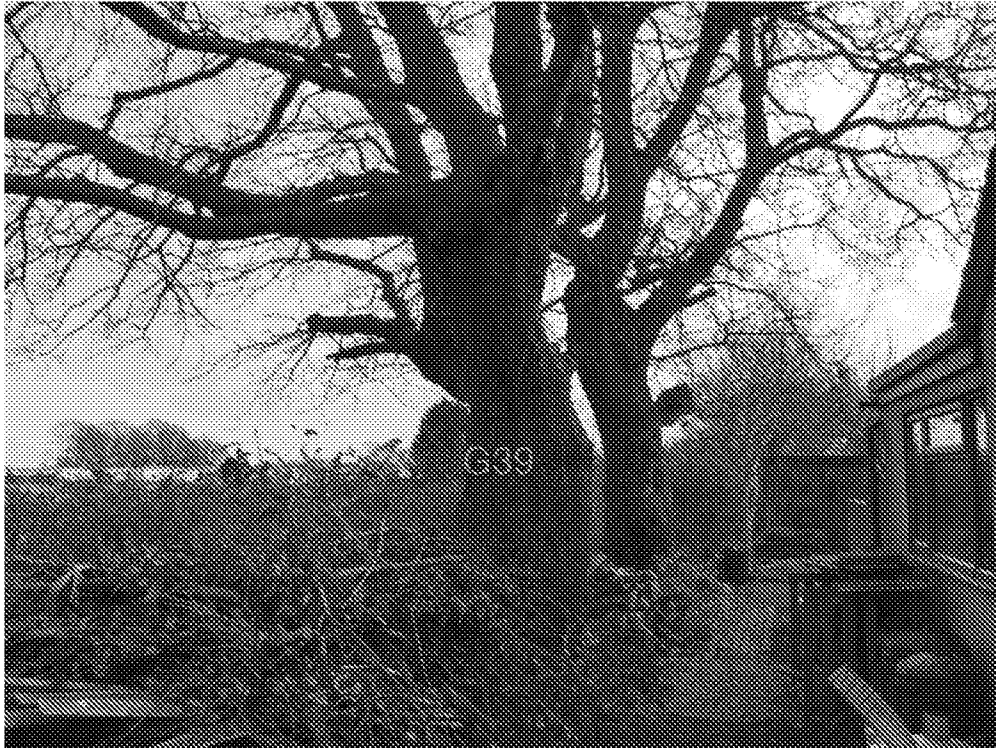
Photoview 15: View looking south towards G39.

- 6.4 Trees in G39 are adjacent to a dwelling. The RPA's of both trees have been adjusted to reflect the presence of the house foundations.
- 6.5 Root systems can be damaged in a number of ways as follows:

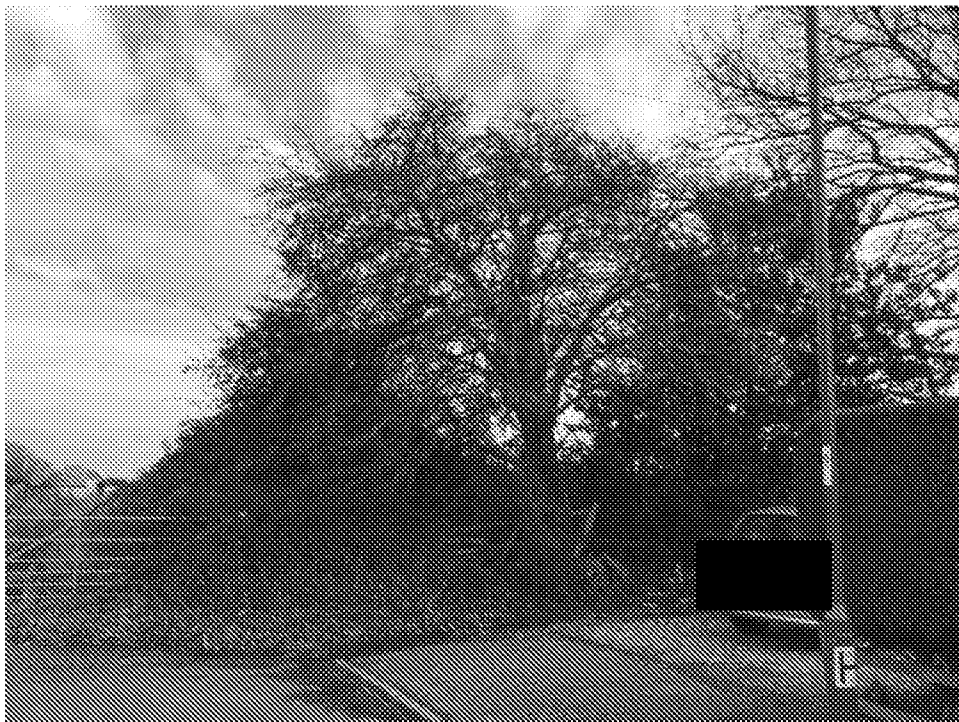
Photoview 16: View looking east towards T45.

- 8.33 Construction of the upgraded access therefore has the potential to lead to root severance and disturbance. It should also be noted that to upgrade the access will require the northern canopy of T45 to be lifted and reduced back to ensure clearance.
