# Tree Survey & Arboricultural Impact Assessment

Land at SRC Recycling,  
Eastergate

October 2021 | Project Ref 06369

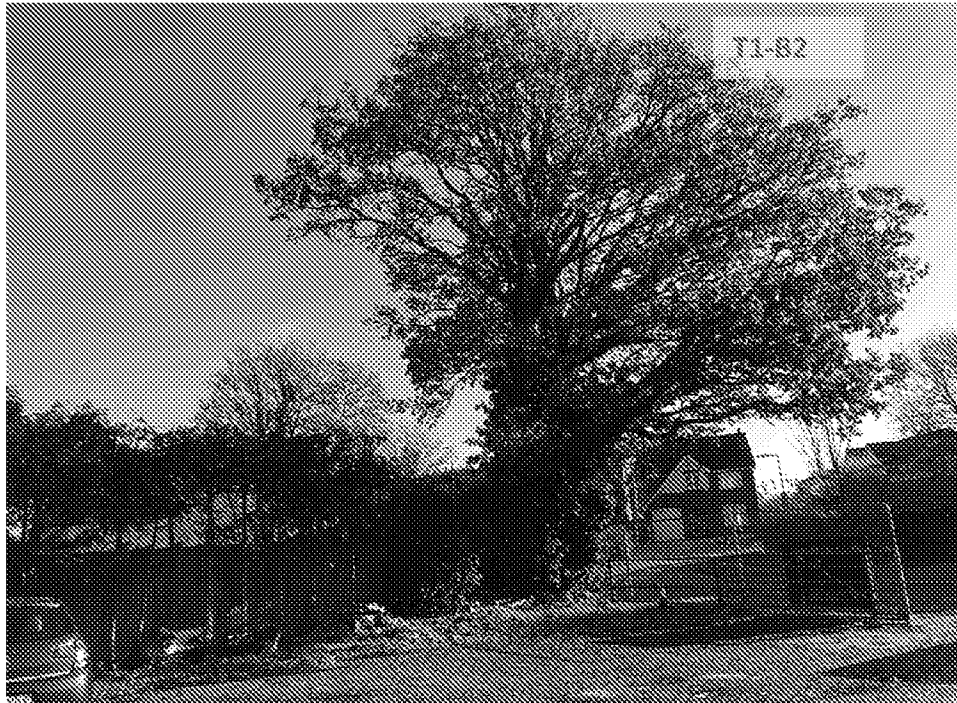
(Above) View looking east, towards the Site access and Fontwell Avenue

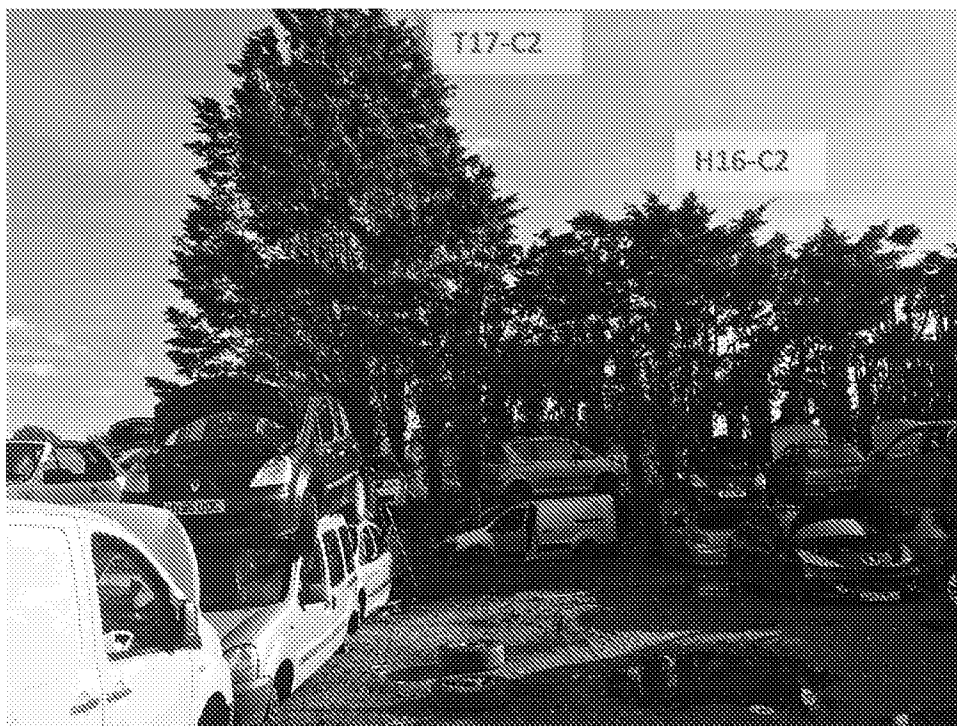
(Below) View looking east, towards the eastern Site boundary and the cypress screen.

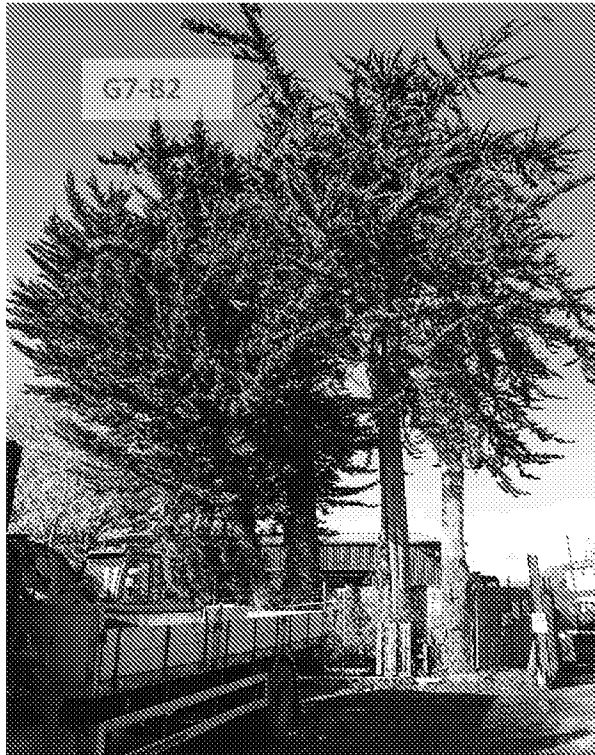
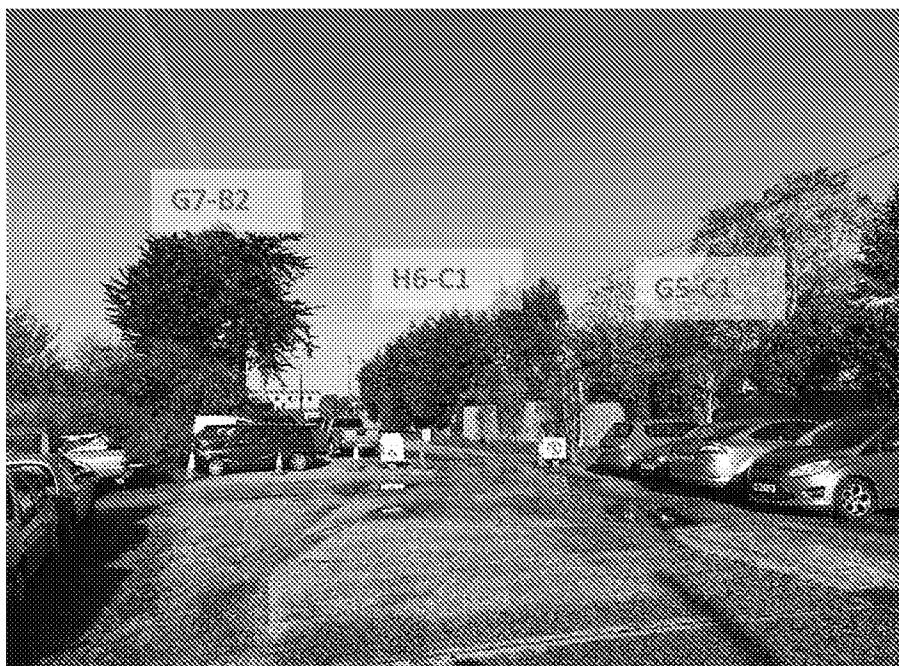
(Above) View looking west from the Site access road, towards the small group of cypress  
(Below) View looking west, from the Site access road, showing the cypress screen adjacent to the boundary fence, with heavily pruned small trees

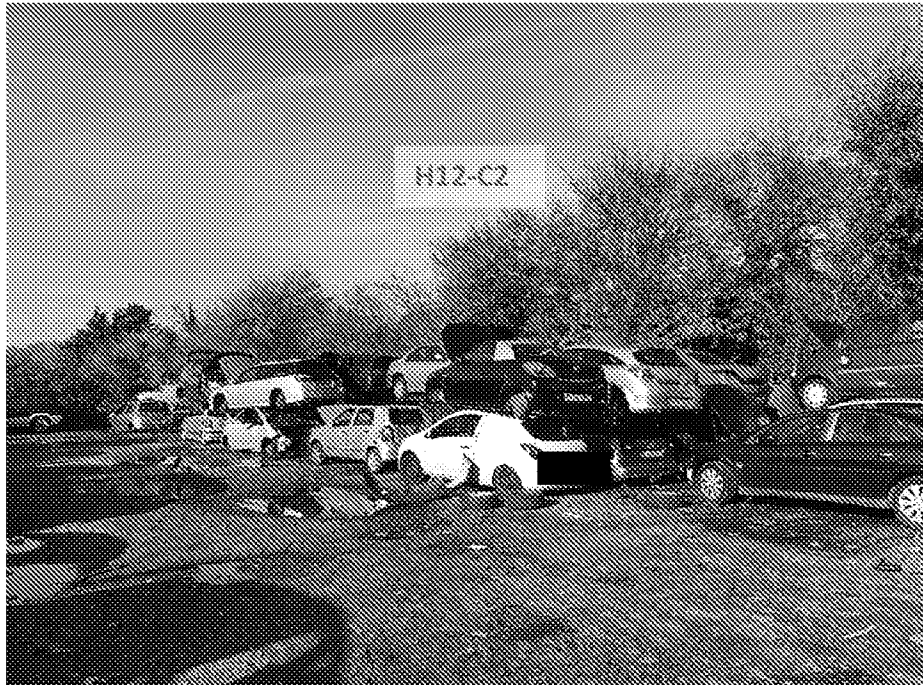
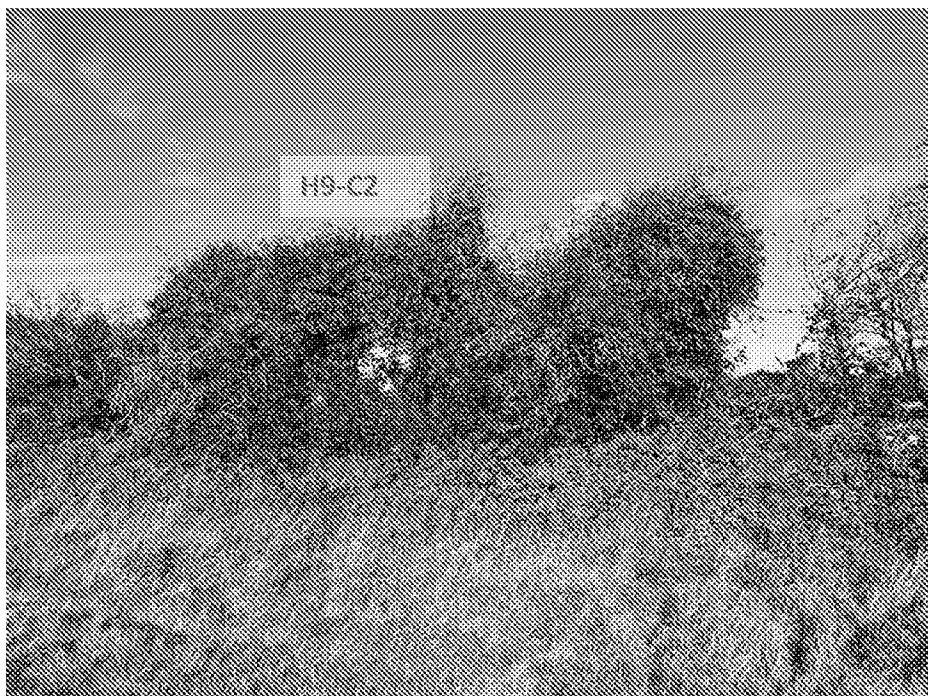
2.7 The hedges are generally in poor condition. The southern and northern boundary hedge comprise mainly native species. They are very undermanaged, with a lot of dead wood and gaps. One internal hedgerow was surveyed as a group. All the hedgerows include areas of bramble. Swathes of brambles and scrub extend throughout the recycling yard and scrap storage areas. The eastern boundary hedge is mainly comprised of a cypress tree screen, between the Site and a neighbouring private property.

(Above) View looking north-west, towards the northern Site boundary  
(Below) View looking north, towards the southern Site boundary hedgerow

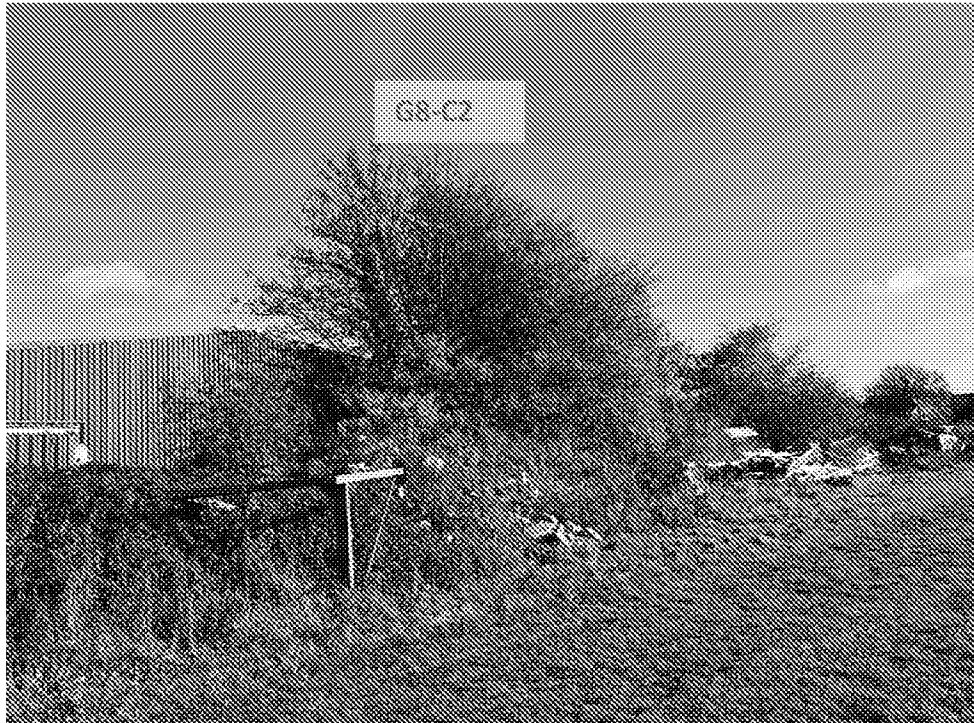
(Above) View looking north-east, towards the south-eastern Site boundary.

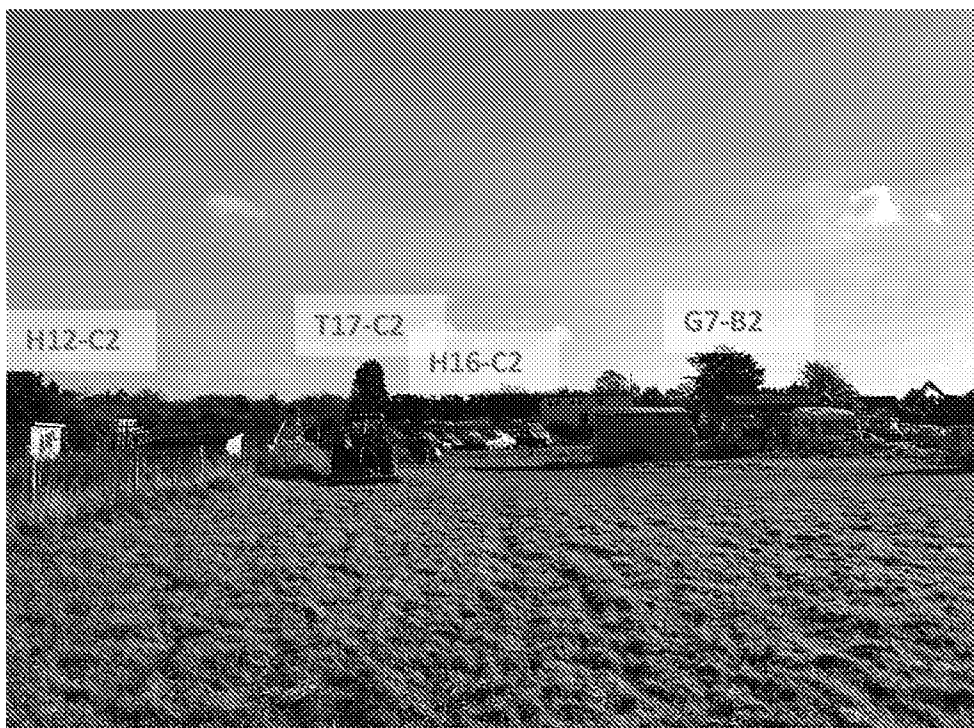
(Below) View looking east, towards the recycling yard, from near the western boundary

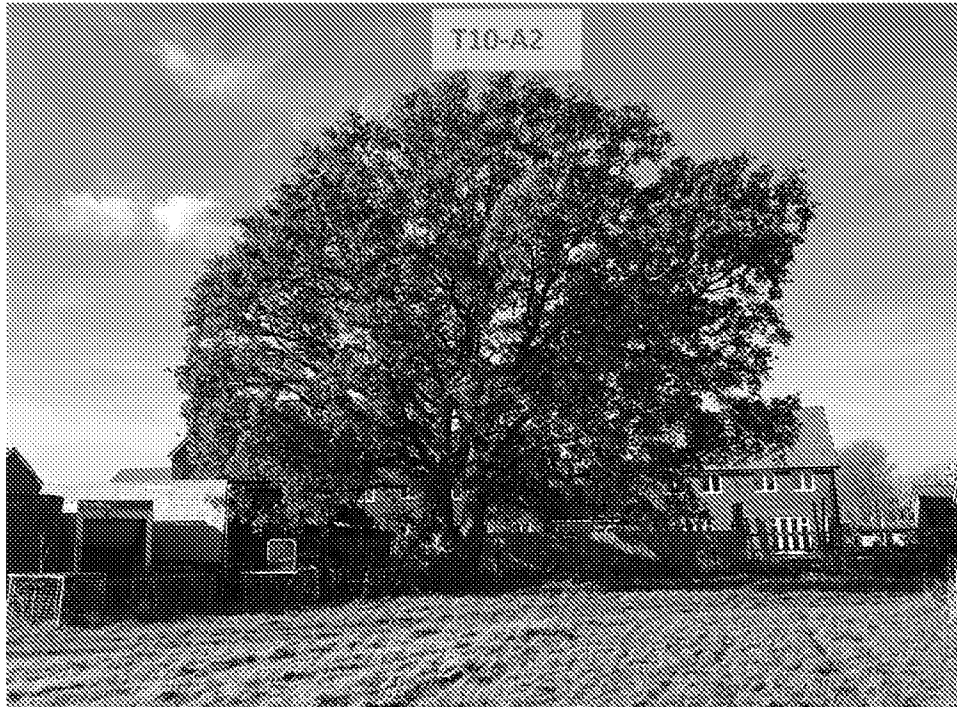
(Above) View looking west, towards the good quality oak near the western Site boundary.

| Ref.no. | Species | Ht. (m) | Stem | | RPA radius | RPA area | Category Grading | Crown Spread (m) | | | | | | | | Life stage | ULE | Physiological Condition | Structural Condition and Notes |
|---|---|---|---|---|---|---|---|---|---|---|---|---|---|---|---|---|---|---|---|
| T10 | Oak | 21.0 | 1 | 1300 | 15.6 | 765 | A2 | 8.5 | 8.5 | 9.0 | 9.5 | 1.5 | # | South | 2.5 | M | 40+ | Good | Lovely spreading crown shape. Adjacent to boundary fence. Forked at 2m. Broken lower lateral on east side. Dbh is estimated because of access problem. |

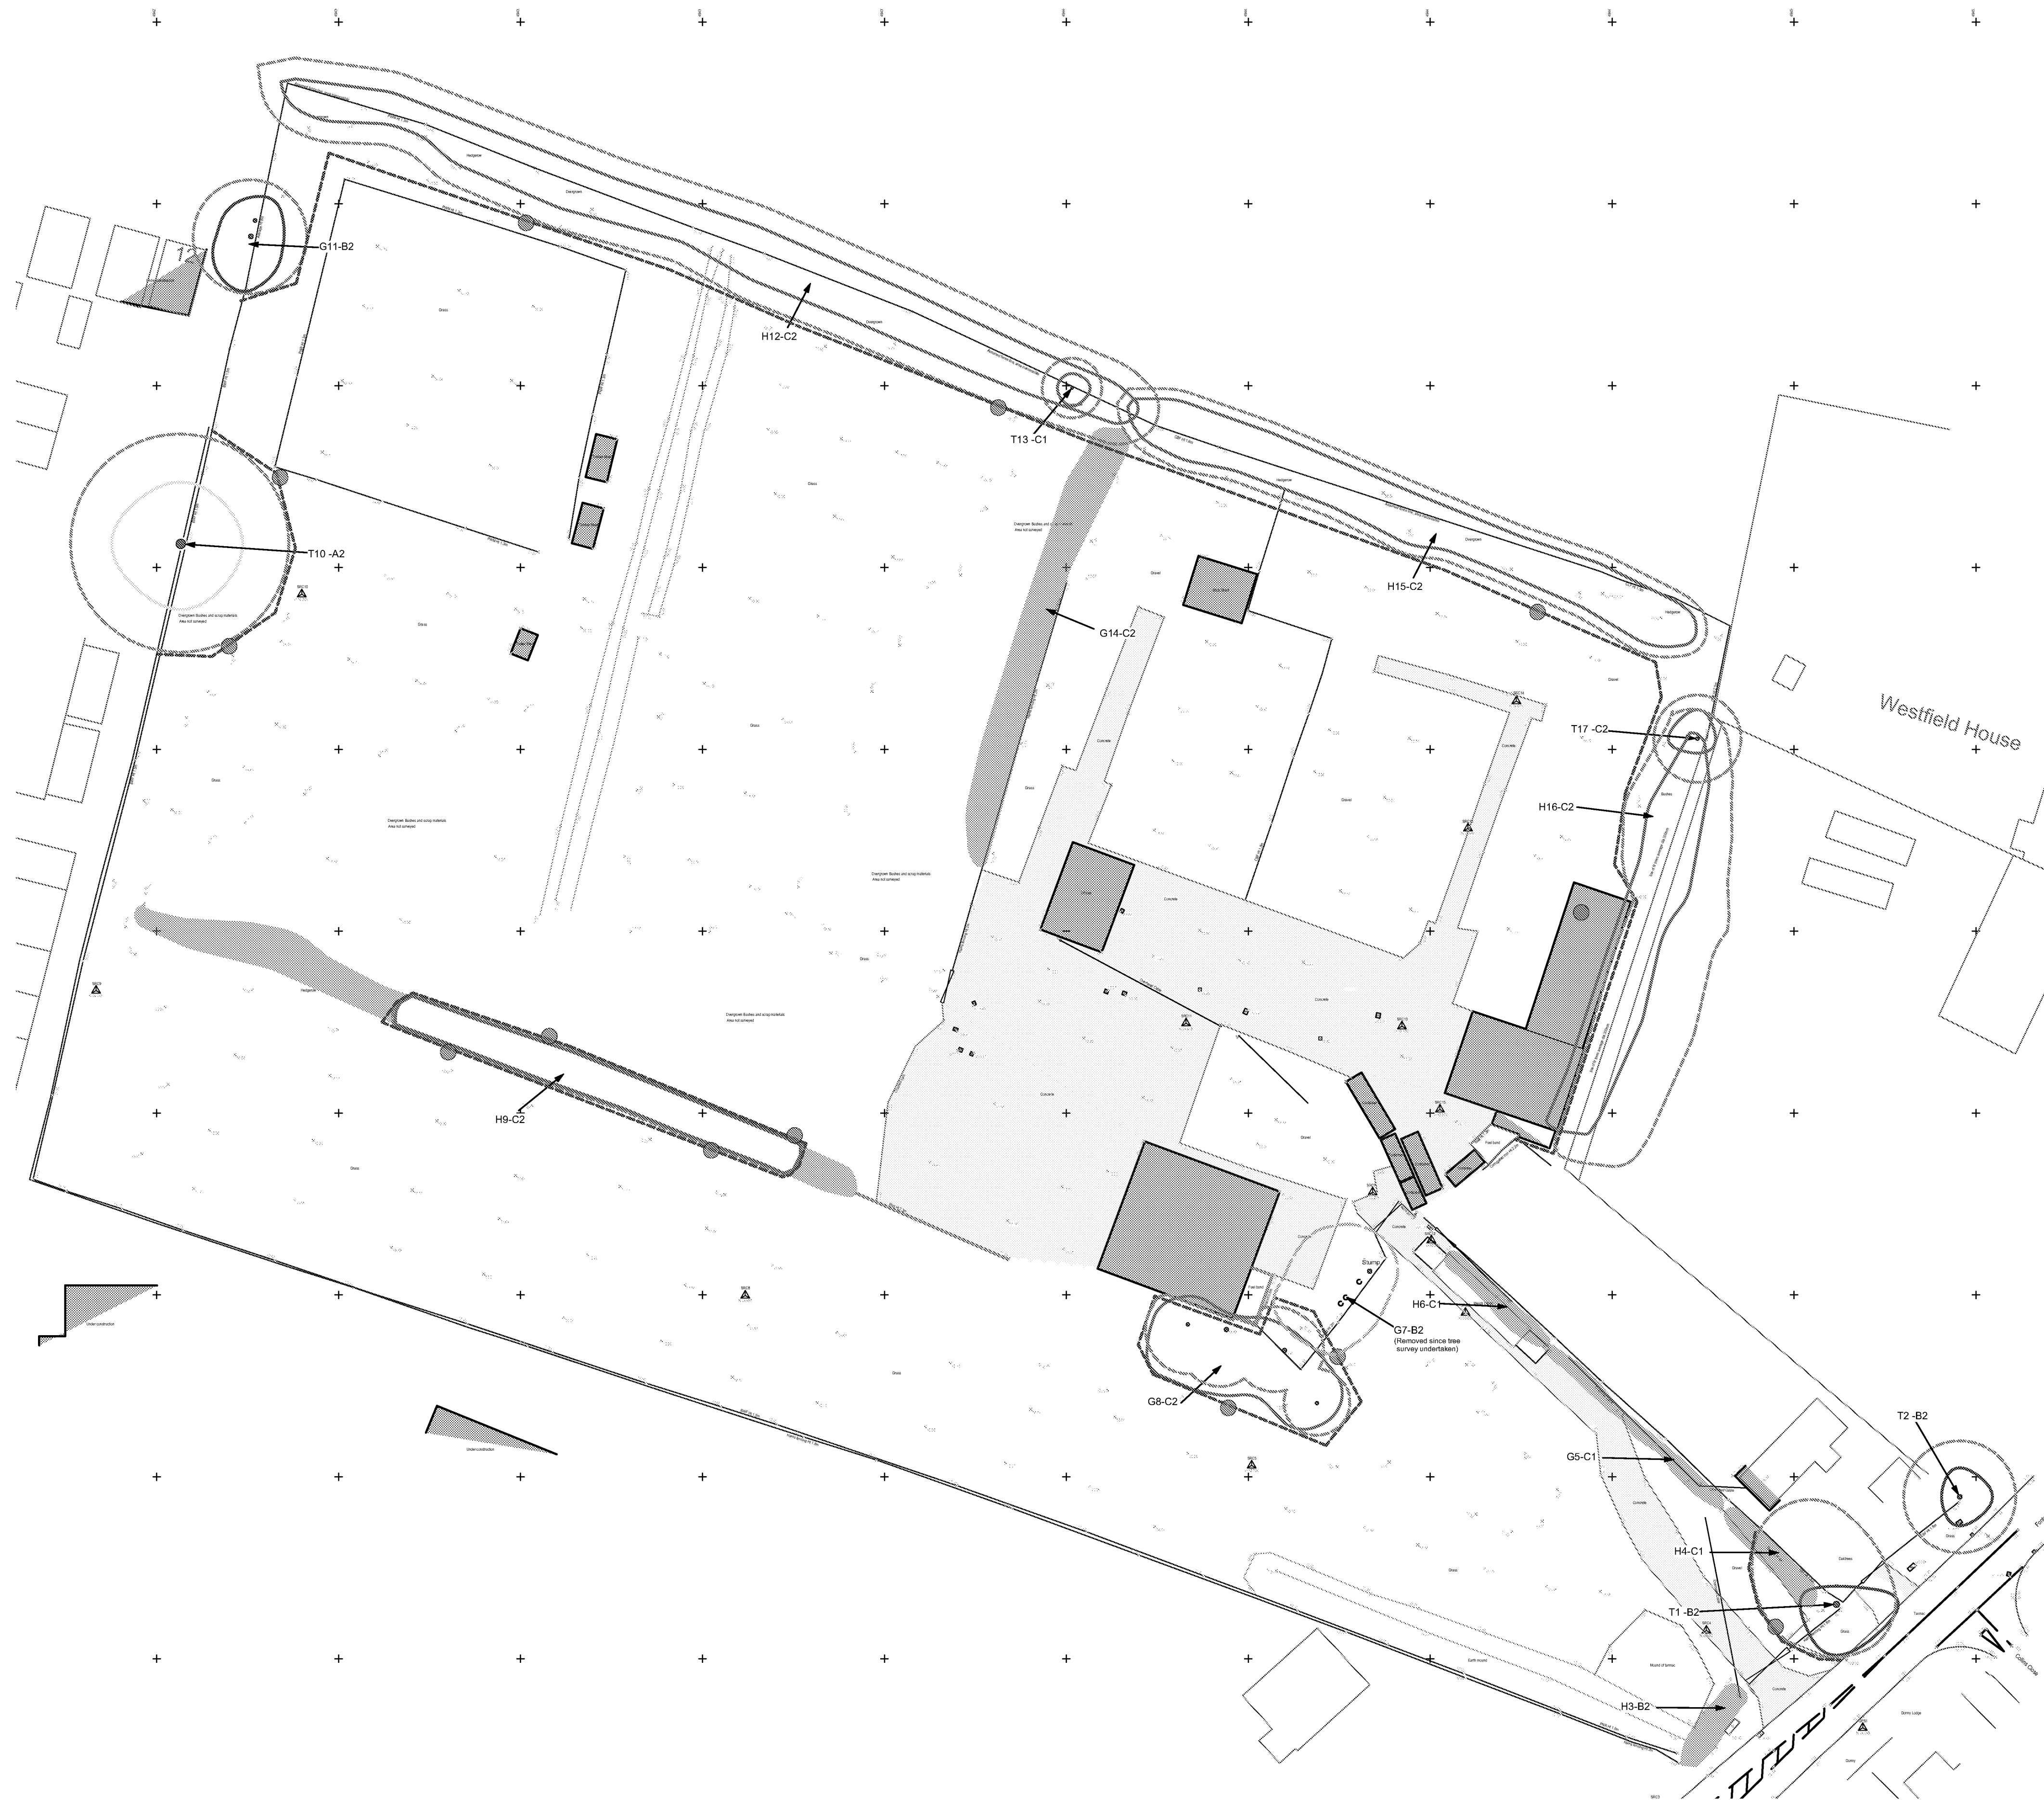
# Tree Retention/Loss & Protection Plan (Demolition)

- 4.13 There are potential impacts to surveyed items due to demolition within the site. These would include damage to tree stems and canopy as well as damage to the tree roots when removing adjacent foundations.

- 4.14 Tree protection fencing (to BS3857:2012 specification) will be erected to keep construction work and vehicles away from the retained trees (G8 and H16). (as shown on the Tree Protection Plan (Demolition) within Appendix 4).
- 4.15 A suitably qualified arboriculturist will need to be present during the demolition works in these areas. Once the buildings, foundations and surfacing are removed the exposed sections of RPA are to be immediately covered with topsoil and or temporary hoarding erected to contain the soil. The works are to be covered by a prescribed method statement.

- 4.26** Tree protection fencing (to BS5837:2112 recommendations) will be installed, as shown in Appendix 4 before demolition and construction work begins on site.
- 4.27** Tree protection fencing moved to the secondary location immediately prior to the construction of the parking area adjacent to H15 (see TPP (Construction) in Appendix 5). This will be a No-Dig construction solution.

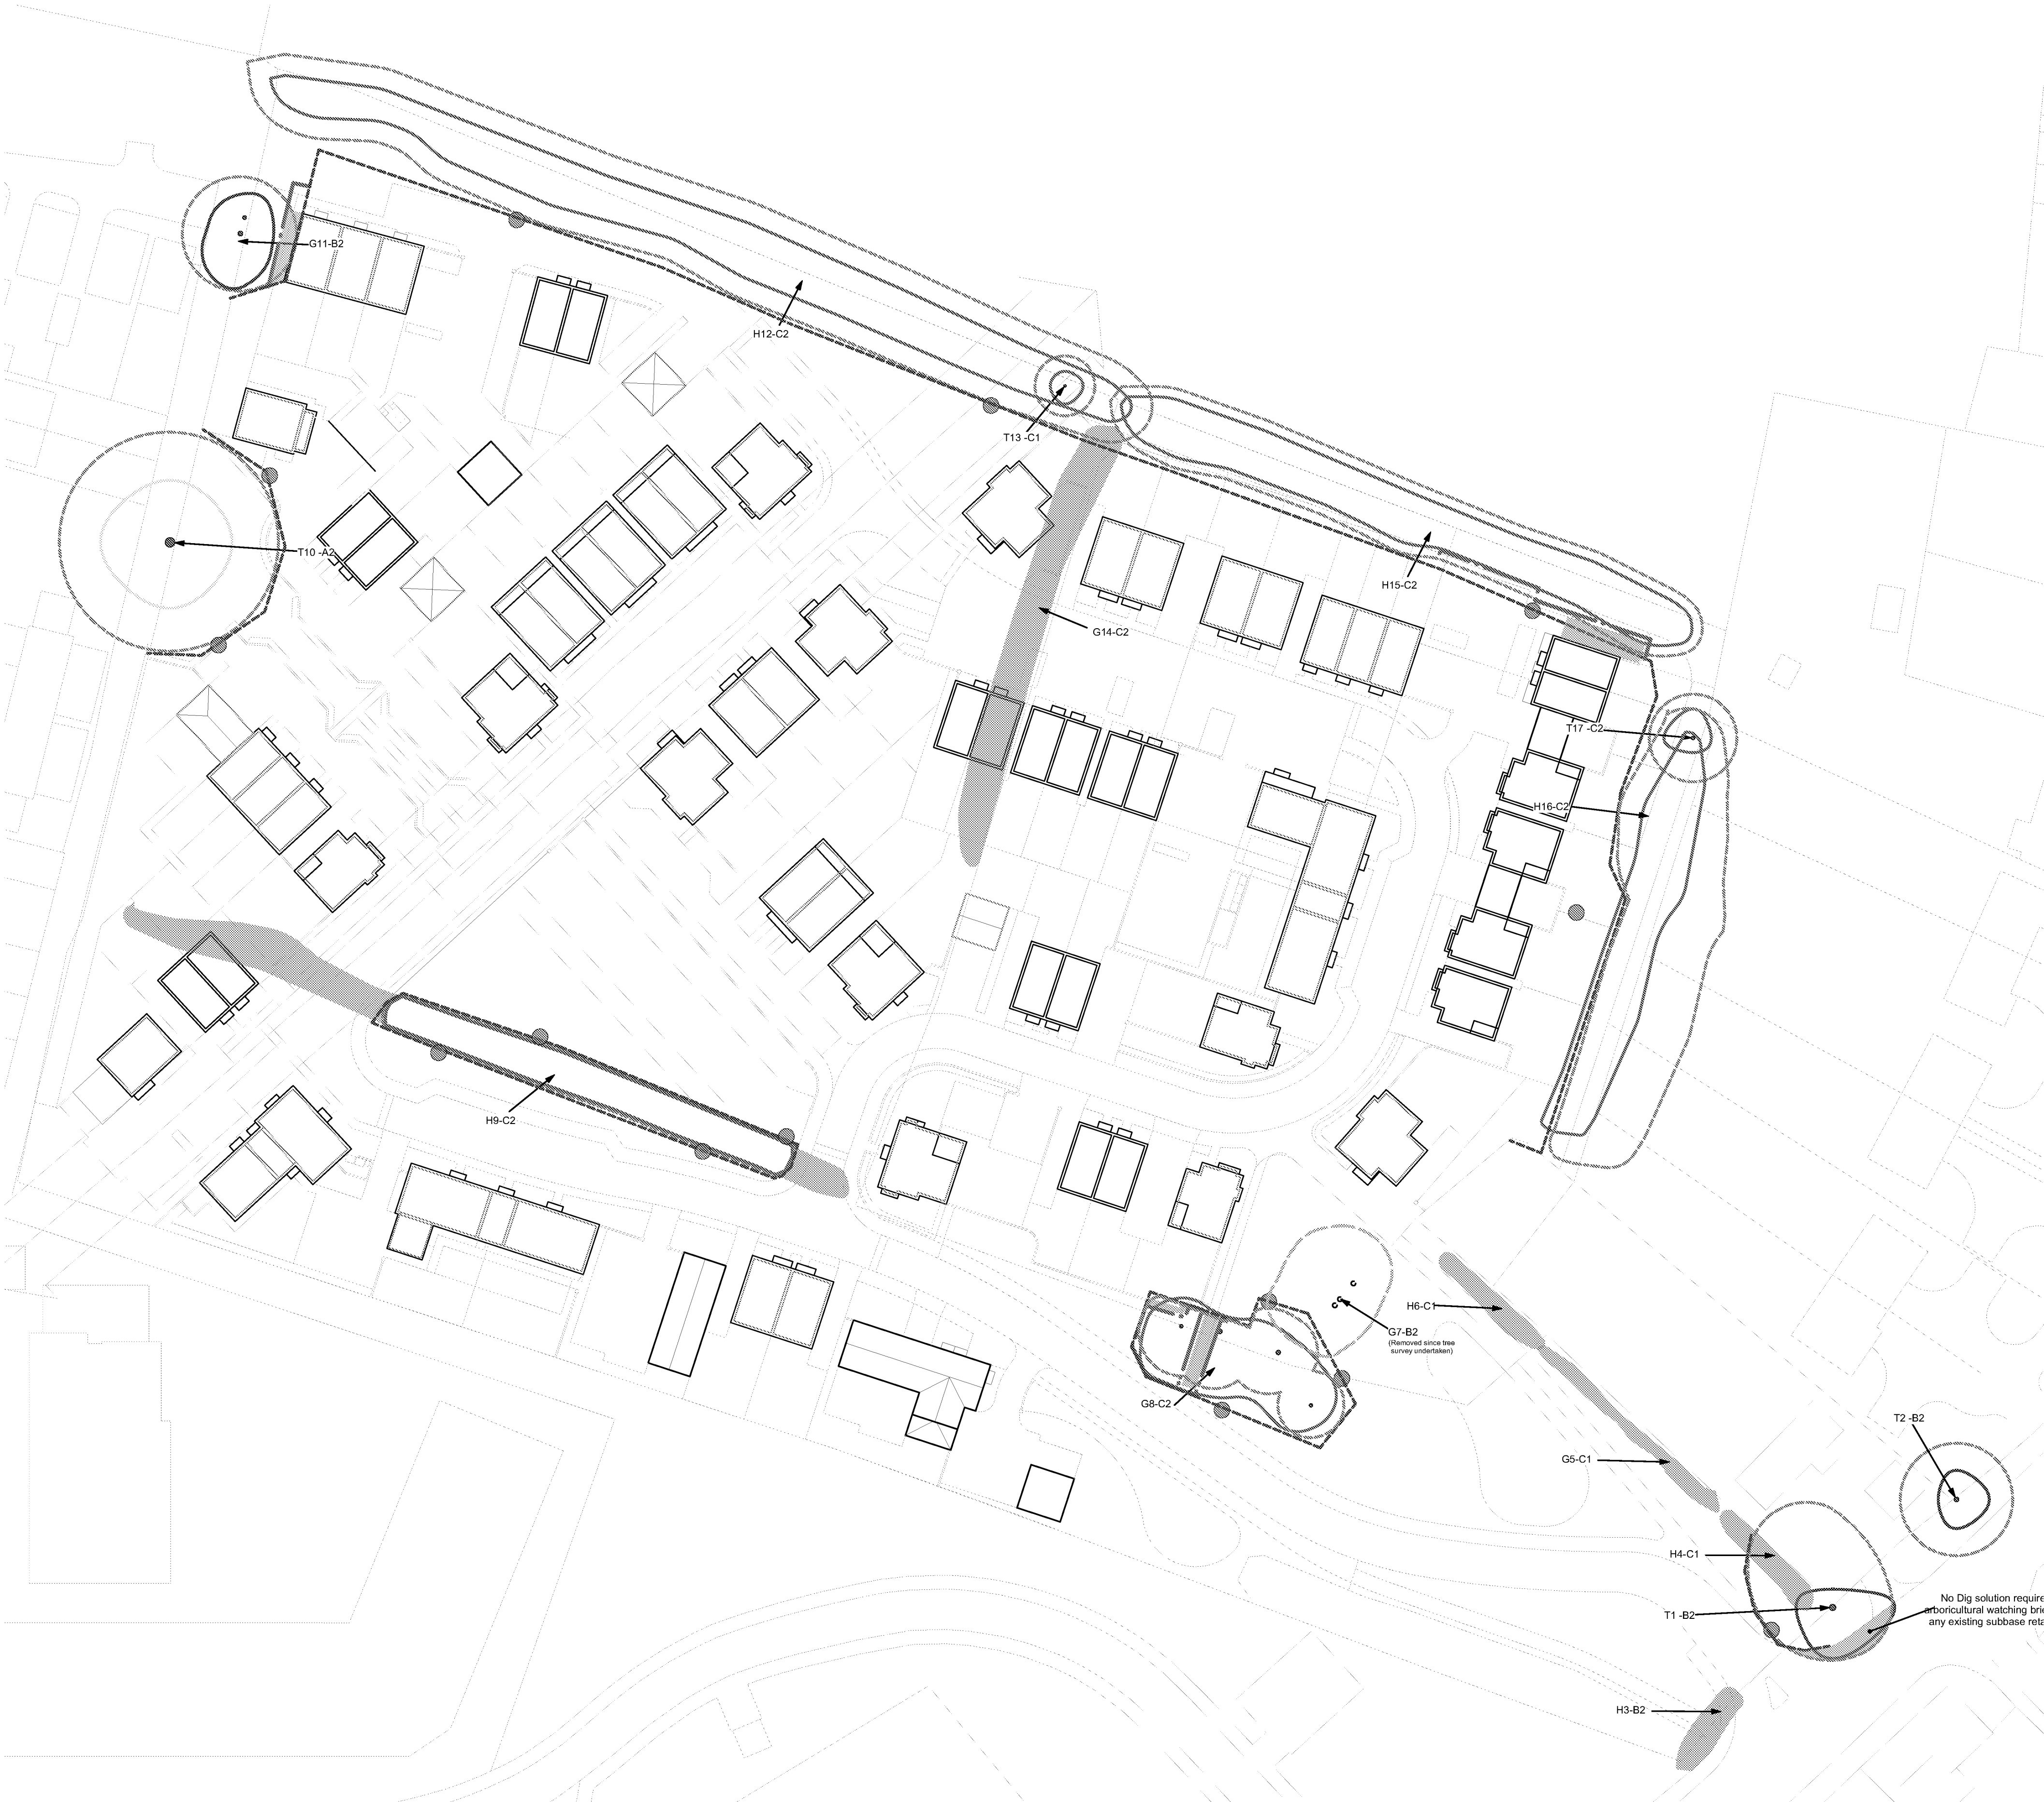
## Tree Protection Plan (Construction)

- 4.19** Generally, the construction work will be located outside the RPA of retained trees. However there may be damage to canopies and soil compaction during construction.
- 4.20** In the case of G8 regarding footpath construction and garden wall construction, there may be root severance during construction, as well as canopy damage and soil compaction within RPAs.
- 4.21** Regarding construction near to G11, there may also be root severance during construction, as well as canopy damage and soil compaction within the RPAs

- 4.25** The road construction and parking areas construction will be almost entirely outside the RPA of any retained trees. However the parking area in the north-east corner could cause direct damage to the roots of H15.

- 4.22** Damage to tree canopies and soil compaction resulting from construction vehicles running within RPAs, and construction personnel, will be avoided with the installation of tree protection fencing (to BS5837:2112 recommendations) as shown in Appendix 4.
- 4.23** Facilitation pruning (by a qualified arboriculturist) to the retained the canopy and root system following BS 3998:2010 recommendations, may be required for T9 and T11.
- 4.24** Ground protection matting (such as ground-guards Euromatt or Litematt (<https://www.ground-guards.co.uk/compare-products/>) will be used within the RPA of T9 and T11 before construction commences.
