Report Prepared by David Meagher Environment Consultants  
for private client - Mr. David Cheney. 13 June 2019

6 Little Babbsham is located within the Aldwick Fields Estate which was constructed in the early 1980s two miles west of Bognor Regis in the parish of Aldwick. This is a single-story dwelling fronted by open lawn with a linear rectangle garden to the rear. The rear boundary is composed of an outgrown beech hedge, the subject of this brief report to extend permissions for maintenance work in a tree preservation area.

Report submitted in conjunction with client's application to carry out remedial work to grown out beech hedge.

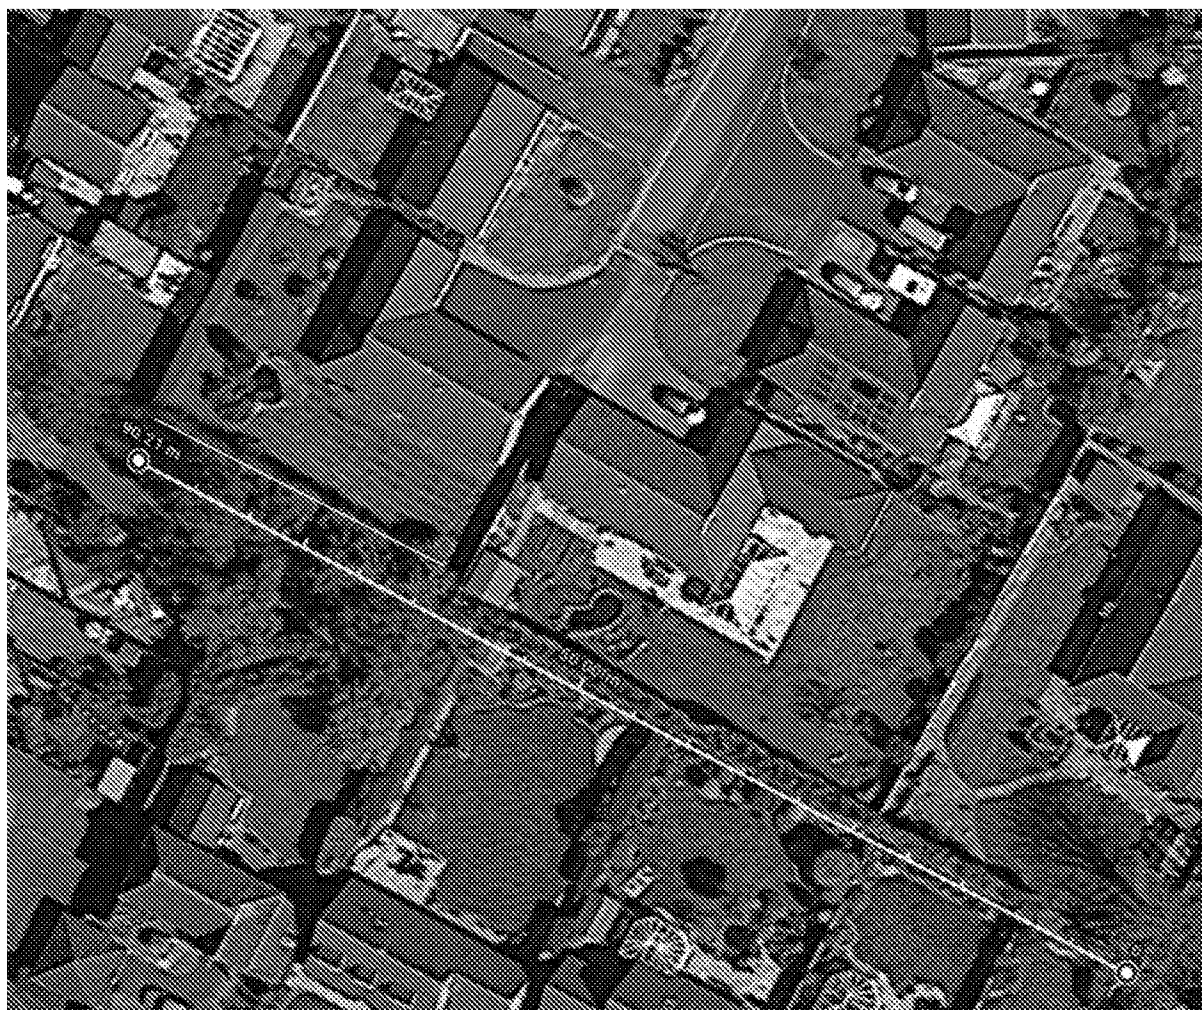
**The 6 Little Babbsham hedge is outlined in yellow and spans 28 metres in length, made up of 14 trees.**

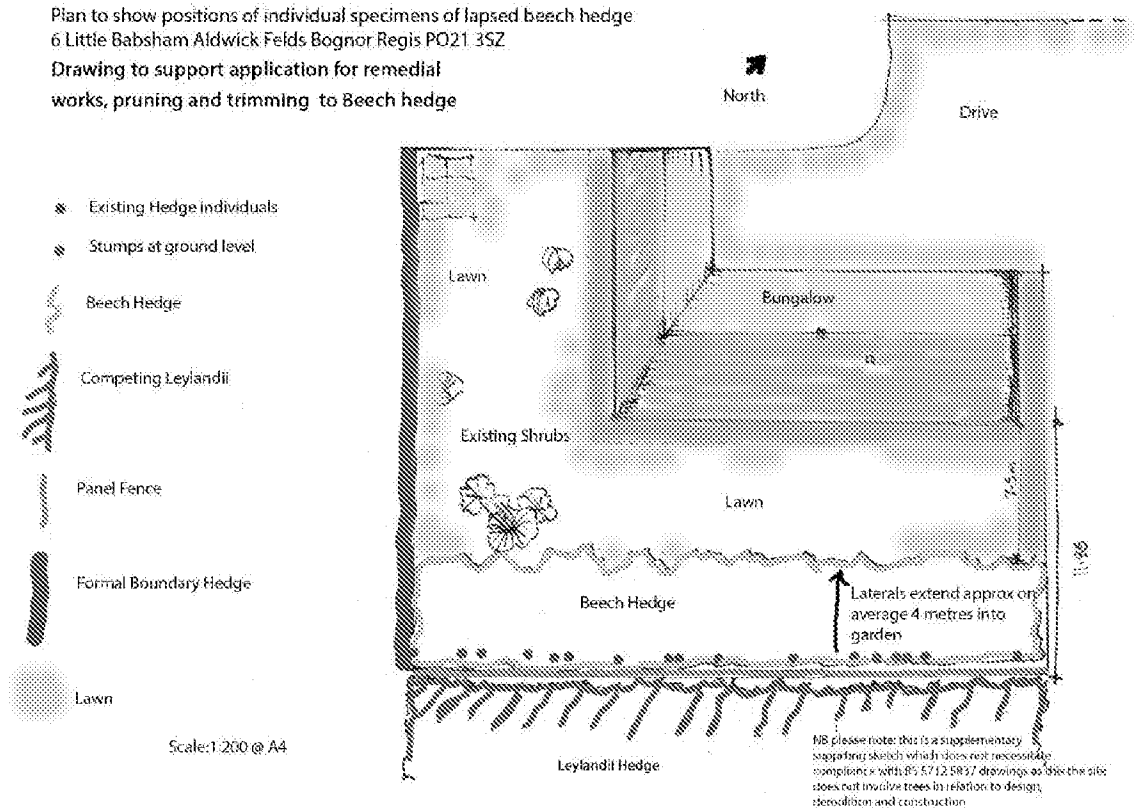
Plan to show positions of individual specimens of lapsed beech hedge  
6 Little Babsham Aldwick Fields Bognor Regis PO21 3SZ  
Drawing to support application for remedial  
works, pruning and trimming to Beech hedge

This a mature hedge which made up of a of sparse line of 14 individual trees. (See plan).

There are large gaps between individuals with evidence of rotted out basal ground level stumps in three places, as evidence of the formal hedge due to spacings, but also that trees had been removed. Fourteen individuals remain. Due to the elderly nature of the residents the trees seem to have once again been neglected until work was carried out to reduce the remaining individuals to approximately 3.5 metres. The results have led to a crowded pollard of one-sided crowns.

All the trees require the laterals pruned and reduction to the replacement leaders. Reduction should be aimed to return to the original level of 3.5 metres and removal of side growth to 300mm. This could be achieved over the course of two visits during the dormant season prior to the nesting period in late autumn or winter over two years. The first visit reducing leaders by 2 metres, then a further metre in the second year. Shortening laterals by three metres in the first year, and on the second visit trimming the remaining metre of lateral or side growth. The hedge at present qualifies as a high hedge but as a deciduous beech does not fall into the category of trees where this work is a legal requirement.

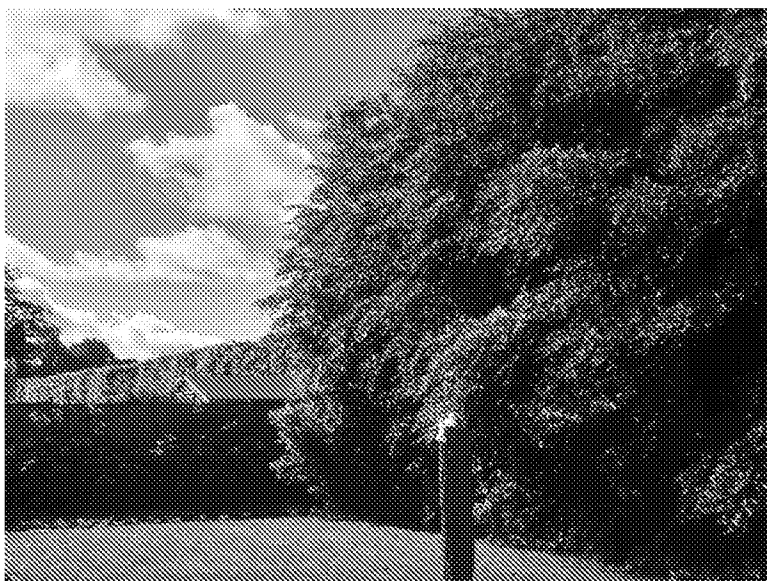
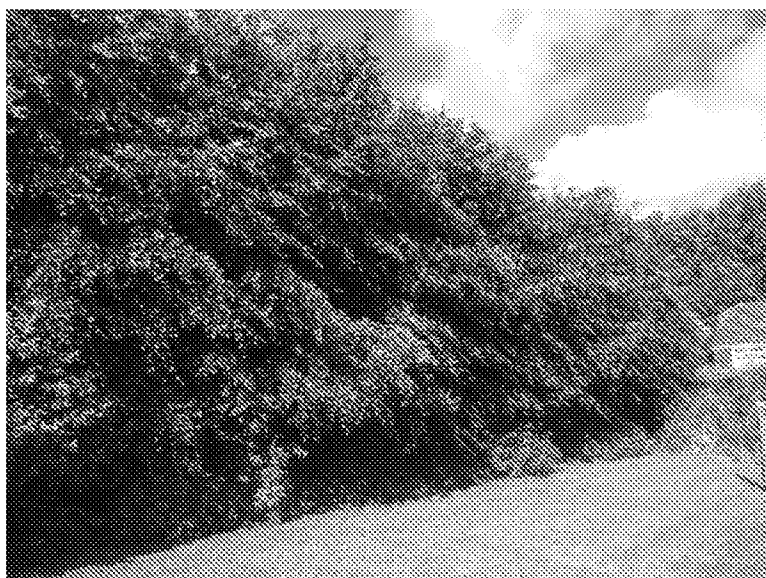
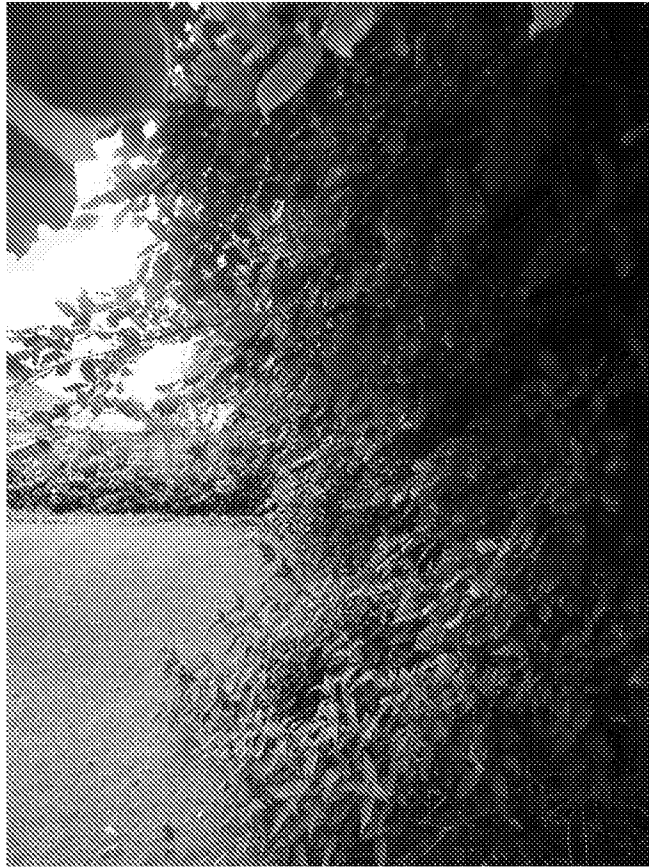
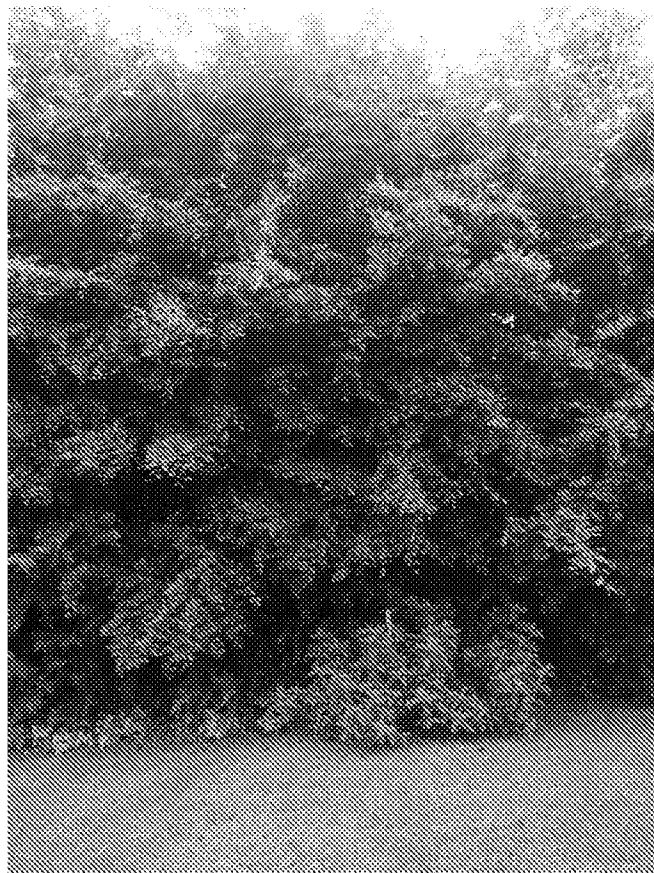
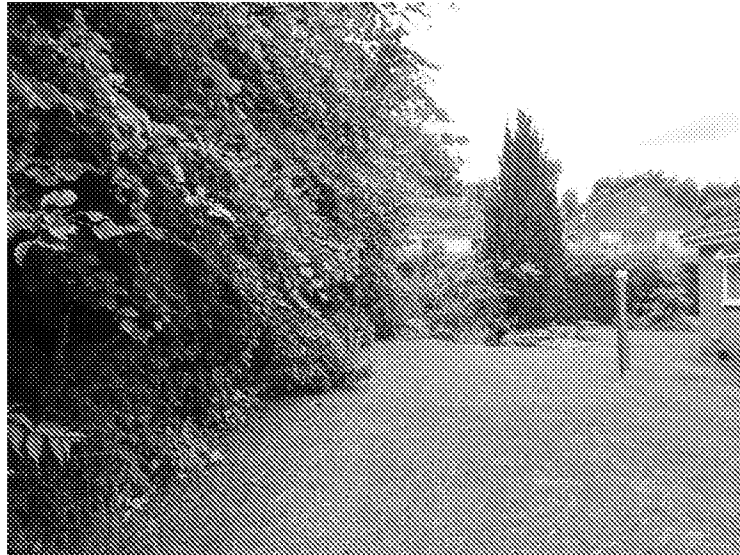
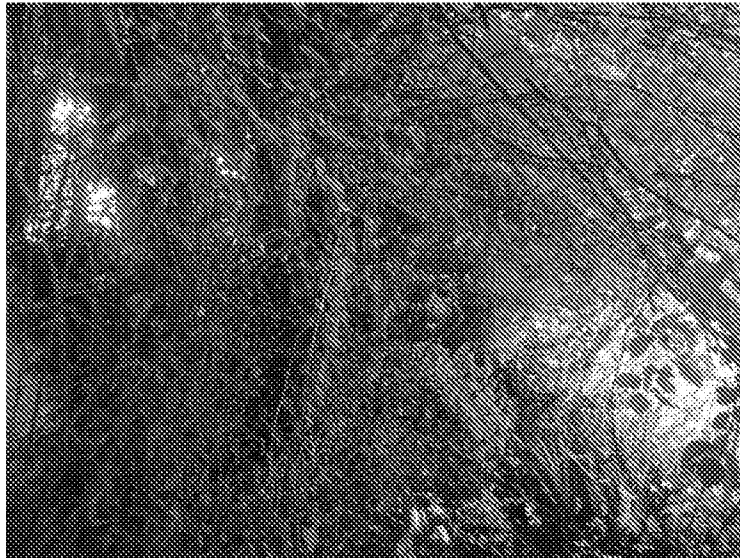
**Photos:**

Since this work there has been stem dieback allowing cavities to form, the ingress of water and decay. The Tree located in the extreme Eastern corner has an open visible cavity from a lost stem. Other trees exhibit scar tissue calluses and bark burrs. Where hedge individuals have lost its neighbour, the canopy has grown to fill the space. Most growth has been in the form of laterals with a northerly spread reaching over 4 metres into the garden (lawn) area. The upper laterals have grown vertically to replace leaders as a response to the earlier treatment of lopping and topping, together with the lack of maintenance the hedge has grown to an average of 8 metres in height.

Whilst most of the fourteen specimens are in decline and will respond to remedial and restorative pruning work the specimen last in line located in the North West Corner is the worst example (see

image). Under the classification by BS 5837 trees in relation to construction this tree would be a call 'U'. Most of the trees in this stand would be classified between U-C. Although this document does not advocate their removal due to their continued value as a screen and for wildlife.

Stabilise fence and re-affix detached panel to prevent leaning and fallen panels interfering and damage to beech and garden plants.
