**I OBJECT** to application **A/109/20/RES** for the following reasons.

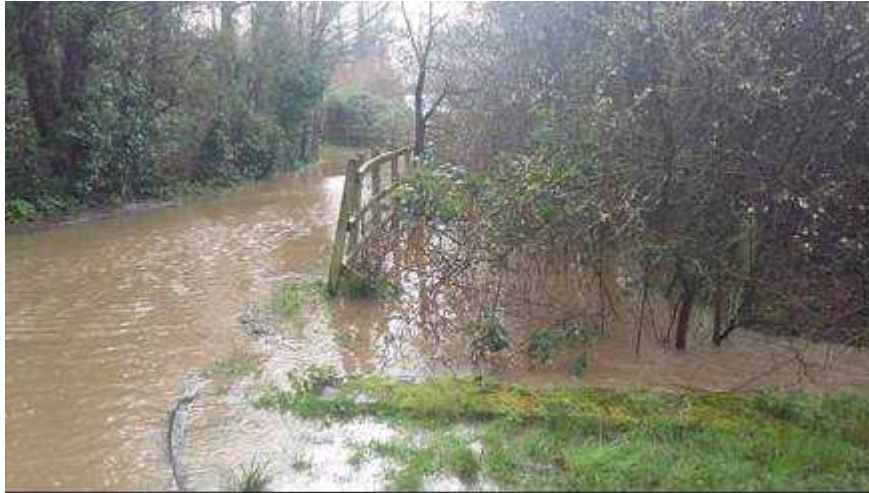
**Culvert under  
A280 by-pass at  
junction with  
Ecclesden Lane**

It has insufficient capacity, so water backs up Ecclesden Lane in both directions. View looking south down Ecclesden Lane.

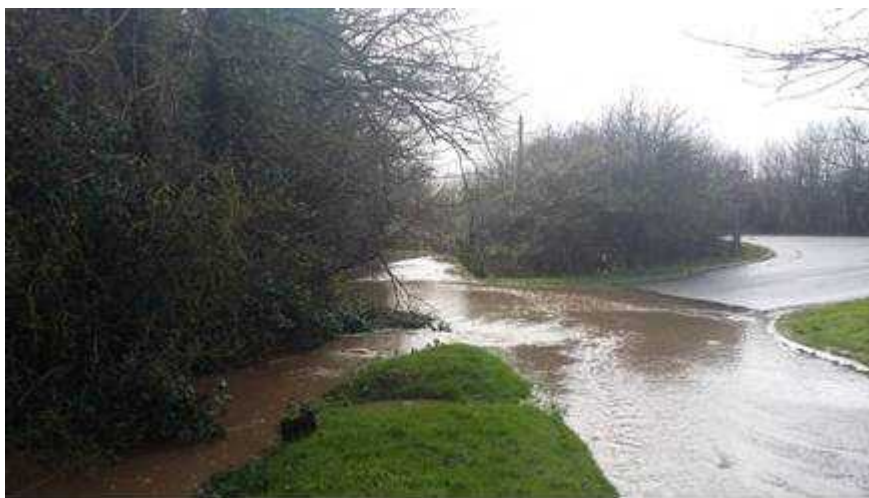
**A280 by-pass /  
Ecclesden Lane  
Junction**

Looking south showing ditch overflowing. Surface water can be seen flowing off the by-pass to the right.

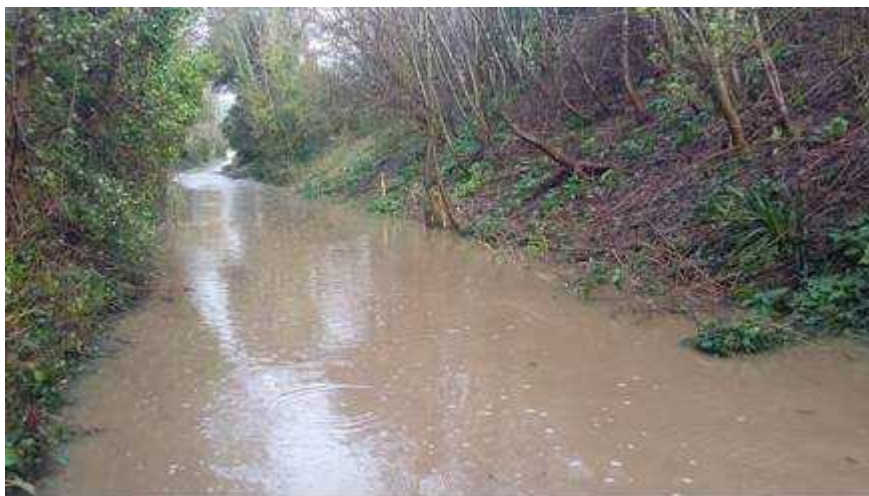
**View from the  
Junction looking  
north.**

With nowhere to go, the ditch has backed up and overflowed as surface water continues to follow its normal route off the Downs.

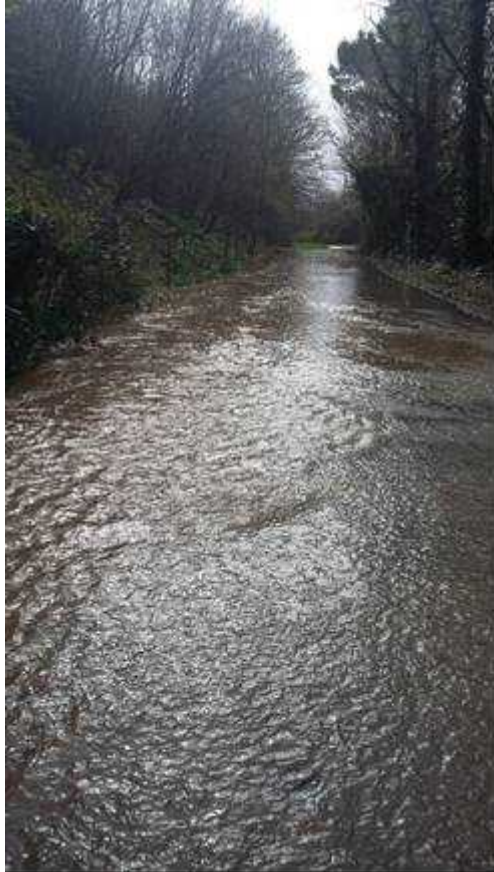
**View from North Ecclesden Lane  
looking towards the junction.**

The ditch (on the left) is fully submerged as surface water flows southwards towards the Culvert.

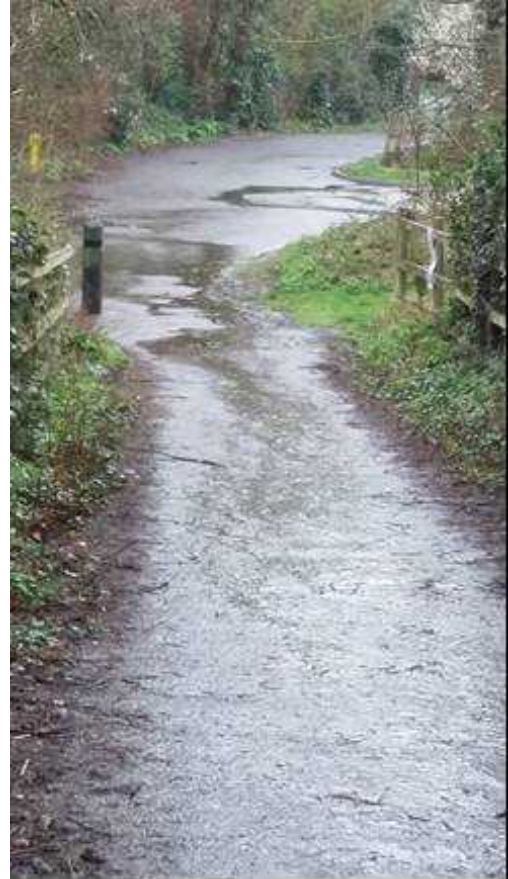
**View from A280 Footbridge.**

Shows surface water flowing down from the footbridge and the by-pass (to the right) and pooling at the junction.
