# JAMES BLAKE ASSOCIATES

## Arboricultural Impact Assessment

Land at Water Lane, Angmering

JBA 19/283 AR01 Rev B

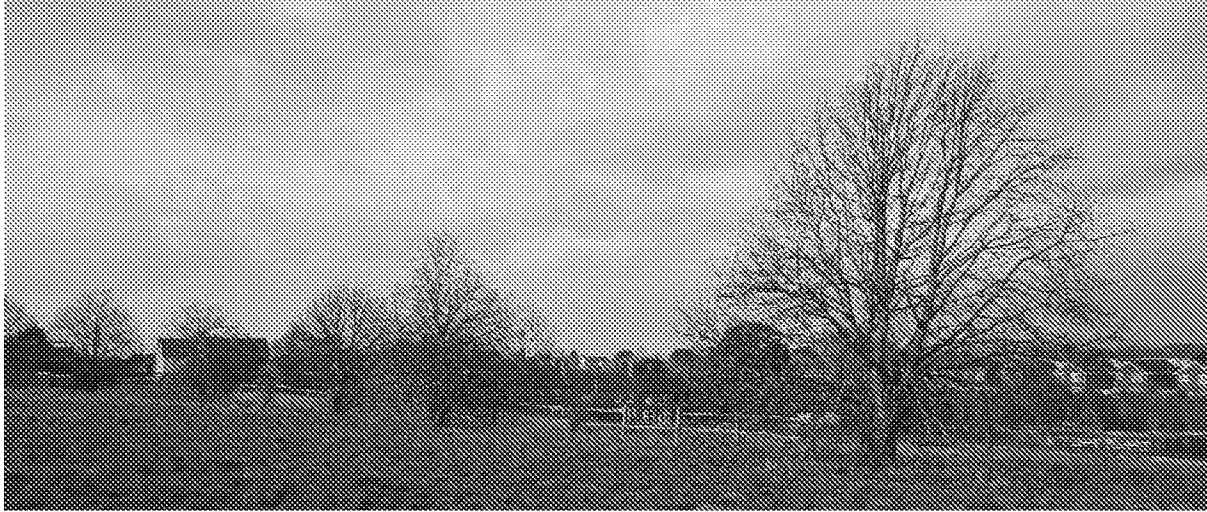
**Photograph 2: View of T1-T5 from within the site**

- 6.11 Five limes (T1-T5) have extensive basal growth and low branches which will obstruct erection of fences around plots 20, 28, 29 and 32 and along the adjacent site boundary. It is proposed to remove the basal growth and sympathetically crown lift low branches to provide a maximum of 2m clearance above existing ground level. This formative pruning will also improve their appearance and allow better inspection of the base of the trees. All five trees are subject to Tree Preservation Order TPO/A/2/17.

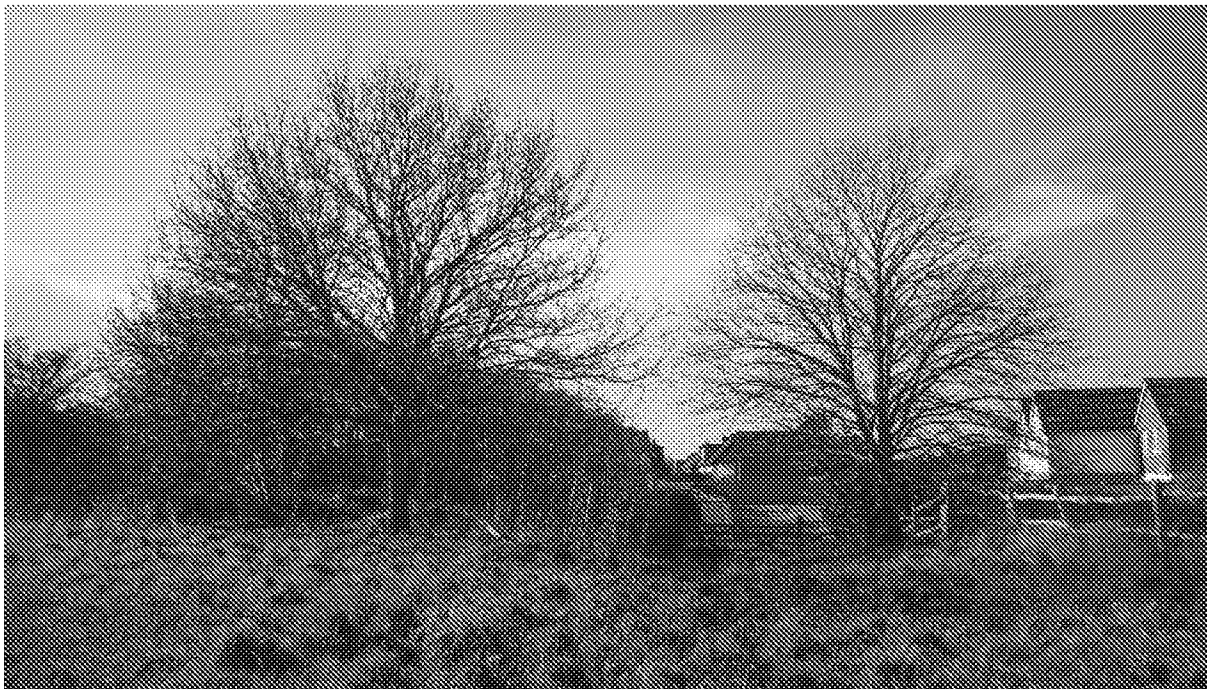
**Photograph 3: View of T6 and T5 from within the site**

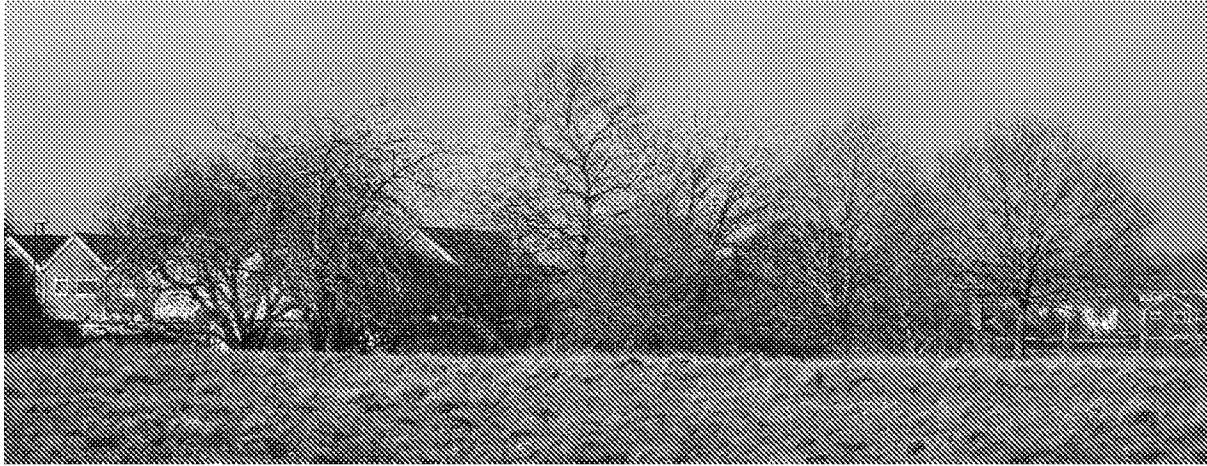
**Photograph 4: View of T5-G12 from within the site**

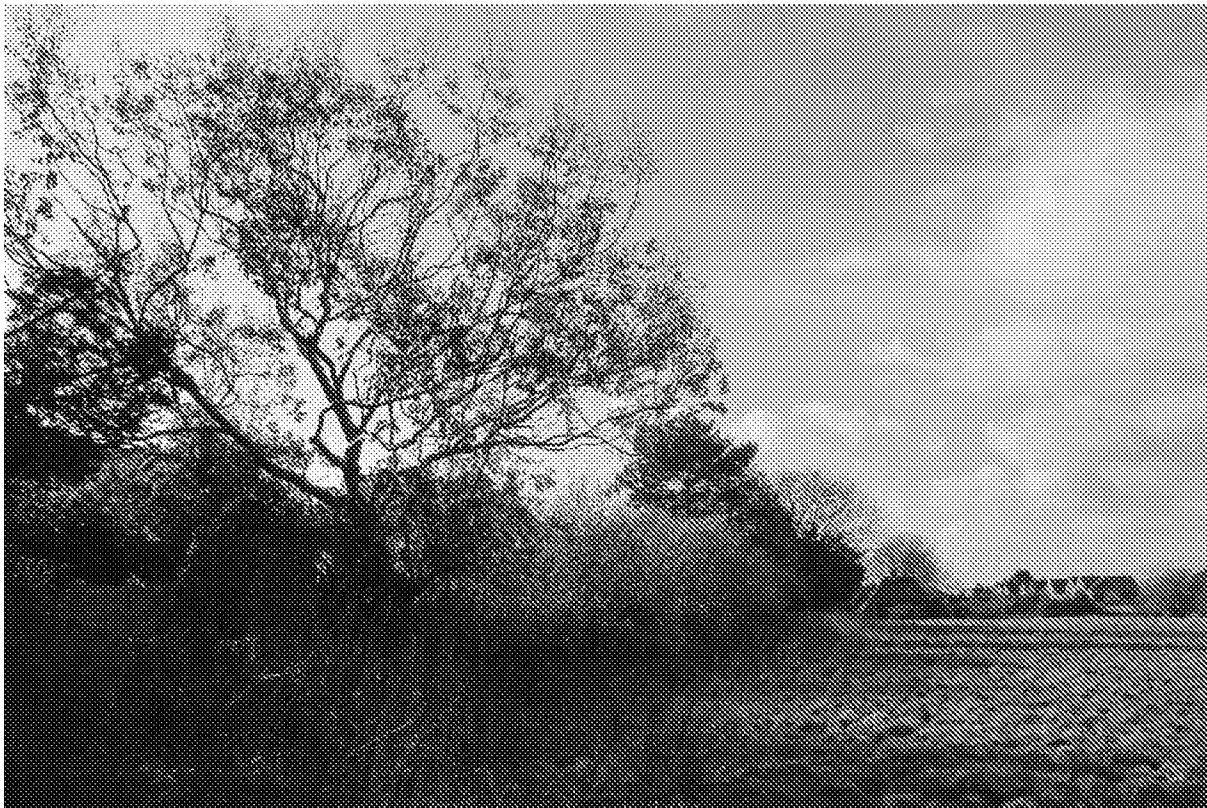
**Photograph 5: View of vegetation along southern edge of westernmost field from within the site (T16 in foreground)**

| Tree No. | Tree Species | Life Stage | Stem Ø (mm) at 1.5m | Height (crown height) (m) | Height of (FSB) | Crown Spread | | | | Condition | Comments | Tree Management Recommendations | Est Remaining Contribution (Years) | BS Cat | RPA Radius (m) | RPA area (m2) |
|---|---|---|---|---|---|---|---|---|---|---|---|---|---|---|---|---|
| T16 | Eucalyptus gunnii (Cider Gum) | SM | 400 | 5.5(3) | 2N | 5 | 5 | 1 | 1 | Poor | Unable to fully inspect - vegetation and fence. Stem diameter estimated. Stem leans to north-east. | | 10+ | C1 | 4.8 | 72 |

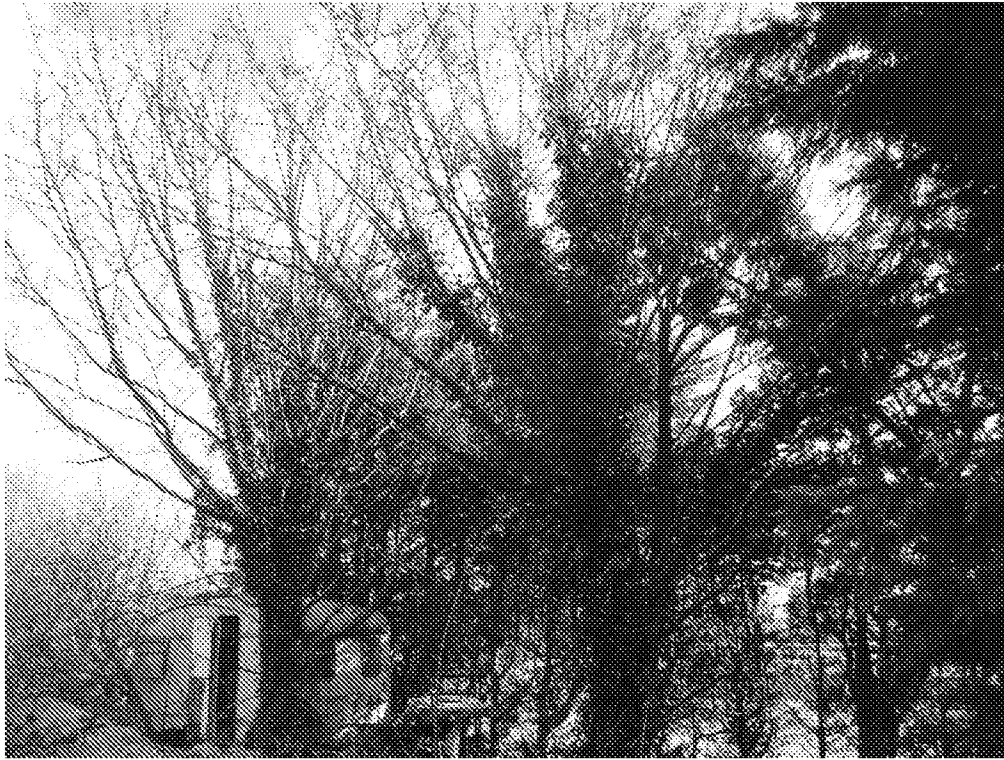
**Photograph 6: View of G24 from within the site**

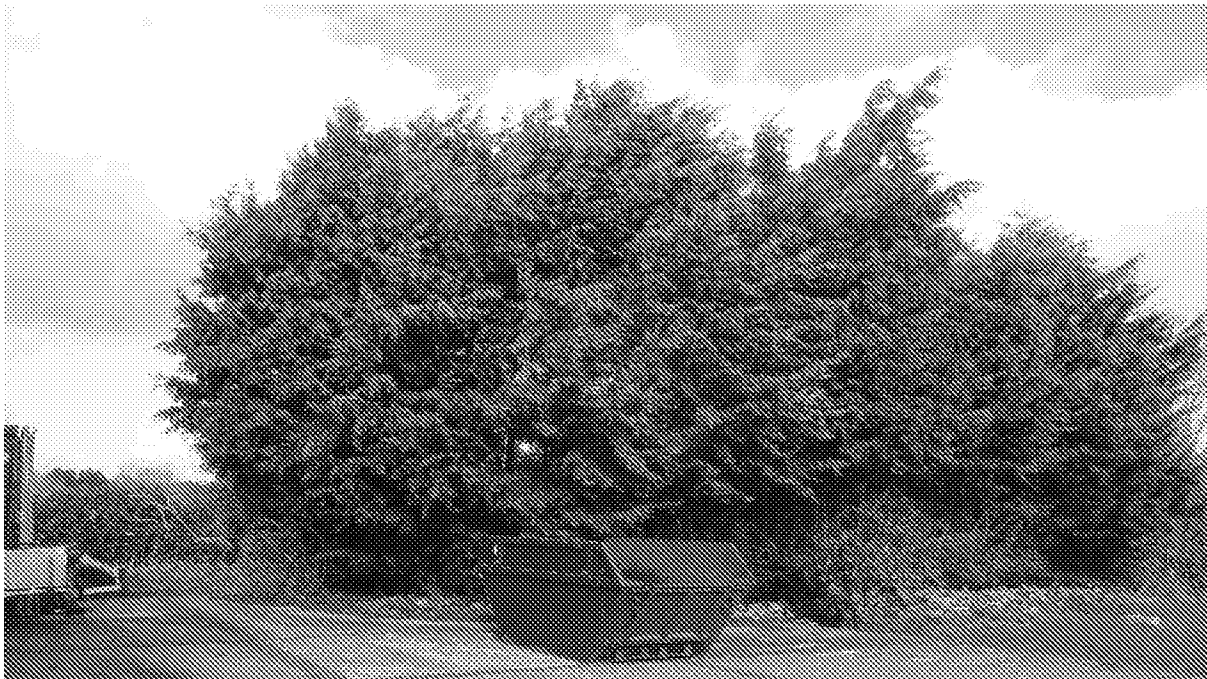
**Photograph 7: View of G25 from outside the site**

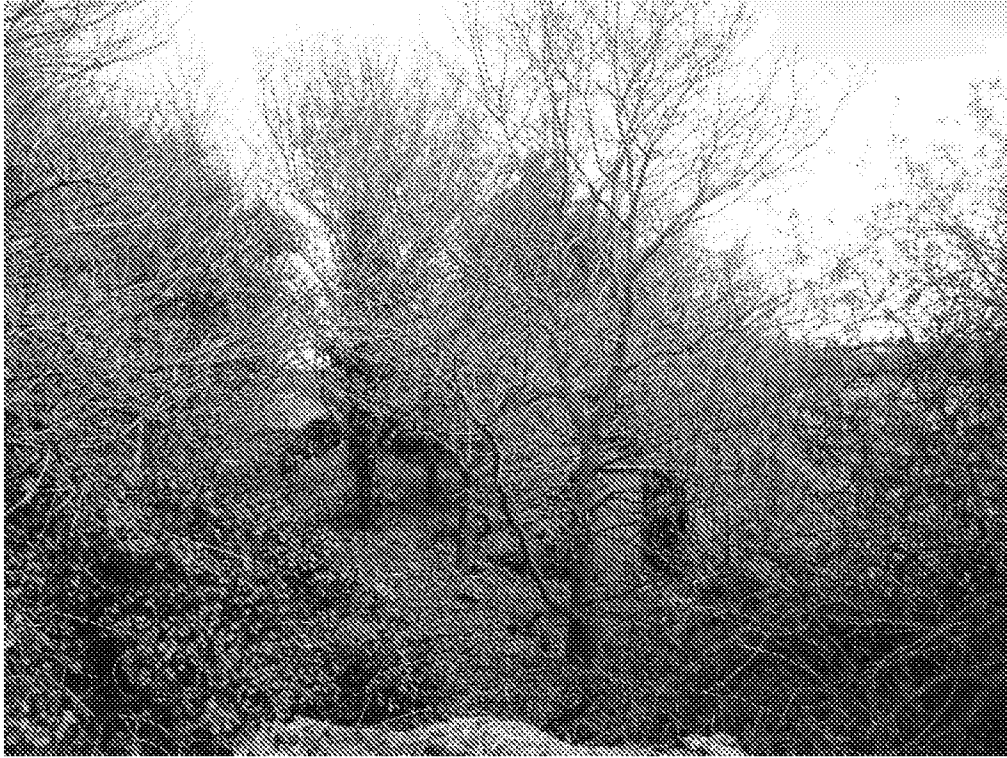
**Photograph 8: View of T26-T30 from within the site**

| Tree No. | Tree Species | Life Stage | Stem Ø (mm) at 1.5m | Height (crown height) (m) | Height of (FSB) | Crown Spread | | | | Condition | Comments | Tree Management Recommendations | Est Remaining Contribution (Years) | BS Cat | RPA Radius (m) | RPA area (m2) |
|---|---|---|---|---|---|---|---|---|---|---|---|---|---|---|---|---|
| T27 | Quercus robur (Common Oak) | SM | 190 | 5.5(2) | 0.5NW | 3 | 2.5 | 3 | 4 | Good | Typical crown form with no major defects. | | 10+ | C2 | 2.3 | 16 |

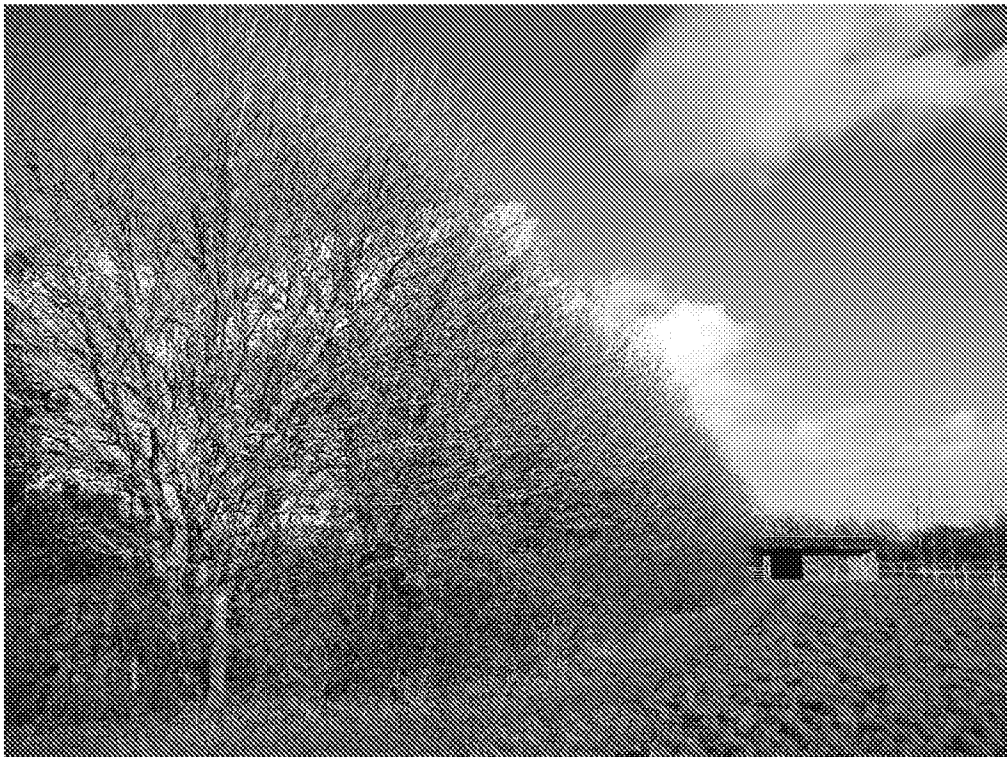
**Photograph 9: View of T37 from the south-west**

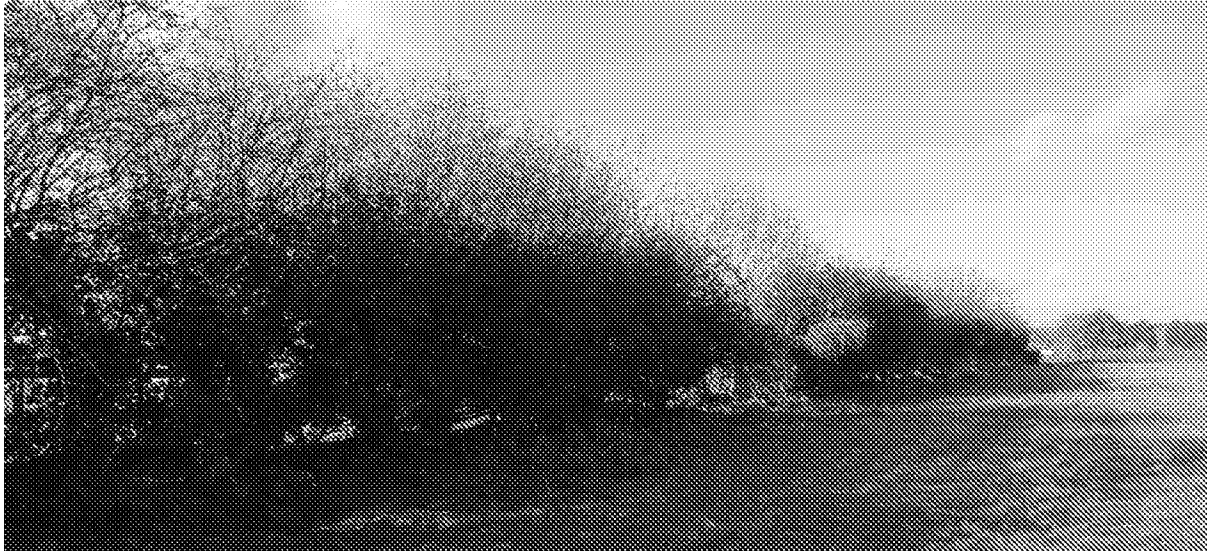
**Photograph 10: View of H38 from within the site**

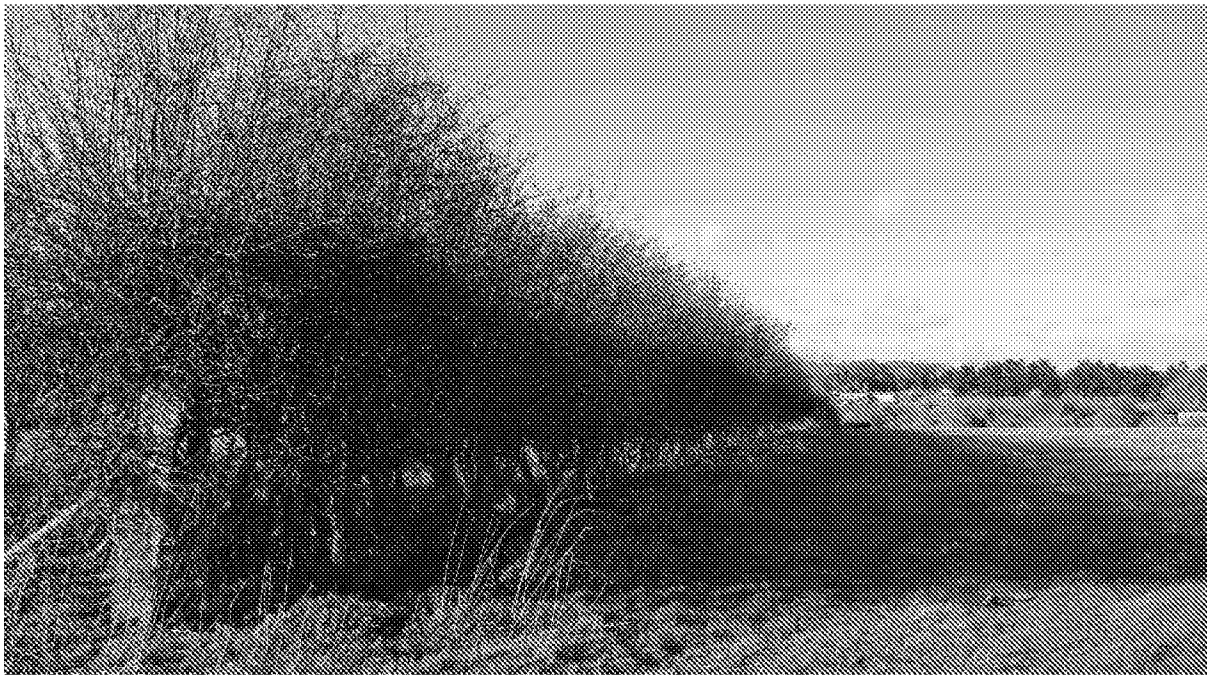
**Photograph 11: View of H41 and H42 from within the site**

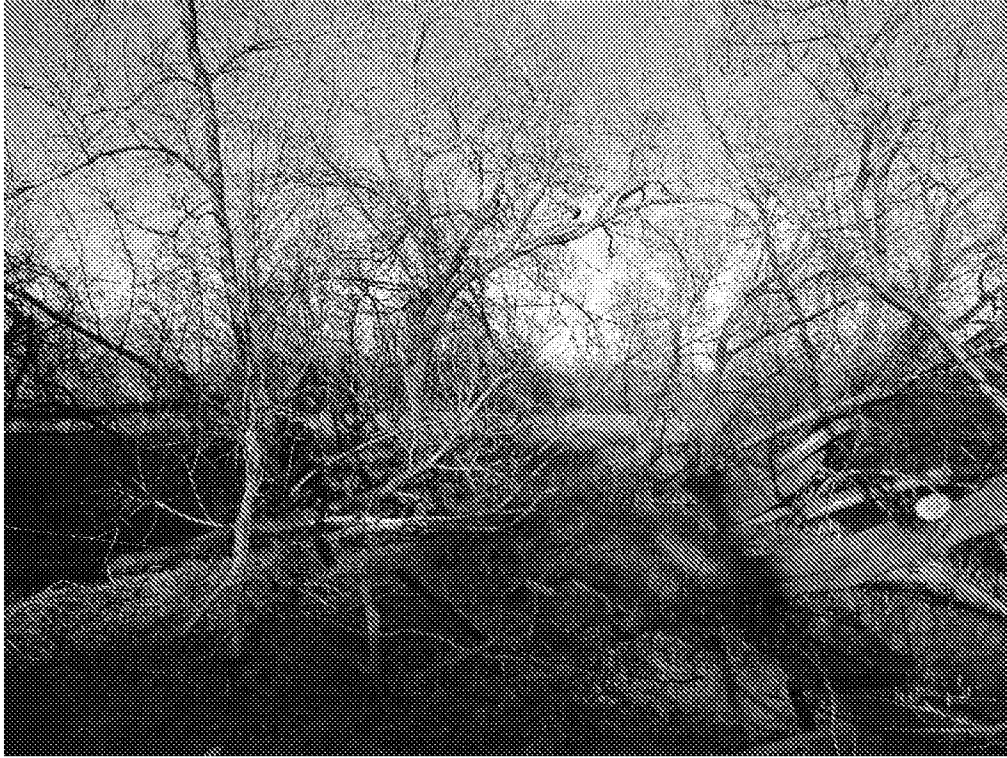
**Photograph 12: View of G43-T48 from outside the site**

| Tree No. | Tree Species | Life Stage | Stem Ø (mm) at 1.5m | Height (crown height) (m) | Height of (FSB) | Crown Spread | | | | Condition | Comments | Tree Management Recommendations | Est Remaining Contribution (Years) | BS Cat | RPA Radius (m) | RPA area (m2) |
|---|---|---|---|---|---|---|---|---|---|---|---|---|---|---|---|---|
| T44 | Salix fragilis (Crack Willow) | M | 600 | 8(1) | 2 | 0 | 3 | 9 | 5 | Fair | Unable to fully inspect - pond. Stem diameter estimated. Stem leans to south-west. | | 10+ | C1 | 7.2 | 163 |
| T45 | Salix fragilis (Crack Willow) | M | 560 | 15(5) | 1N | 7 | 4 | 8 | 7 | Fair | Unable to fully inspect - ivy. Historic split of secondary leader from main stem. | | 10+ | C1 | 6.7 | 142 |
| G46 | Crataegus monogyna (Common Hawthorn) | M | 900 | 15(6) | | 5 | 7 | 7 | 3 | Fair | Unable to fully inspect - pond. Unable to fully inspect - vegetation. Stem diameter estimated. Historic stem fractures with subsequent vertical regrowth. | | 10+ | C2 | 10.8 | 366 |
| T47 | Salix fragilis (Crack Willow) | M | 800 | 12(2) | 0.5 | 7 | 12 | 5 | 0 | Fair | Unable to fully inspect - vegetation. Stem diameter estimated. Stem wounds. Stem leans to south-east. Historic stem failure. | | 10+ | C1 | 9.6 | 290 |

| Tree No. | Tree Species | Life Stage | Stem Ø (mm) at 1.5m | Height (crown height) (m) | Height of (FSB) | Crown Spread | | | | Condition | Comments | Tree Management Recommendations | Est Remaining Contribution (Years) | BS Cat | RPA Radius (m) | RPA area (m <sup>2</sup> ) |
|---|---|---|---|---|---|---|---|---|---|---|---|---|---|---|---|---|
| T48 | Salix fragilis (Crack Willow) | EM | 300 | 8(4) | 3SE | 1 | 6 | 3 | 0 | Fair | Stem diameter estimated. Stem leans to south-east. | | 10+ | C1 | 3.6 | 41 |

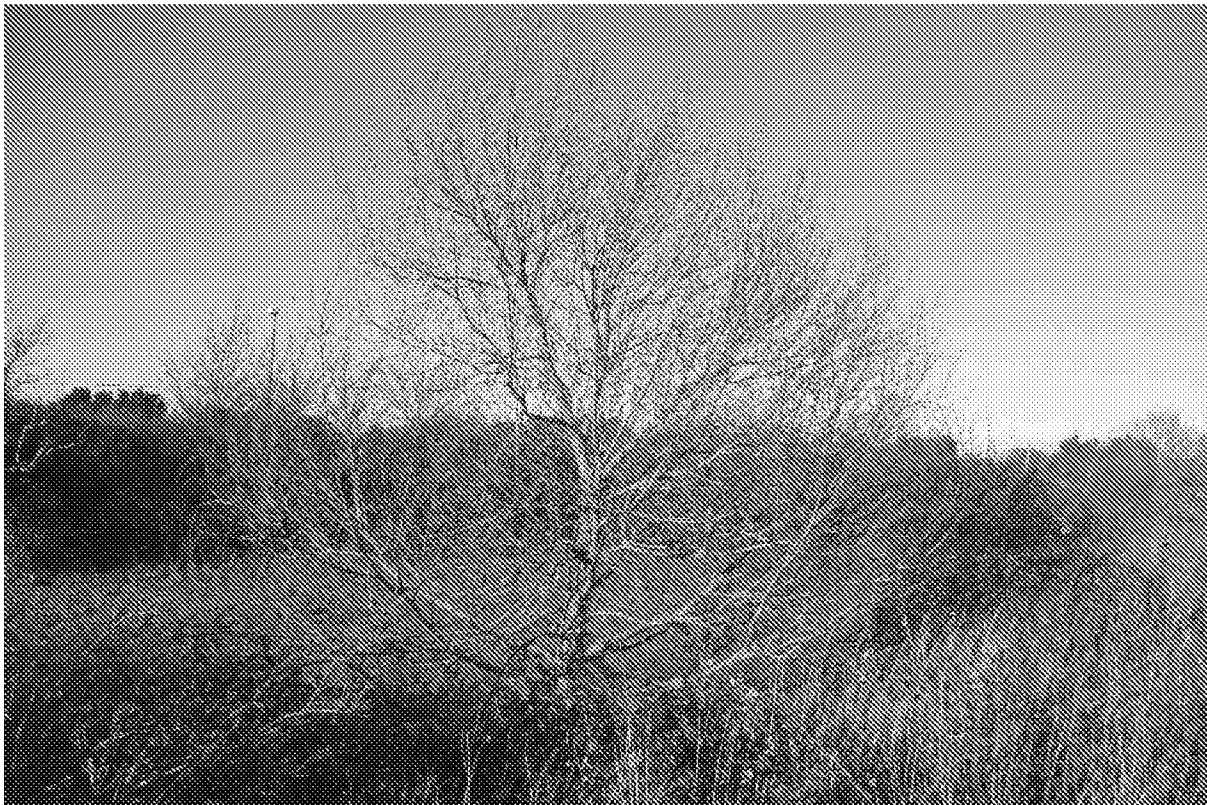
**Photograph 13: View of T49 and T50 from within the site**

| Tree No. | Tree Species | Life Stage | Stem Ø (mm) at 1.5m | Height (crown height) (m) | Height of (FSB) | Crown Spread | | | | Condition | Comments | Tree Management Recommendations | Est Remaining Contribution (Years) | BS Cat | RPA Radius (m) | RPA area (m <sup>2</sup> ) |
|---|---|---|---|---|---|---|---|---|---|---|---|---|---|---|---|---|
| T49 | Salix fragilis (Crack Willow) | SM | 350 | 8(1.5) | 2.5S | 5 | 5 | 6 | 5 | Good | Unable to fully inspect - terrain. Stem diameter estimated. Typical crown form with no major defects. At watercourse level north of steep bank. | | 20+ | B1 | 4.2 | 55 |
| T50 | Salix fragilis (Crack Willow) | SM | 280 | 6(3) | 2SW | 3.5 | 3.5 | 3 | 3 | Fair | Unable to fully inspect - terrain. Stem diameter estimated. Stem wounds. At watercourse level north of steep bank. | | 10+ | C1 | 3.4 | 35 |

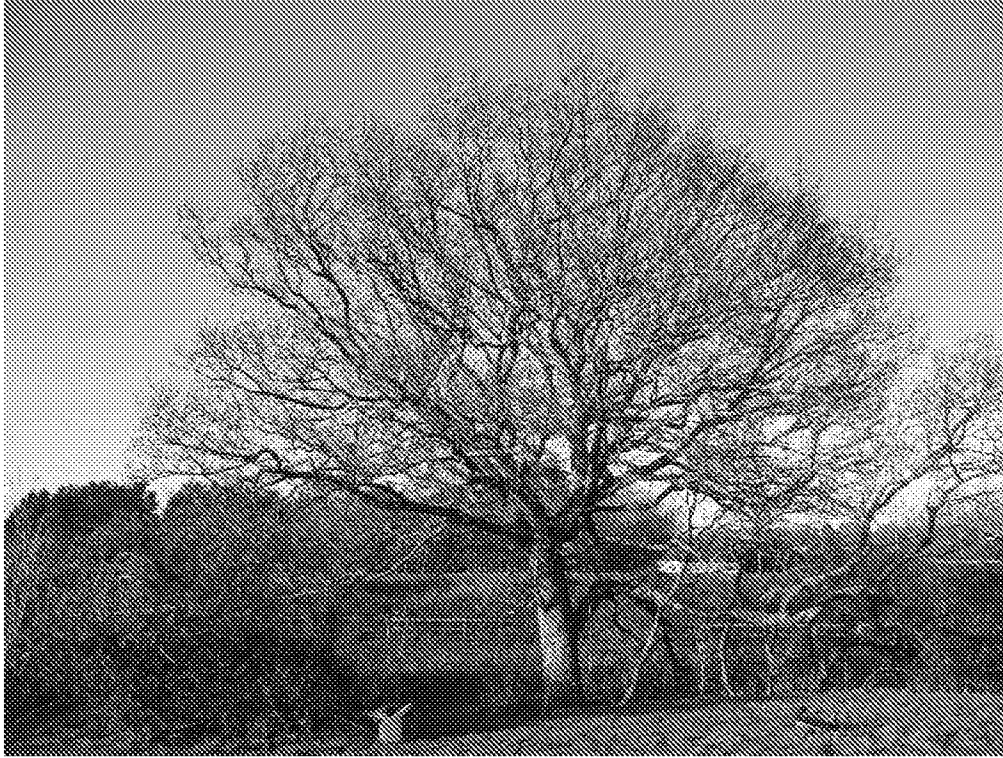
**Photograph 14: View of T55 from within the site**

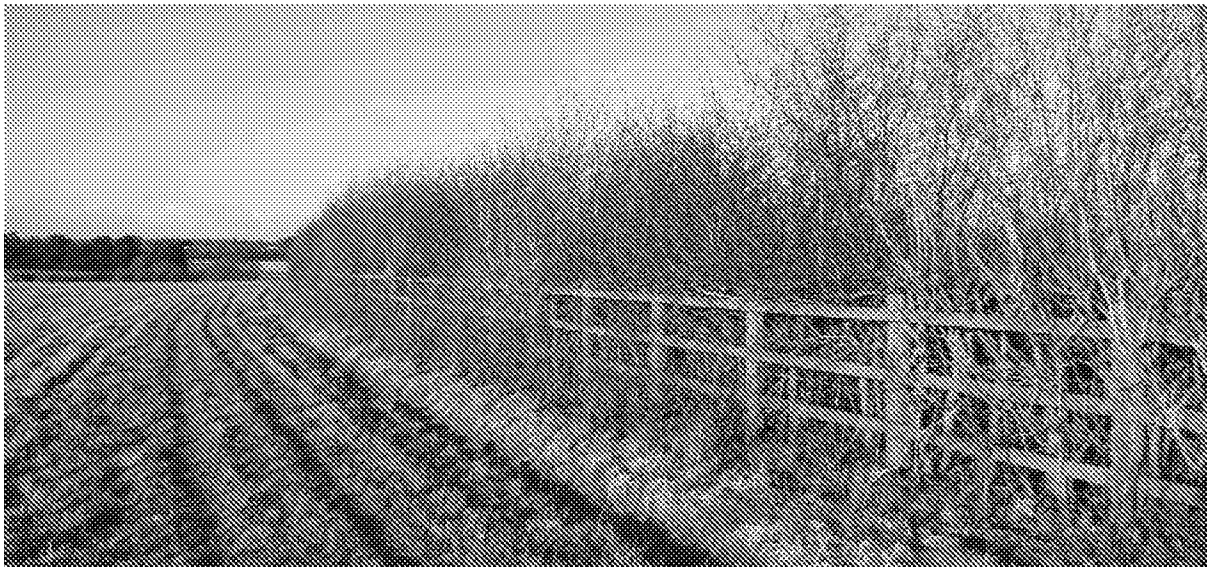
**Photograph 15: View of H58 from within the site**

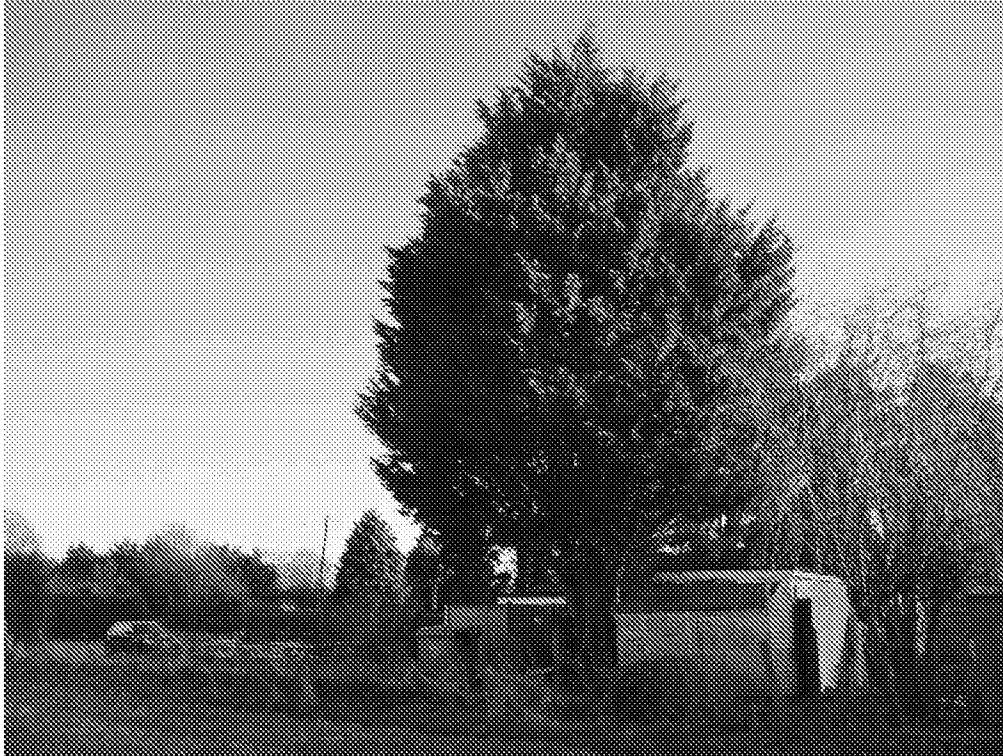
**Photograph 16: View of T61 from within the site**

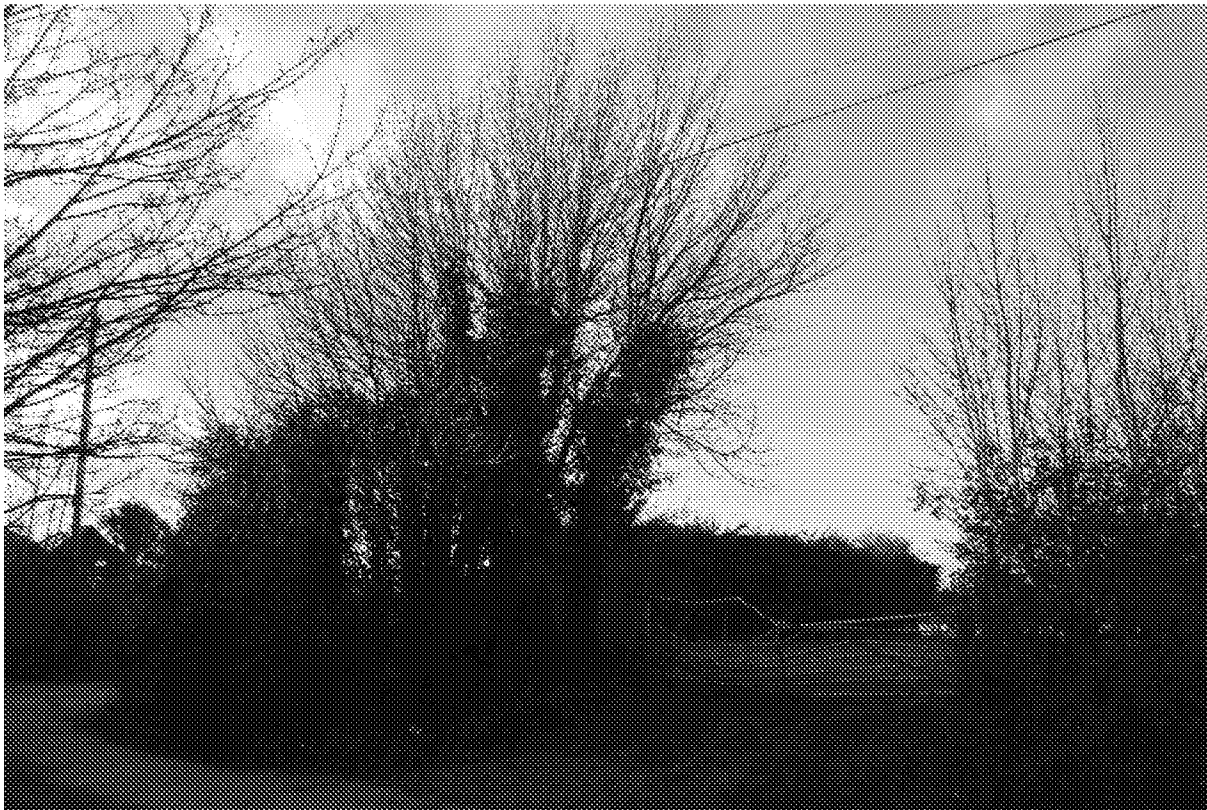
**Photograph 17: View of T62 from outside the site**
