## Arboricultural Report

Premier Inn  
Roundstone Lane  
East Preston  
Littlehampton  
West Sussex  
BN16 1EB

**Whitbread PLC**

Site Visit Date:  
11 June 2015  
Report Date:  
28 July 2015

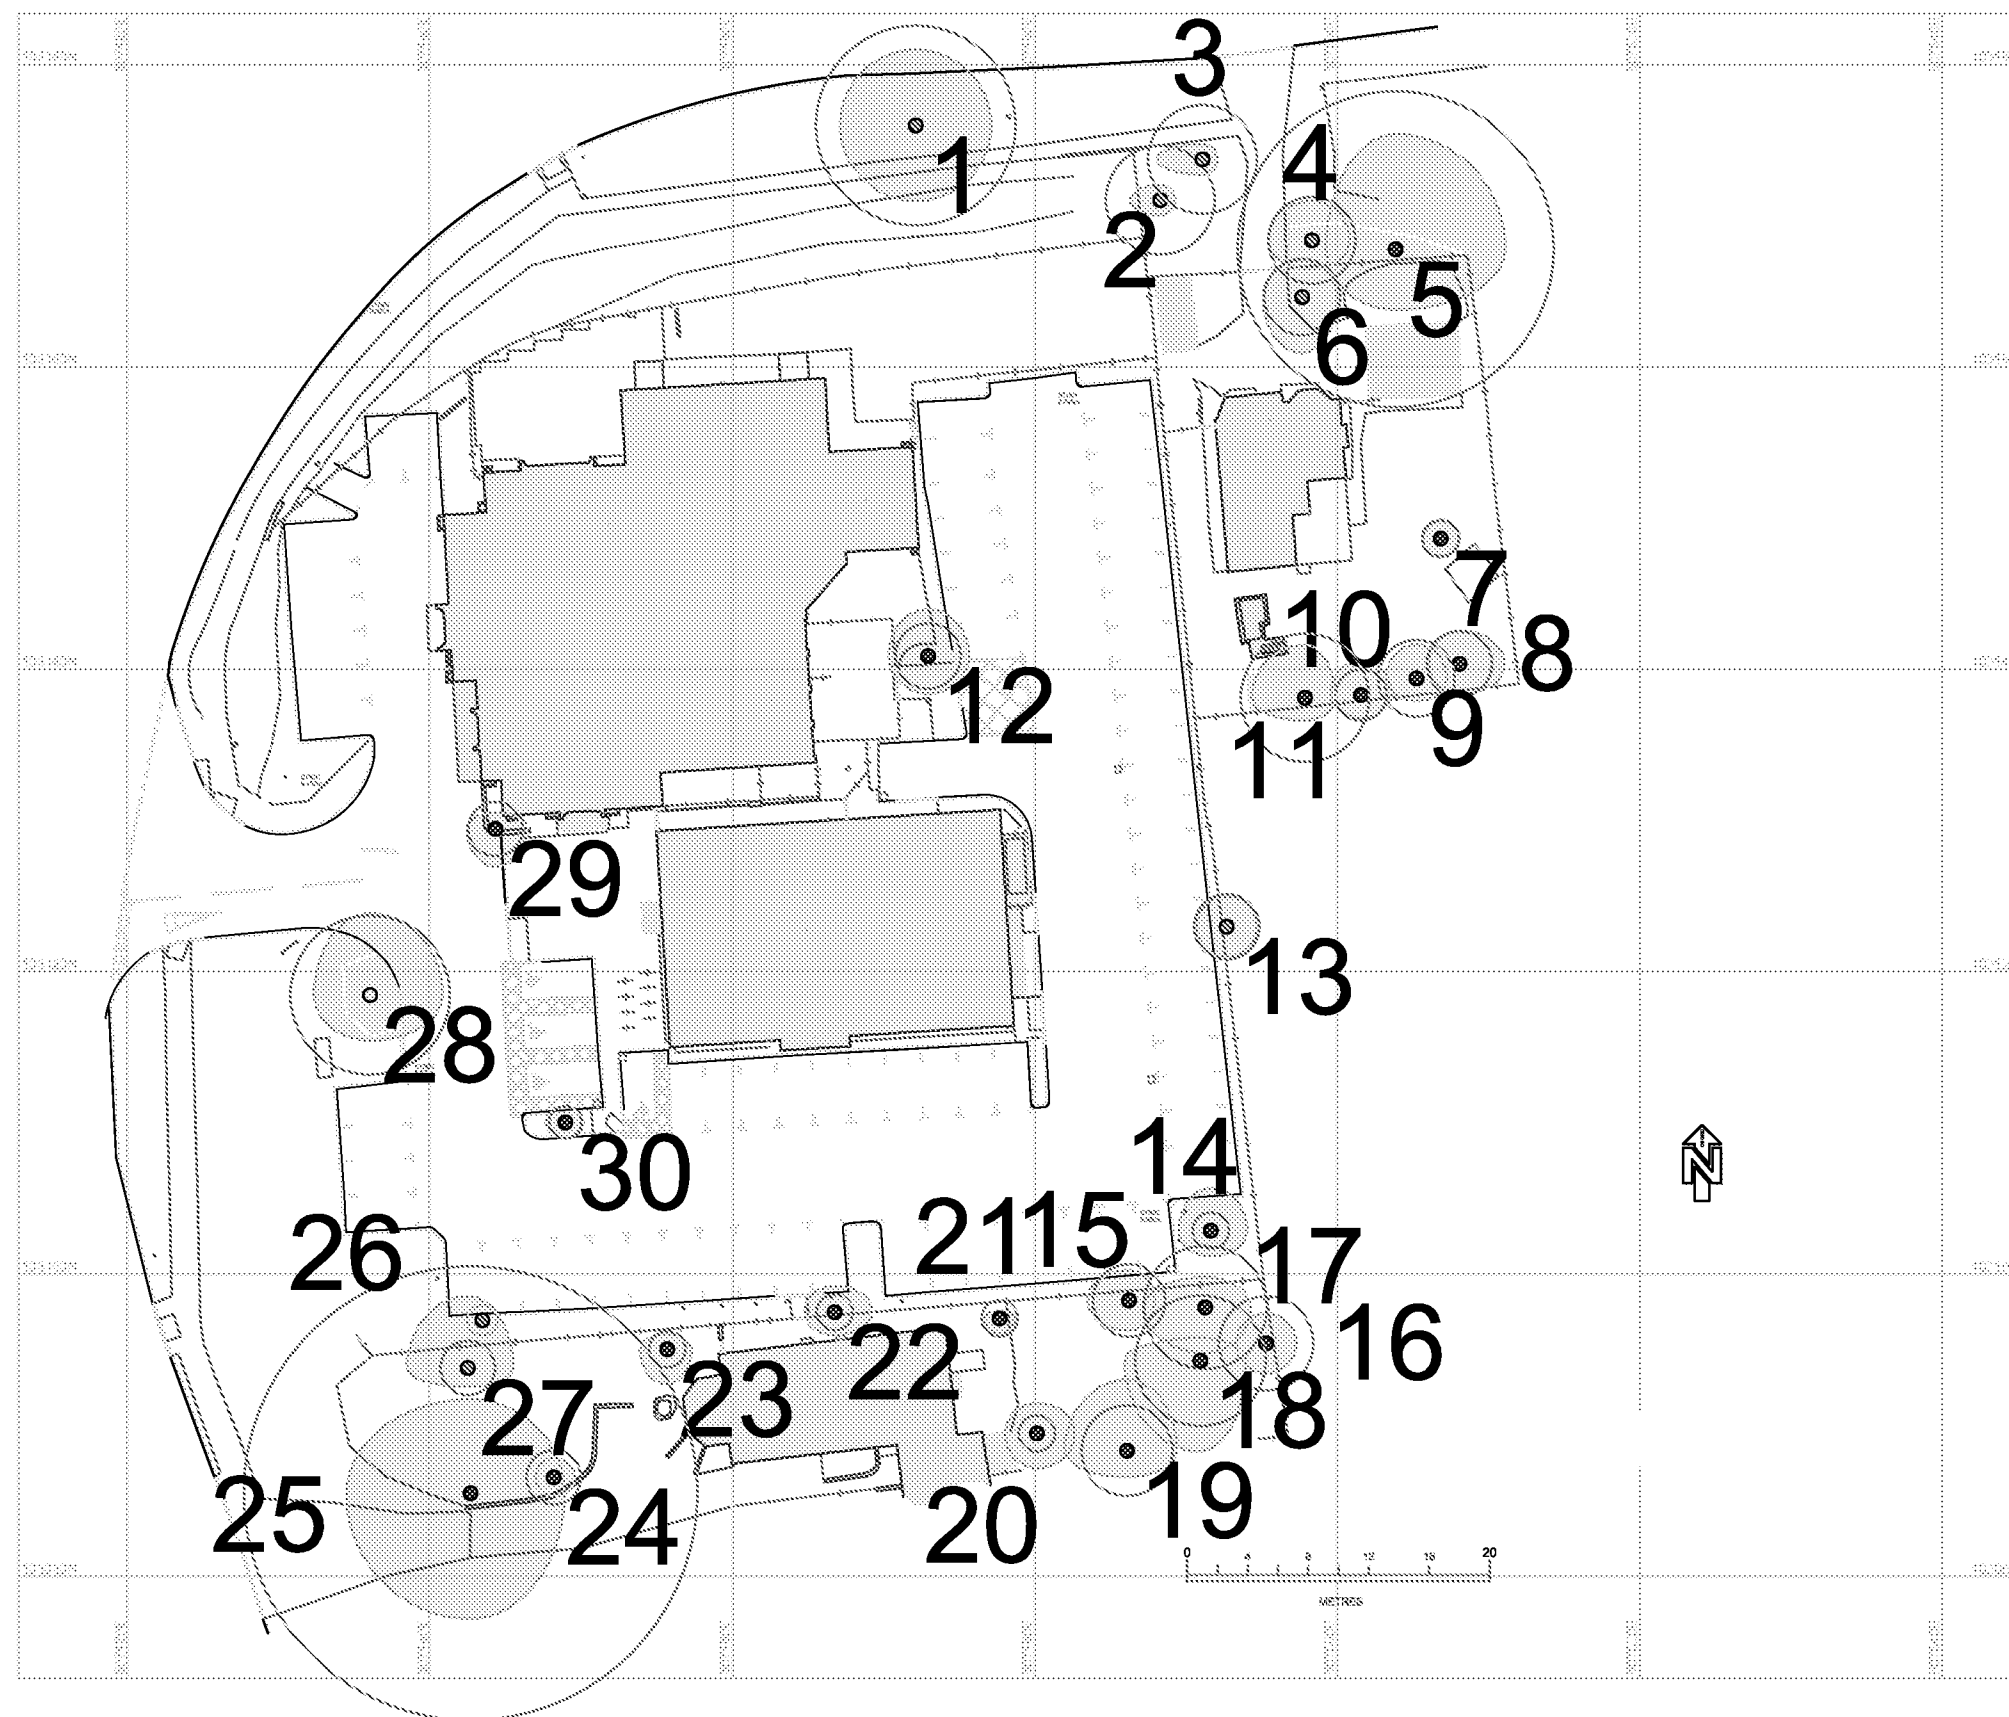
Figure Number: 1570-1 Rev: A

- 4.1 The survey recorded 30 items of vegetation. Details of the trees are provided in Appendix 3 to this report. Their locations are shown in Duramen Plan 1570-1 ver. A.
- 4.2 No aged or veteran trees were recorded in the survey.
- 4.3 The surveyed trees are all of modest size – to 14 metres height and stem diameter 45 cms other than T25 with a stem diameter of 86 cm.
- 4.4 Species composition is mixed with mostly introduced species and ornamental varieties consistent with previous landscape and domestic garden planting. There are a mix of evergreen

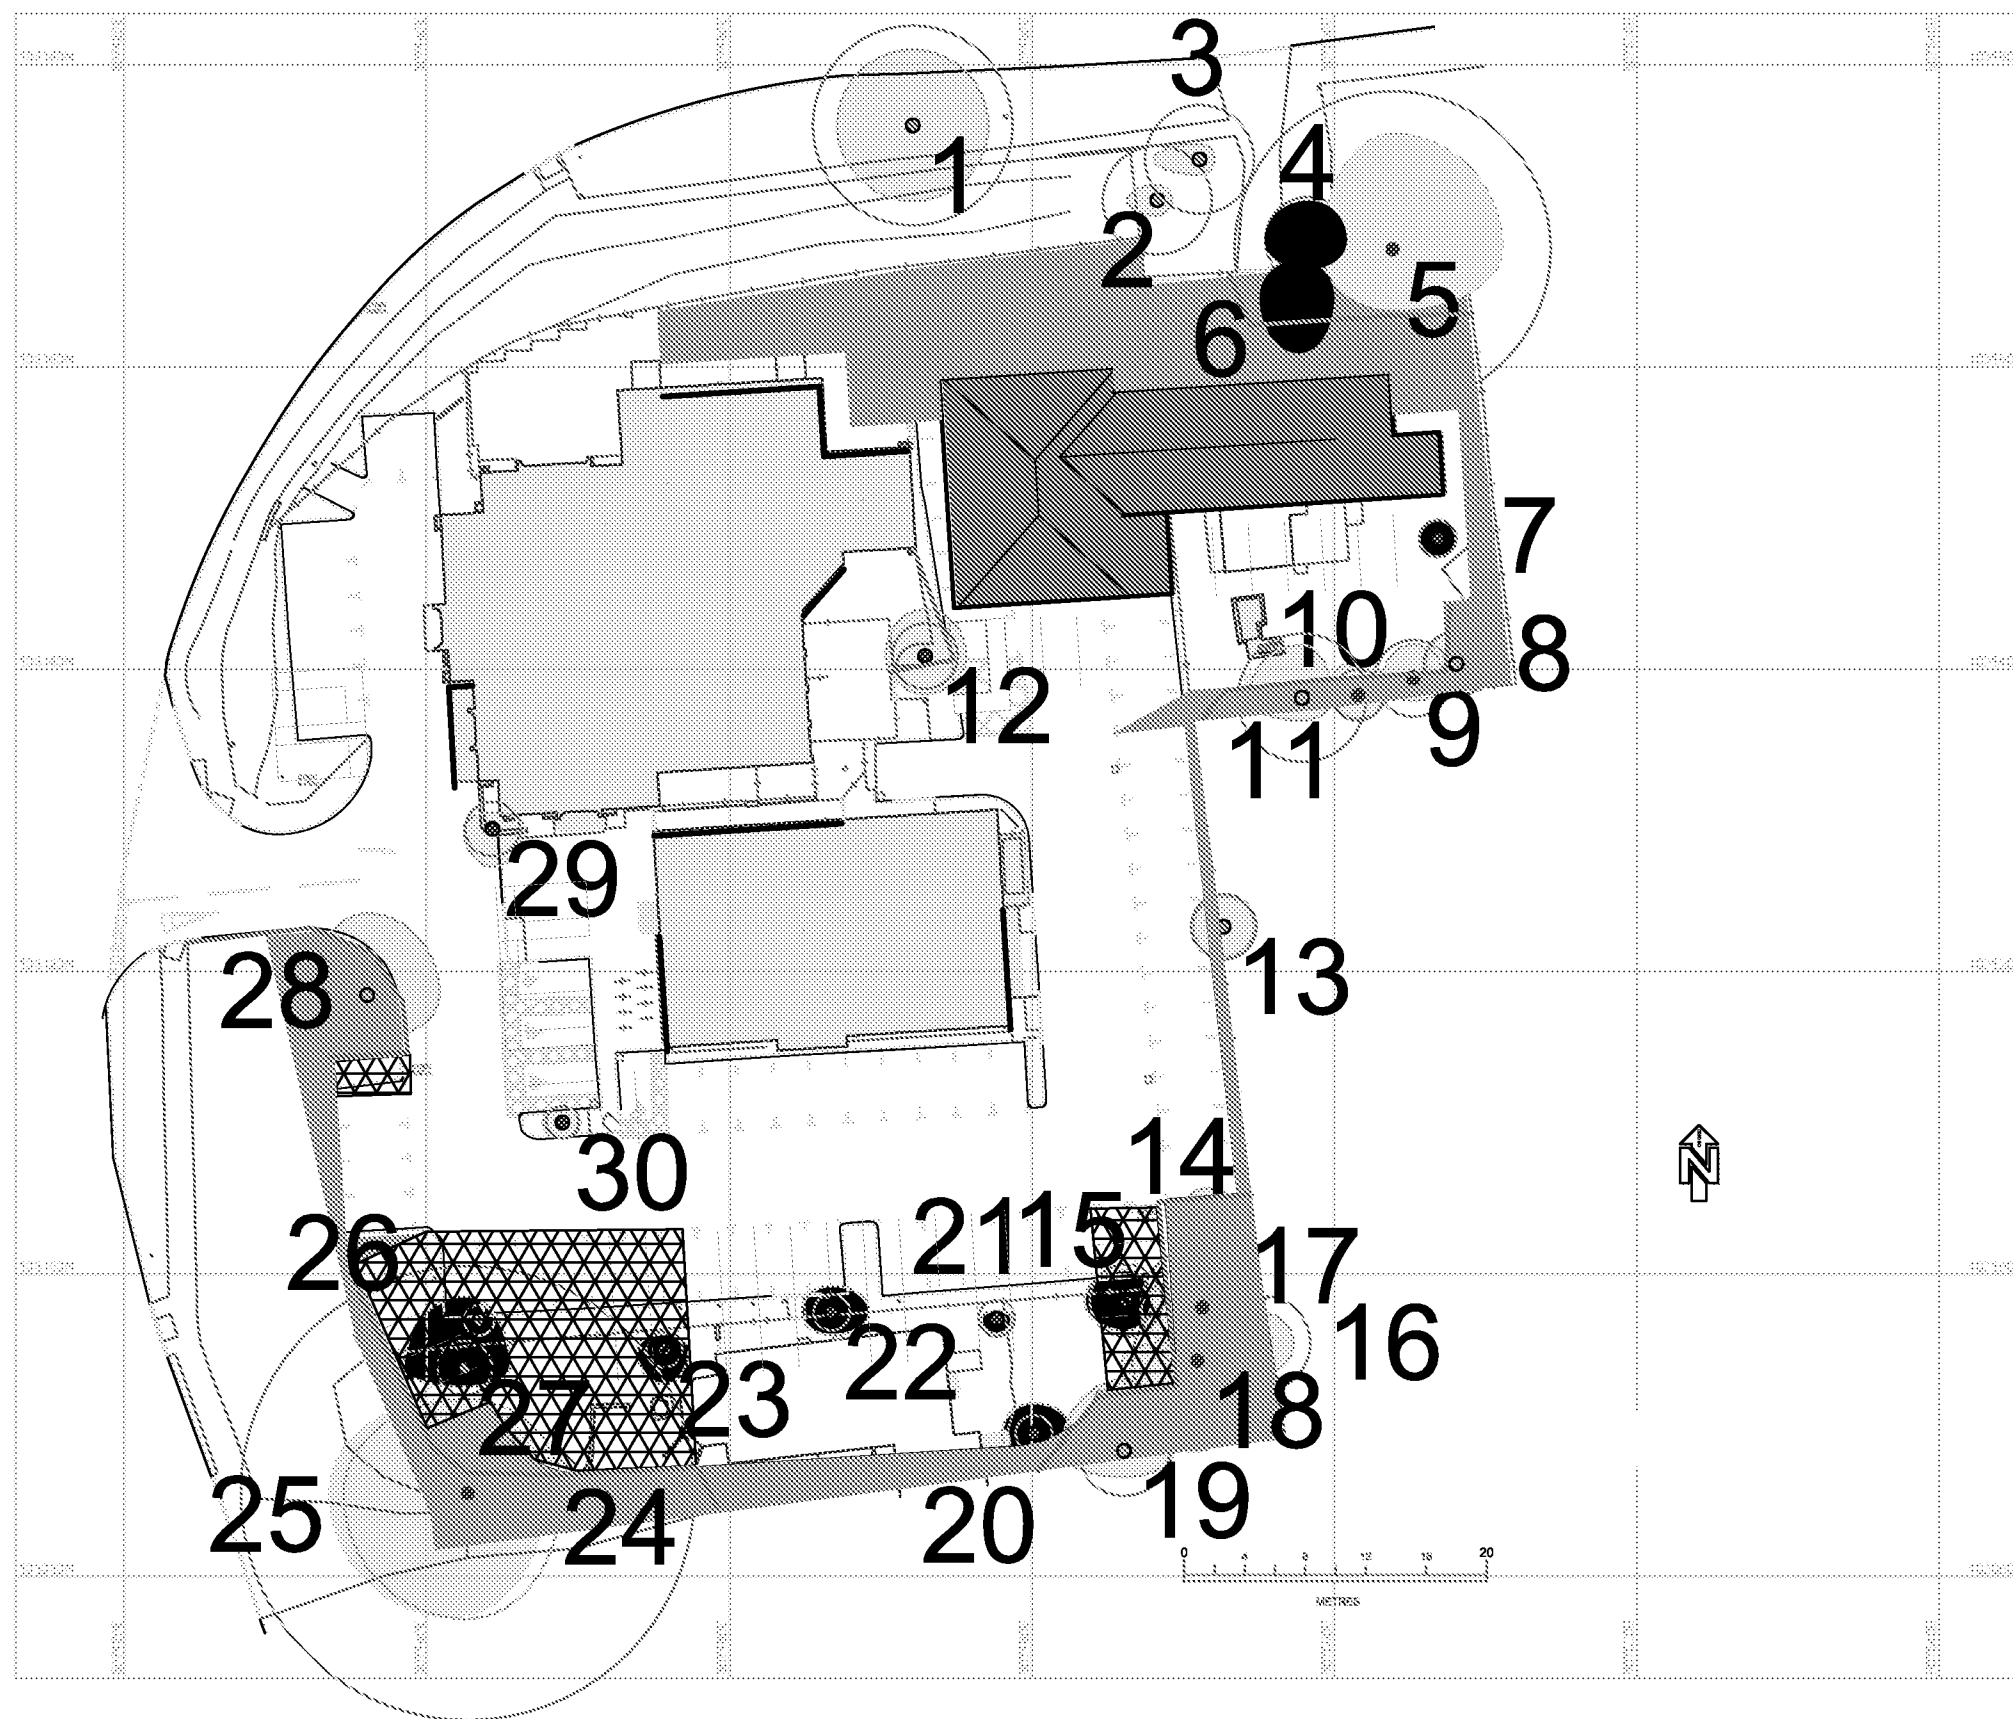
Figure Number: 1570-2 Rev: A

- 6.1 The proposed development will require the demolition of the two surveyed properties. This work should not have any material arboricultural impact greater than that planned and described below.
- 6.2 The proposed development requires removal of T4/T6 to accommodate the proximity of the proposed extension and T7, T15, T21, T22, T23, G26 and T27 to reflect the changes in parking layout. All of these removals are relatively poor quality trees and/or of small size. The landscape impact should be small. The proposed landscape scheme will establish trees and shrubs both on the boundary with Roundstone Lane and to the rear of Burberry House.

- 6.3 Only G26 is categorised as not suitable for long term retention, regardless of development plans.
- 6.4 Pruning works will be required to one side of T5 to create an adequate gap between the next extension and the tree which will re-grow rapidly. The precise gap will be determined later but the tree is located 8 metres from the extension and the crown dimensions towards the south is estimated to be 4 metres so the pruning should not be extensive.

- 7.1 A tree protection plan is provided in Duramen Plan 1579-2. It shows the proposed location of protective fencing around retained trees in 6 locations around the site.

- 7.5 Works within RPAs are planned near T5 and the group of trees T16, T17 & T18.
- 7.6 New access and parking is proposed nearby T25 and T28. The relatively large stated RPA for T25 exaggerates the size of the tree as a result of swelling around a multi-stemmed tree. Part of the circular RPA is already developed for the driveway to Spinney and the existing Premier Inn car park. It is also occupied by other trees (G26, T27) so the extent T25 root growth is likely to be complex.
- 7.7 The proposal respects the likely structural roots of trees T16-T18, T25 and T28 by installing a 3-D geotextile across the RPAs of affected trees. The areas for the geotextile are shown in Duramen plan 1570-2. The specifications are given in Appendix 5.

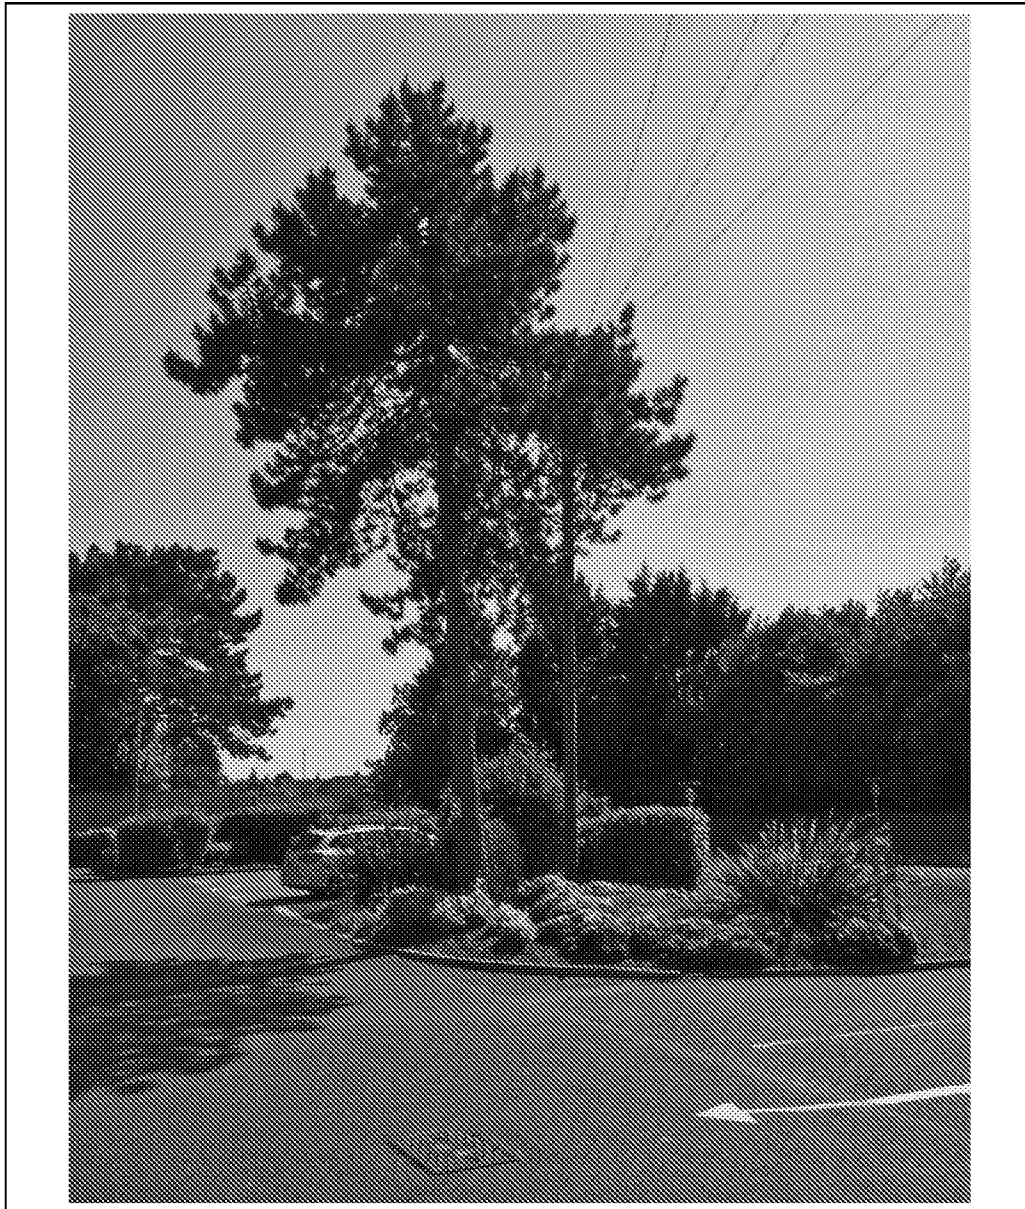
**Figure 1:** T28 at the entrance to the Premier Inn

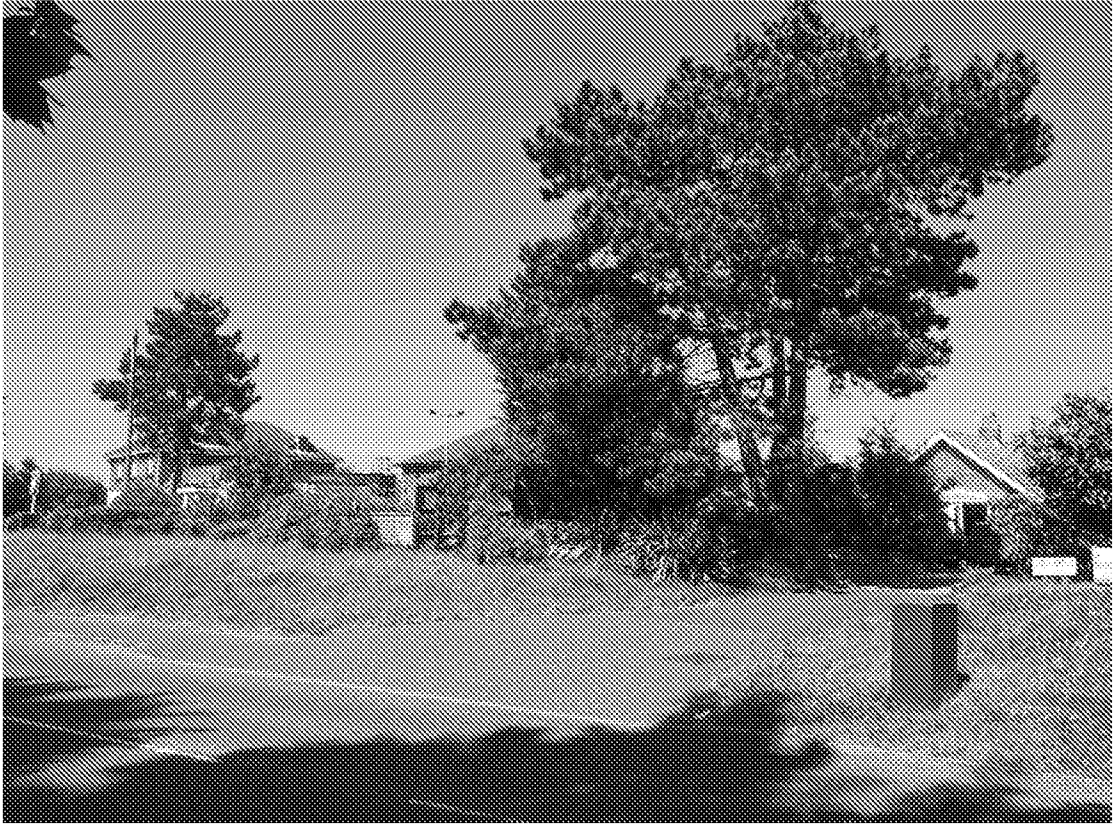
**Figure 2:** T25 at the entrance to “Spinney” with T28 to the left

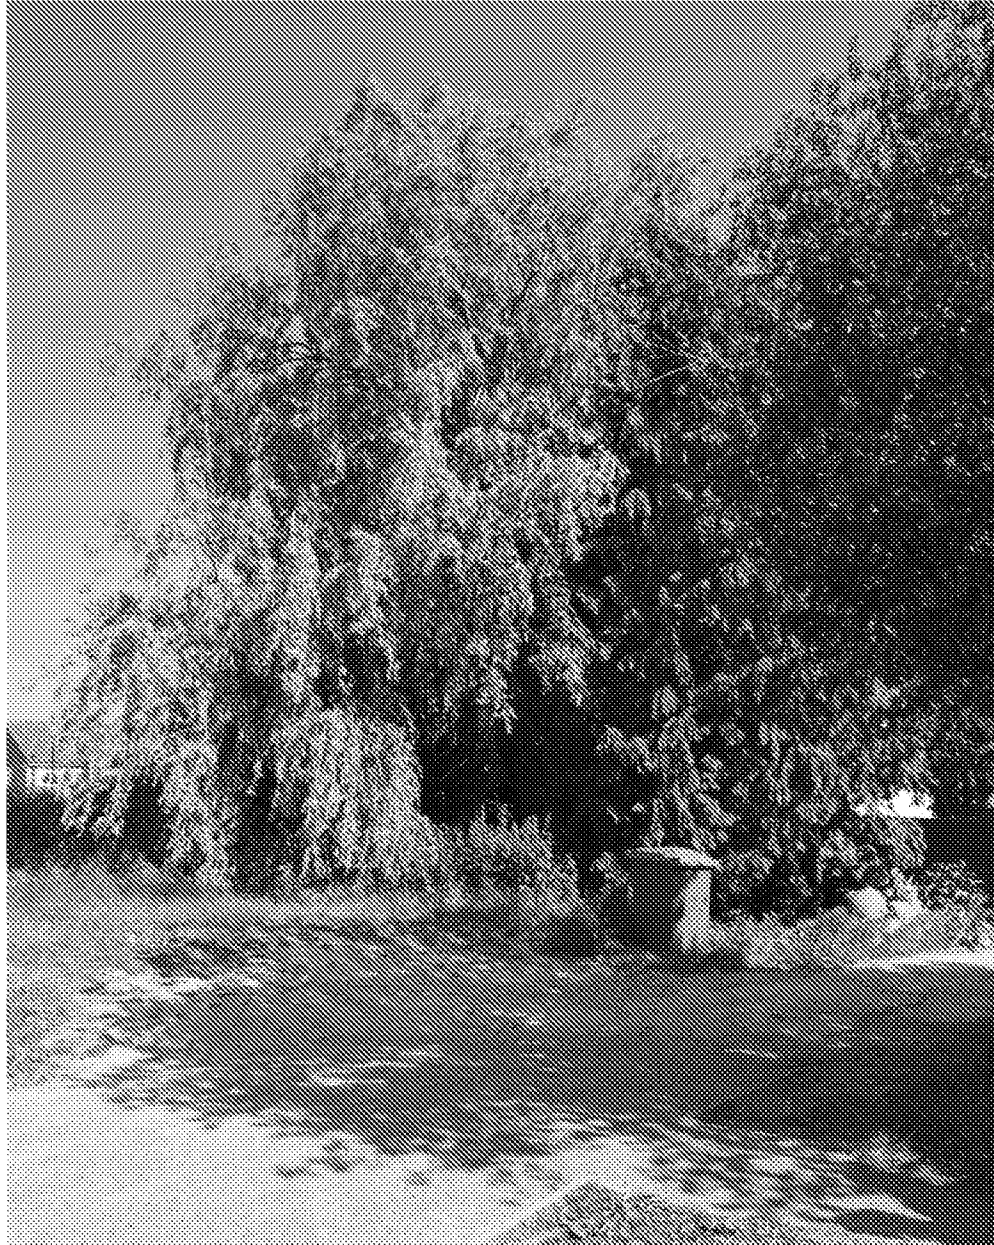
| Tag Number | Number of stems | Species (Common Name) | Height (m) | Stem diameter (mm) | Branch spread (m)<br>North East South West | | | | Height of crown clearance (m) | Age class | Estimated remaining contribution (years) | Growth Potential | Structural condition (pole, fork, wounds, decay, dead wood) | Physiological Condition | Other Comments - Ivy, Competing Growth, Open Grown | Root Protection Area (radius equiv m) | B5 3037 Category Grading |
|---|---|---|---|---|---|---|---|---|---|---|---|---|---|---|---|---|---|
| T5 | 2 | Weeping Willow | 11.5 | 616 | 7.6 | 7.3 | 4 | 4.6 | 1 | Mature | 20 - 40 | Low | Main stem divides at c1m | Sparse crown | Crown merges with T.4. Additional small Cypress beneath crown, not shown on Topo. | 7.4 | B1 |

**Figure 3:** T5 at the entrance to Burberry House
