**Tree Survey, Arboricultural Impact Assessment  
Arboricultural Method Statement & Tree Protection Plan  
In Accordance with BS 5837:2012**

| Proj. No<br>7921 | Rustington Golf Centre, Golfers Lane, Angmering, West Sussex BN16 4NB | | |
| Date of Report: | 22/01/2020 | Revision: | Original |

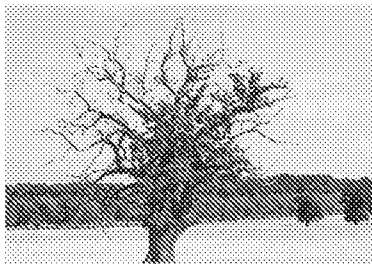
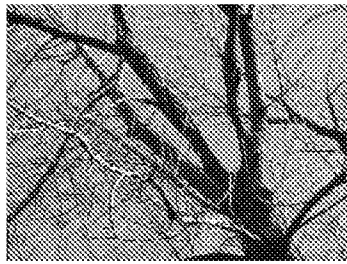
| <b>Symptoms/damage type and cause:</b> | This relates to dead branches in the crown of the tree. In the majority of cases, this is caused by the natural ageing process of the tree or shading due to its close proximity to neighbouring trees. However, in some situations, it may be related to fungal, bacterial or viral infection. |
| <b>Consequence:</b> | Depending upon the location and mass of dead wood removal of the affected tissue may be necessary to prevent harm to persons or property as the wood will become unstable as it decays and in some circumstances is likely to fall from the tree with little or no warning. |

| <b>Control:</b> | Detailed monitoring should be undertaken on those trees showing signs of excessive deadwood production to identify the underlying cause. |

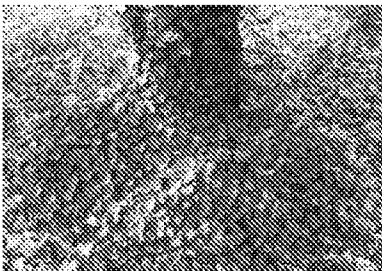
| <b>Symptoms/damage type and cause:</b> | Ivy may grow to varying degrees on all areas of a tree from the base to the upper crown. It is possible that in doing so it will out-compete the host tree for available light thereby suppressing the host. |

| <b>Control:</b> | Ivy should only be removed if absolutely necessary because it provides abundant cover to wildlife and then by severing twice close to the ground and removing a length of stem thereby causing the gradual dying away of the aerial parts of the plant providing extended benefit to wildlife whilst relieving the pressure on the tree. |
