**Planning Application Ref:** A/20/18/DOC

**Location:** Land North of Roundstone By-Pass, Angmering (formerly Haskins GC)

**Description of works:** Application for approval of matters reserved by condition imposed under Appeal reference APP/C3810/W/16/3151980 (A/162/15/PL) relating to condition 5 (Tree Protection)

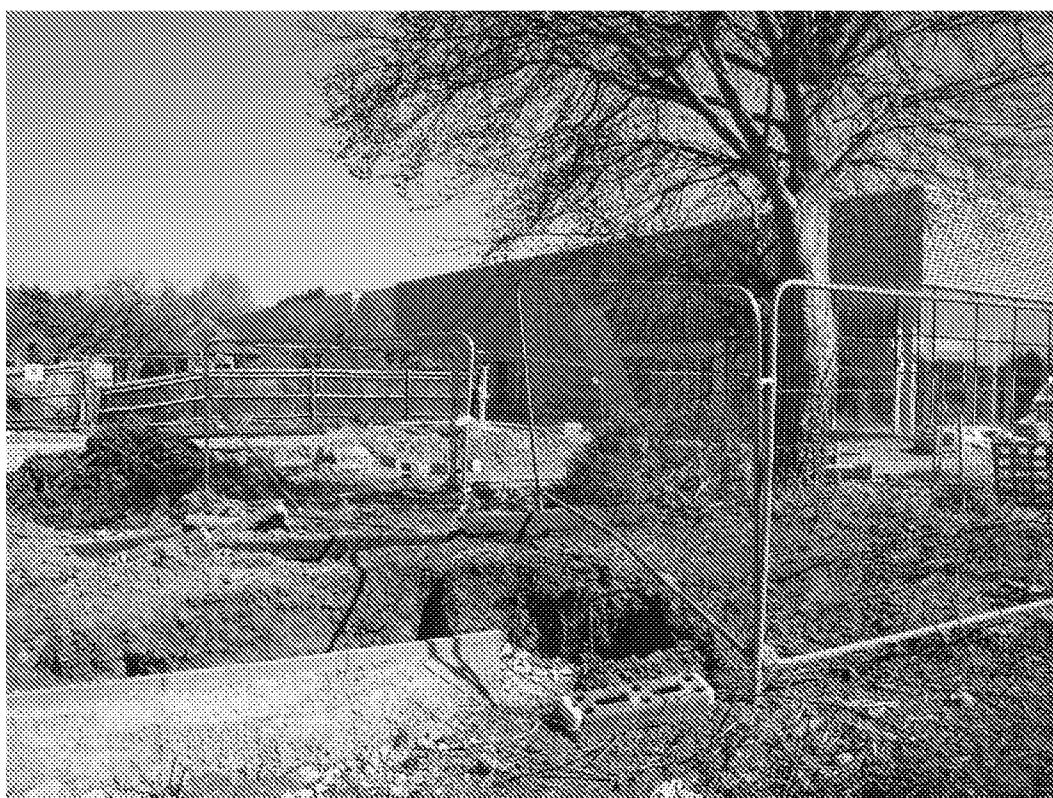
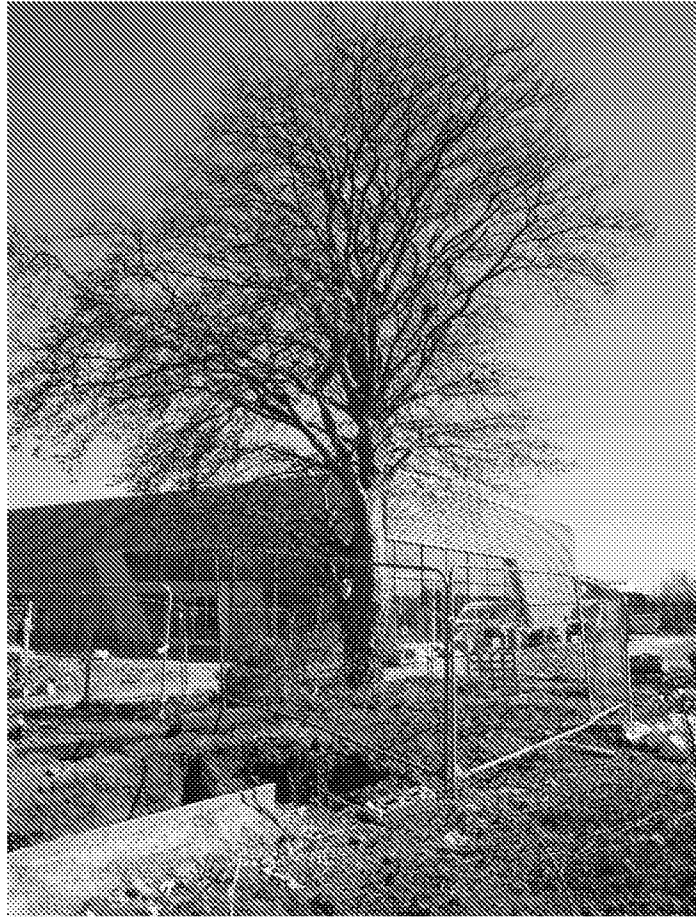
Tree no. T1

Insecure fencing extends from 3-4m on all aspects in a broadly rectangular configuration. Some of the HERAS fence panels are sat in movable block trays, others are simply resting on the ground. There are no stabilizing struts, ground penetration of uprights nor are the panels adequately clamped together; the whole structure can be moved around as it suits and offers little if any resistance to an impact. There is an obvious gap in the enclosure which appears to have been deliberate so as to allow deep excavation within the intended Construction Exclusion Zone (CEZ). There are no Tree Protection notices attached to the fencing (Figs.1 & 2).

- I anticipate that both T1 and T2 will undergo a gradual but progressive decline. They are now sufficiently compromised in respect of their projected ongoing vitality so as to be unviable for long-term retention. They appear to remain stable at this time but now have increased vulnerability to environmental stresses and the ingress of pathogens which could lead to disease and accelerated rate of decline.

Fig.1 – View NE towards T1

Fig.2 – View NE towards T1

- I am unable to sign off on this condition as they have demonstrably failed to meet their obligations. In the absence of any practical measures that would allow for adequate preservation of T1 and T2 in the landscape, I cannot seek further input from their appointed arboricultural consultant and now leave you to decide whether you wish to pursue the matter of a breach of Planning Condition here.

- The introduction of one extra Dawyck beech (*Fagus sylvatica Dawyck*) at the location of T1 (once removed) of size as specified for elsewhere across the site.

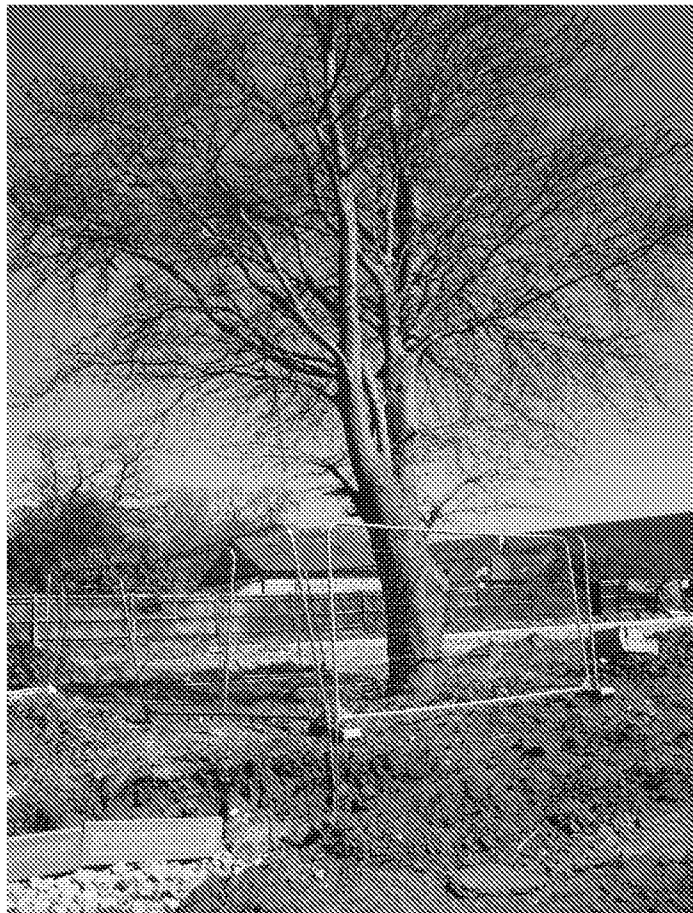
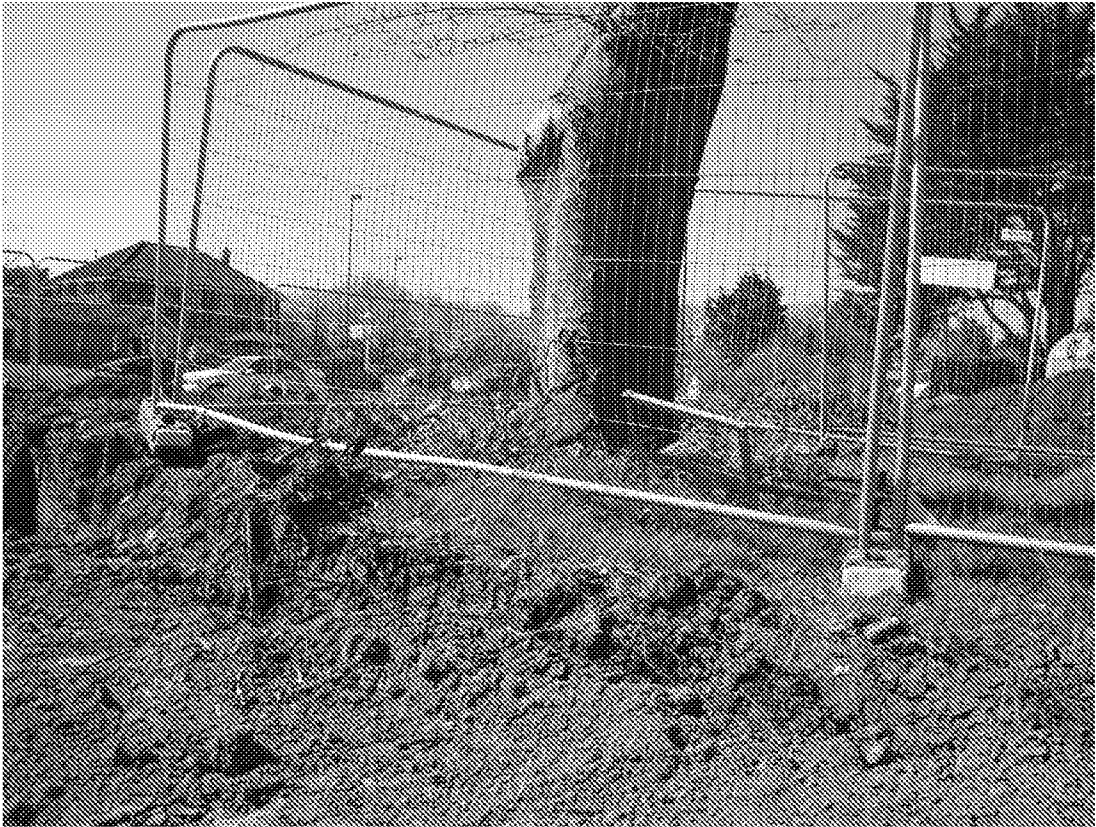
Tree no. T2

Insecure fencing extends from the following aspects (N-5m, E-1m, S-1m, W-2.5m) 3-4m in a broadly rectangular configuration. Some of the HERAS fence panels are sat in movable block trays, others are simply resting on the ground. There are no stabilizing struts, ground penetration of uprights nor are the panels adequately clamped together; the whole structure can be moved around as it suits and offers little if any resistance to an impact. The agreed hammerhead extension of the CEZ to the south (by way of compensation for Root Protection Area intrusion on other aspects) is absent and the ground has been subject to heavy compaction from tracked plant movement. Fragments of recently torn roots up to 50mm diameter were clearly evident in this area. There are no Tree Protection notices attached to the fencing. Excavation has occurred on the tree’s east side to a depth of 500mm and to within 1.5m of its main stem, culminating in the severance of multiple roots to a diameter of 30mm (Figs.3 & 4).

Fig.3 – View NE towards T2

Fig.4 – View SW towards T2

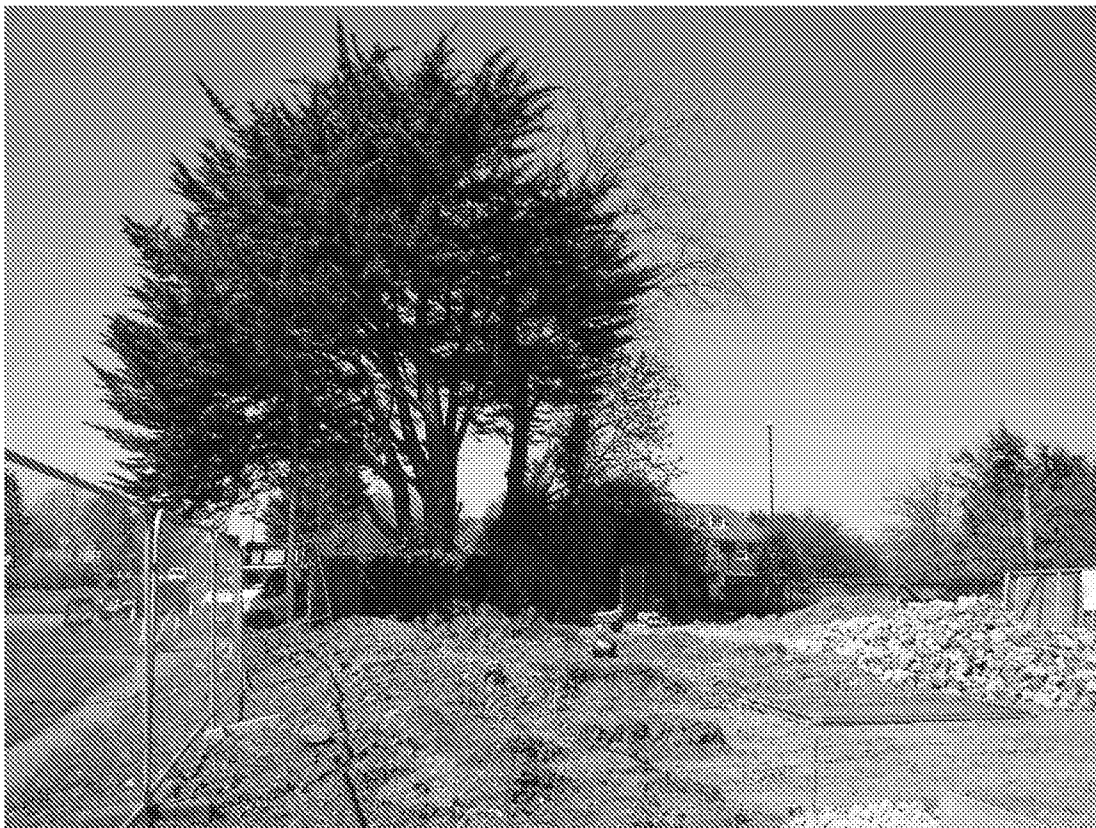
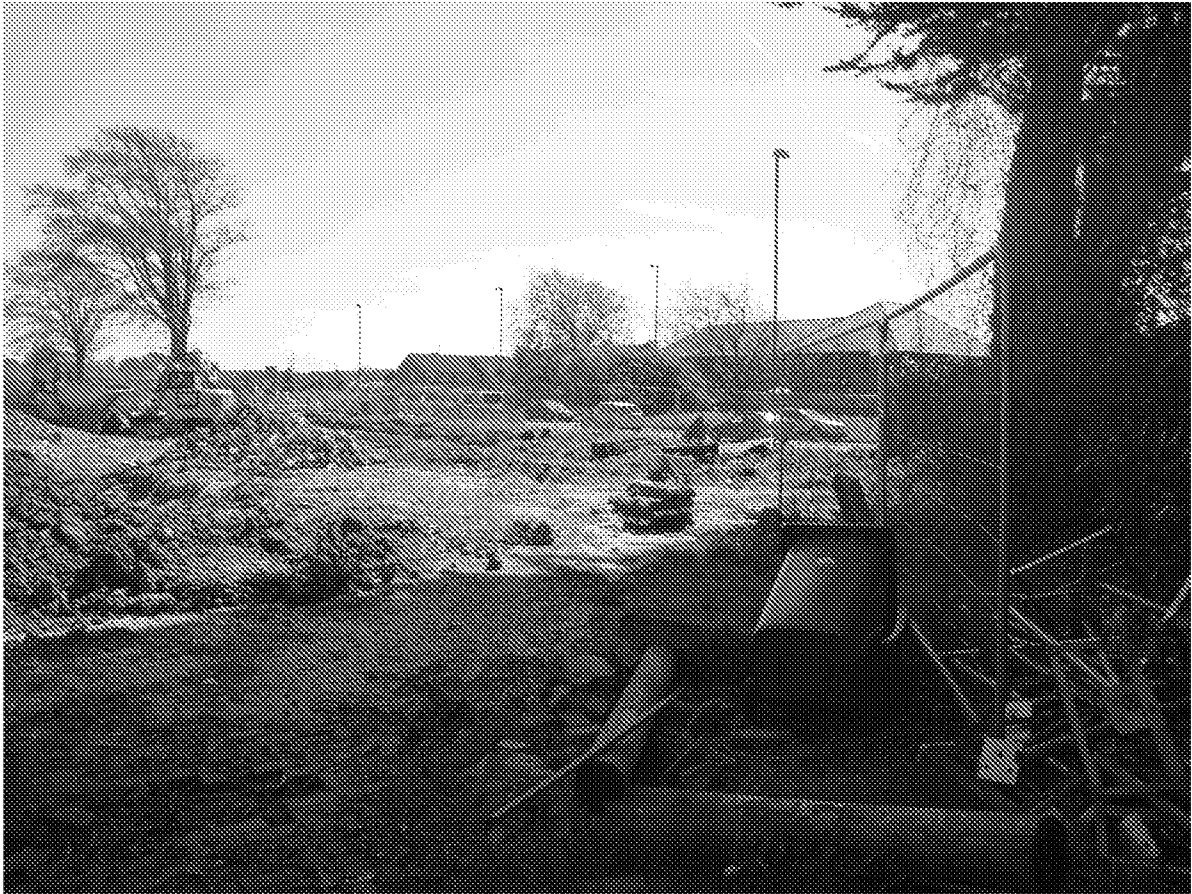
Tree nos. T3 & T4

Tree Protection Fencing is absent from within the site perimeter and allows for unconstrained access up to the boundary hedgeline. There is no ground protection in place (Figs.5 & 6).

Fig.5 – Looking W towards T3 & T4

Fig.6 – Looking SE across site

- In respect of T3 and T4, the developer should be asked to erect the agreed Tree Protection Fencing as a matter of urgency.
- The developer should now be required to compensate for the anticipated demise of T1 and T2 with an adequate tree replacement planting programme, to be agreed with the Planning Department.
