**ARBORICULTURAL IMPLICATIONS ASSESSMENT  
FOR  
PROPOSED 12 UNIT RESIDENTIAL DEVELOPMENT**

**LAND TO THE SOUTH OF  
MAYFLOWER WAY  
ANGMERING  
WEST SUSSEX**

**Tim Laddiman  
BSc.(Hons) M.I.C.For. M.Arbor.A.  
Chartered Arboriculturist**

**Our ref: J54.22  
9<sup>th</sup> November 2017**

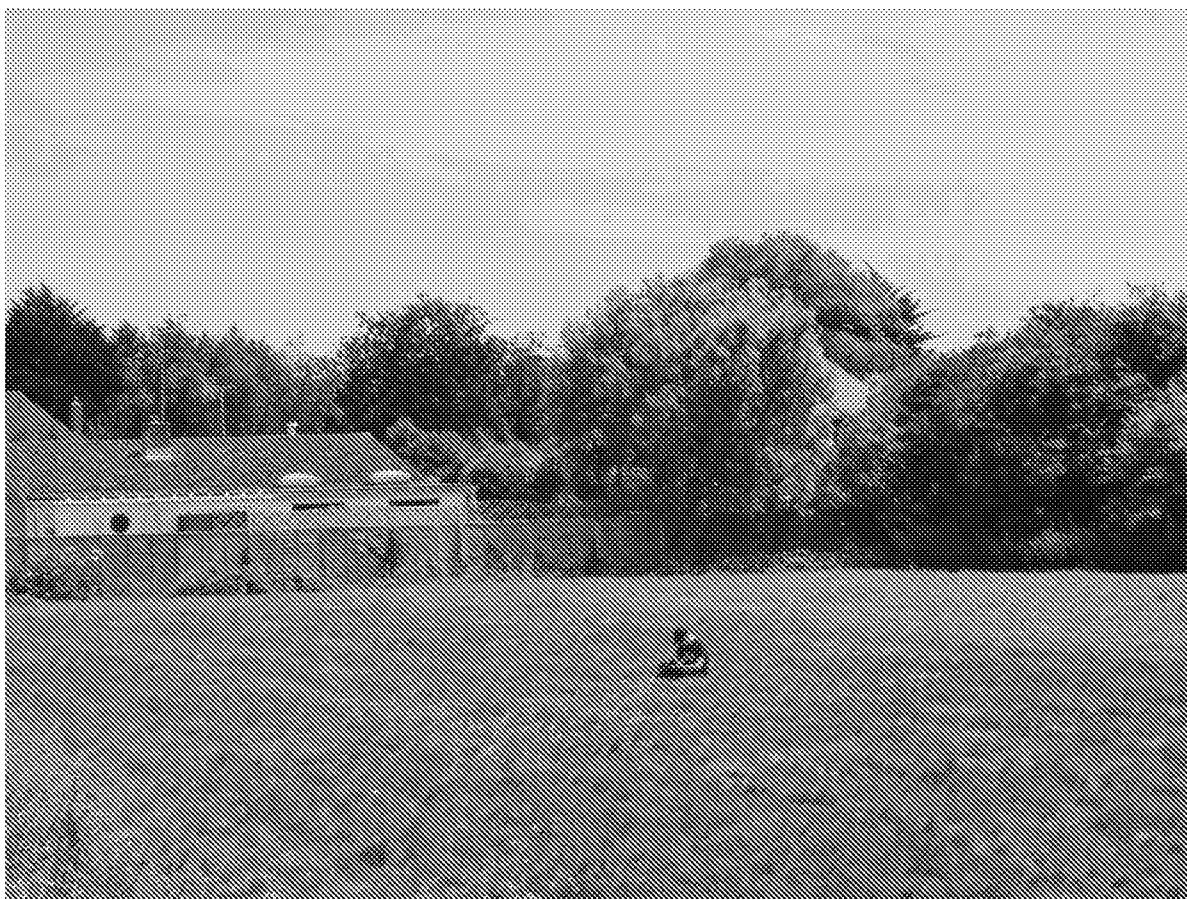
**View towards southeast corner of site and  
T1 Corkscrew Willow in adjoining garden**

| Tree ref. no. | Species | Height (m.) | Stem Count | Stem diameter or equivalent (mm.) | Branch spread (m.) | | | | Age class | Ht. of crown clearance (m.) | Physiological condition | Estimated remaining contribution (years) | Category grading | Structural condition and Notes | Preliminary management recommendations |
|---|---|---|---|---|---|---|---|---|---|---|---|---|---|---|---|
| 1 | Corkscrew Willow | 8 | Multi | c350 | 4.5 | c4 | 5 | 4.5 | MA | 1.1+ | Unconfirmed | 20-40 | B2 | Multi stemmed from under 1m. Located in adjoining garden therefore no basal inspection. | |

- 9.1 To accommodate the parking bays 22-24 it will be necessary to raise the overhanging crown of the Corkscrew Willow, T1, situated offsite. As overhanging foliage this is within Common Law Rights of the landowner to raise the canopy without requiring the permission of the tree owner, though any removed material has to be offered back to the tree owner.
- 9.2 Cutting back of outer foliage of elements of the overgrown hedge line to the south will also be necessary for the installation of the new garden fences.

| Tree No. | Species | Works Required |
|---|---|---|
| T1 | Corkscrew Willow | Raise overhanging crown to give 3m ground clearance. |

- 10.3 The only conflict with tree RPAs is with that of T1 Corkscrew Willow and the approach drive to parking bays P22-P24. In theory the roots of T1 are trespassing within the site and could be legally severed under Common Law Rights and this should not represent a planning constraint. However, a reasonable approach would be to minimise any potential impact and cause the minimum reasonable root disturbance.

- 10.4 It would be proposed that a porous minimal dig drive construction be applied within the RPA of T1. The upper soils will be dominated by the dense root systems of the thick grass sward. This turf will be removed by hand tools only within the indicated RPA of T1. This approach and the installation of a minimal dig sub base is indicated on the Tree Protection Plan, which can be referred to in a specifically worded Condition.

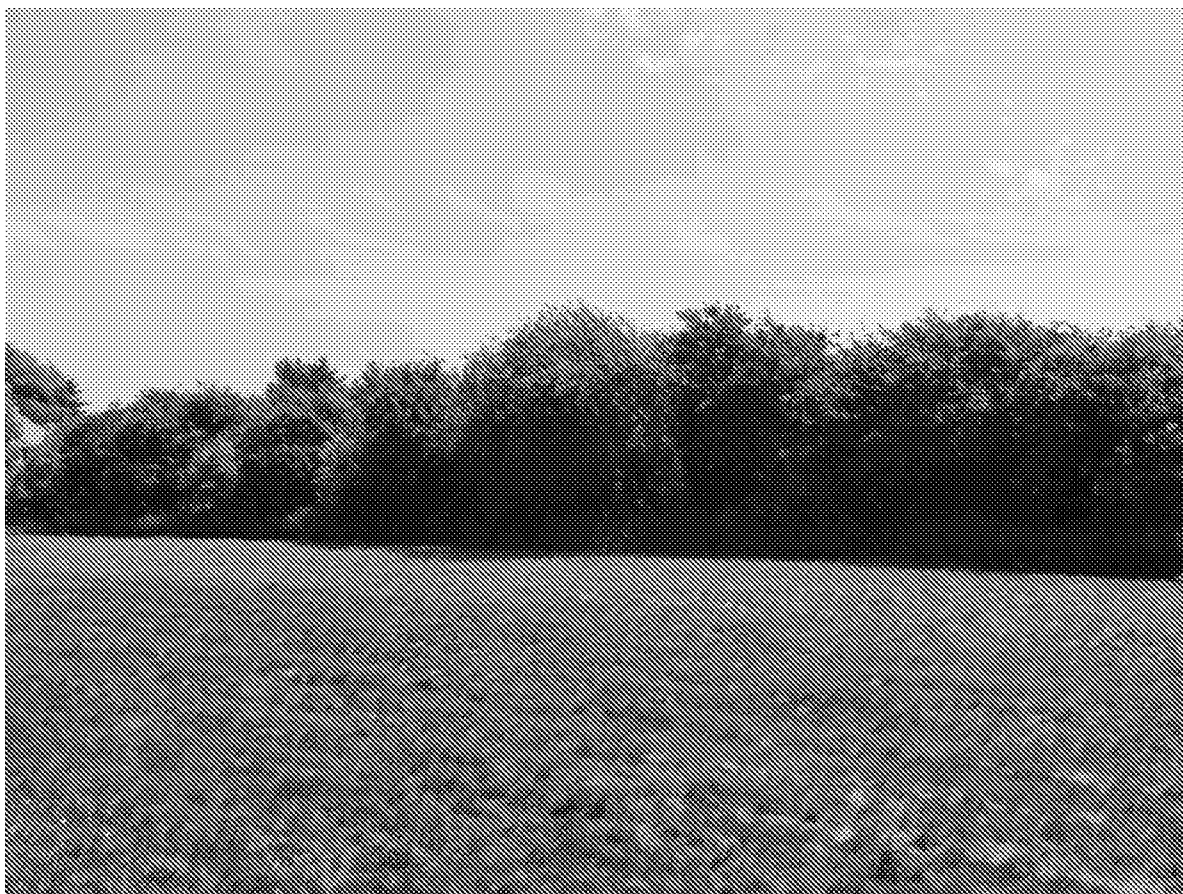
- 6.1 A total of 12 individual trees and groups were inspected, with the majority representing components of an overgrown hedgerow along the southern boundary (trees G2-G10 inclusive). These are in variable condition and indicate the hedge line has not been maintained for at least two decades. A more regularly maintained hedgerow, G11, runs along the western boundary.
- 6.2 To the southeast corner in the rear garden of the adjoining residential property, “Shangri-La” is a maturing Corkscrew Willow which overhangs the site.
- 6.3 To the north side of Mayflower Way the offsite linear group G12 comprises Poplars and Cypress planted as a fast growing screen and then left unmaintained for many years. Branches now hang low over the road and a number of the Poplars have torn/split/weak limbs over the road that should be addressed by the Council or Highways on safety grounds.

**General view of overgrown hedge line to south of site.**

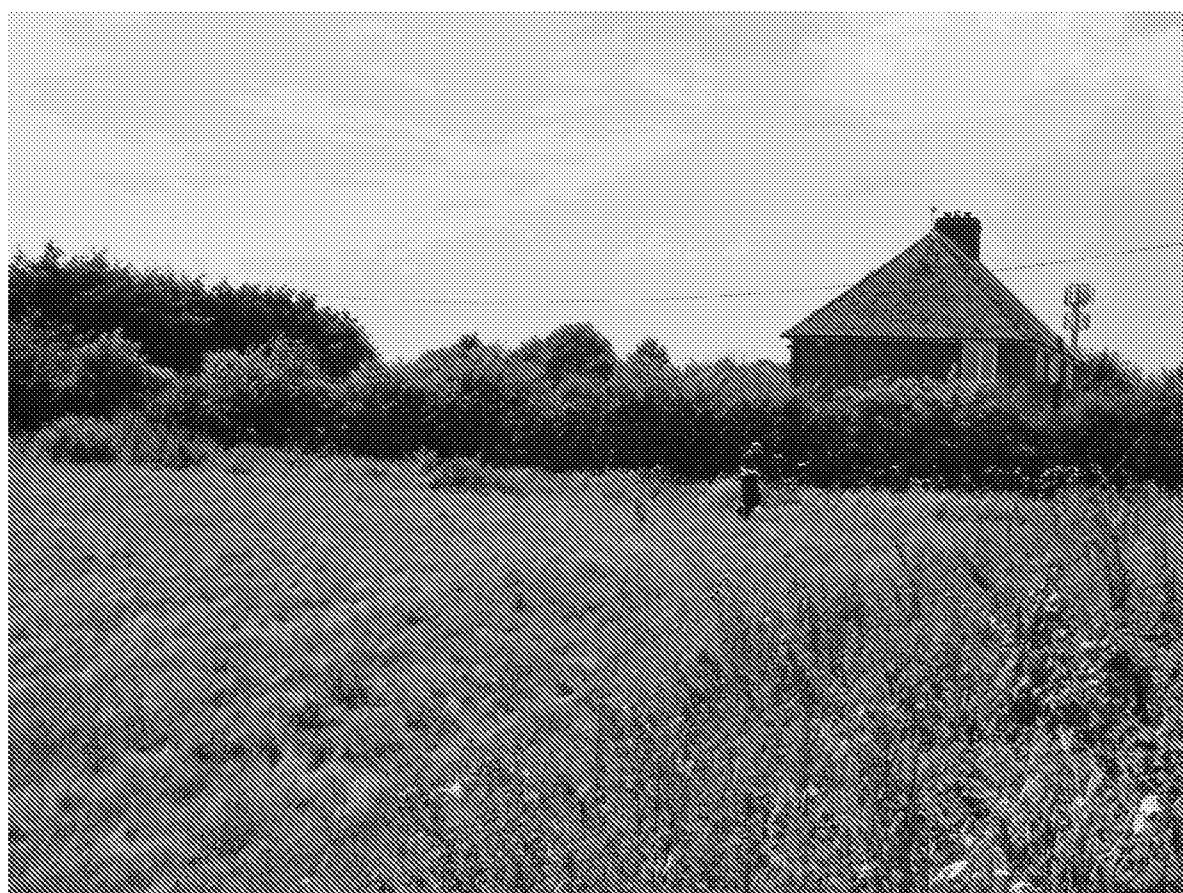
**View to west of regularly maintained hedgerow G11.**

| Tree ref. no. | Species | Height (m.) | Stem Count | Stem diameter or equivalent (mm.) | Branch spread (m.) | | | | Age class | Ht. of crown clearance (m.) | Physiological condition | Estimated remaining contribution (years) | Category grading | Structural condition and Notes | Preliminary management recommendations |
|---|---|---|---|---|---|---|---|---|---|---|---|---|---|---|---|
| G11 | Hawthorn, occ. Elder | <3.5 | Multi | <100 | <1 | <1.5 | <1 | <1 | M | 0+ | Good | 40+ | C2 | | |

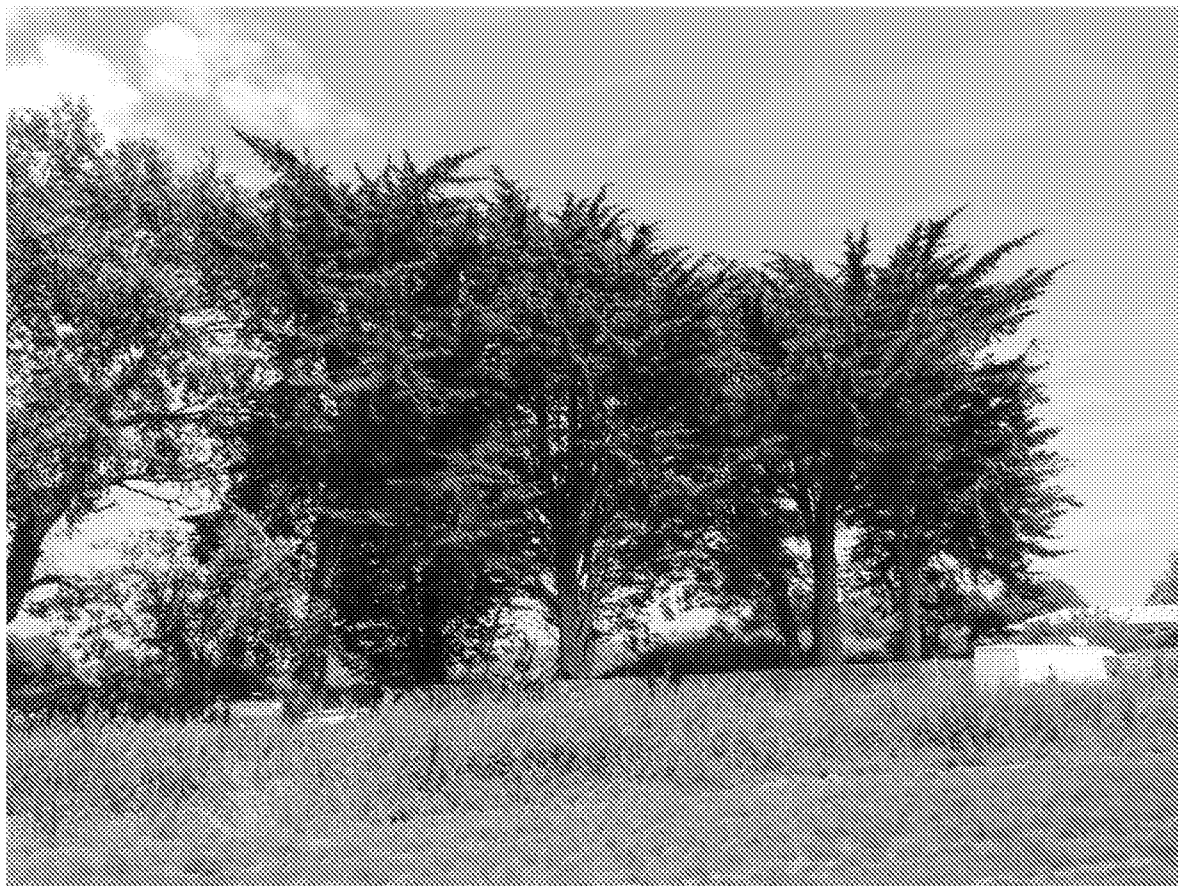
**View of part of G12, Poplar and Cypress representing a visually prominent overgrown screen containing safety issues and low hanging branches.**

| Tree ref. no. | Species | Height (m.) | Stem Count | Stem diameter or equivalent (mm.) | Branch spread (m.) | | | | Age class | Ht. of crown clearance (m.) | Physiological condition | Estimated remaining contribution (years) | Category grading | Structural condition and Notes | Preliminary management recommendations |
|---|---|---|---|---|---|---|---|---|---|---|---|---|---|---|---|
| G12 | White Poplar, Monterey Cypress | <20 | Multi | <700 | <7 | <6 | <8 | <6 | M | 1.7+ | Variable | 0-40 | B/U1 | Linear group inter mixed. Poplar with numerous split/torn limbs, several with stem decay. | Remove split/torn pendular branches and raise to 5m. |
