# Arboricultural Impact Assessment

Land north of Water Lane & Dappers Lane  
Waters lane  
Angmering  
BN164EJ

2 February 2018

PJC ref: 4652/17-02 Rev-01

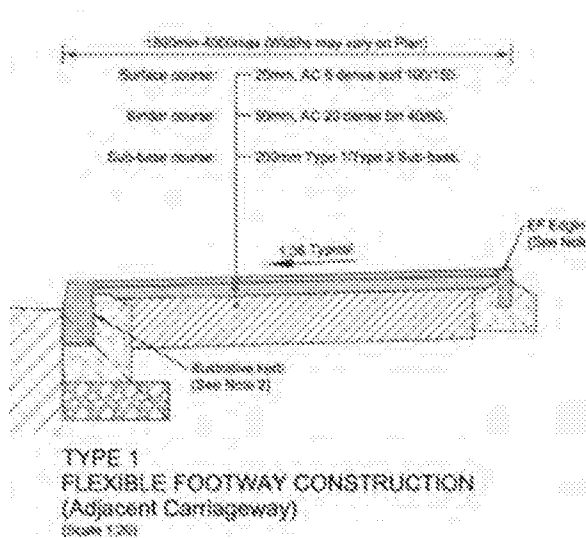
Image 1 (above): standard footpath design section drawing.

WSSCC adoptable highways footpath section:  
Proposed footpaths west of Dappers will be 1.5m wide (with edging). Standard construction would lead to a depth of 270mm, this can be reduced to 170mm with reduced 100mm of sub-base in areas where there are no drives crossing where occurring within RPAs.
