## Arboricultural Survey

Land adjacent to and including:  
The Oval Raceway  
Waters lane  
Angmering  
BN164EJ

20 March 18

PJC ref: 3874/15-01 Rev 04

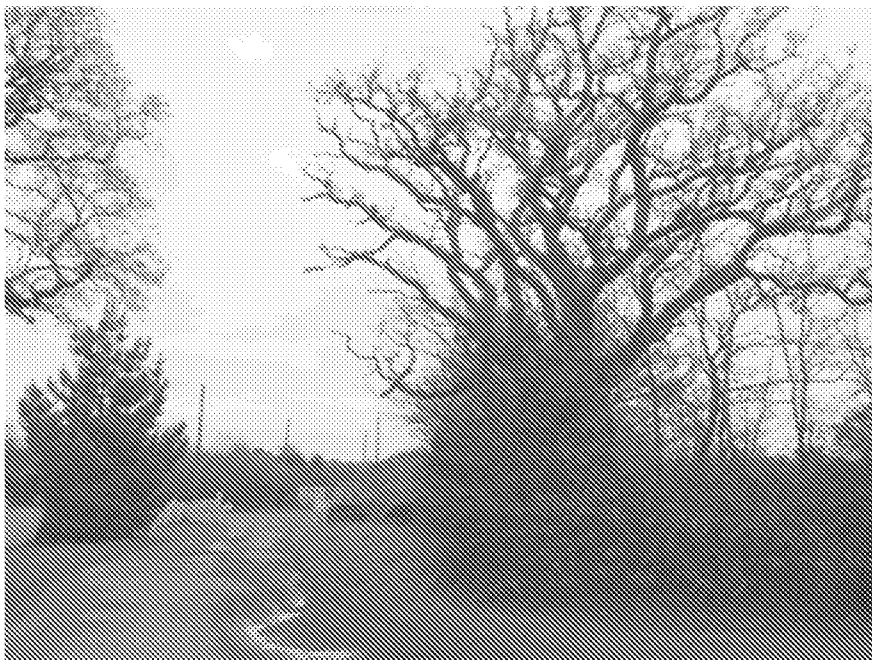
**Photograph 2** – View north toward race track of oak in decline.
