## HERITAGE STATEMENT

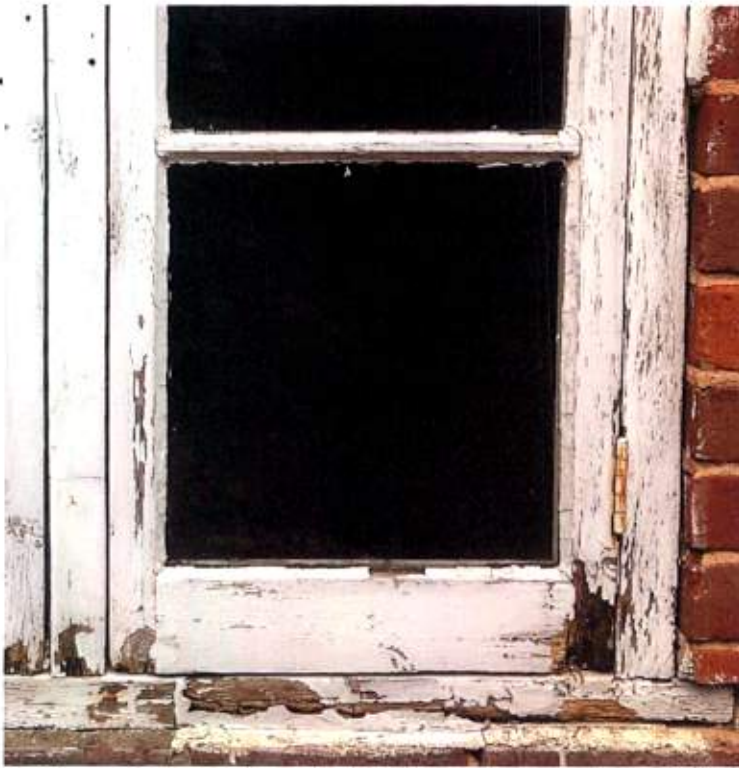
This proposed change to the windows is intended to preserve and enhance the special historic and architectural importance of the building. Many of the current windows are in a poor state (see picture below) which detracts from the building's appearance and also contributes to accelerated decay of the building's structure. The extremely poor insulation of the current windows also creates draughts, dust and dampness inside the building, which causes further deterioration and also results in high energy costs, in addition to contributing to climate change. The proposal to fit new double-glazed windows will help to ensure that the special appearance of the building is preserved for future generations.

*Detail of one of the windows. The window is badly-fitting and has been installed with no damp-proof barrier, so there is moisture transfer from window to wall and vice versa. This makes it impossible to stop the window from rotting, however often it is painted, and also impossible to stop the walls from deteriorating.*

*The other windows are of similar construction and condition.*

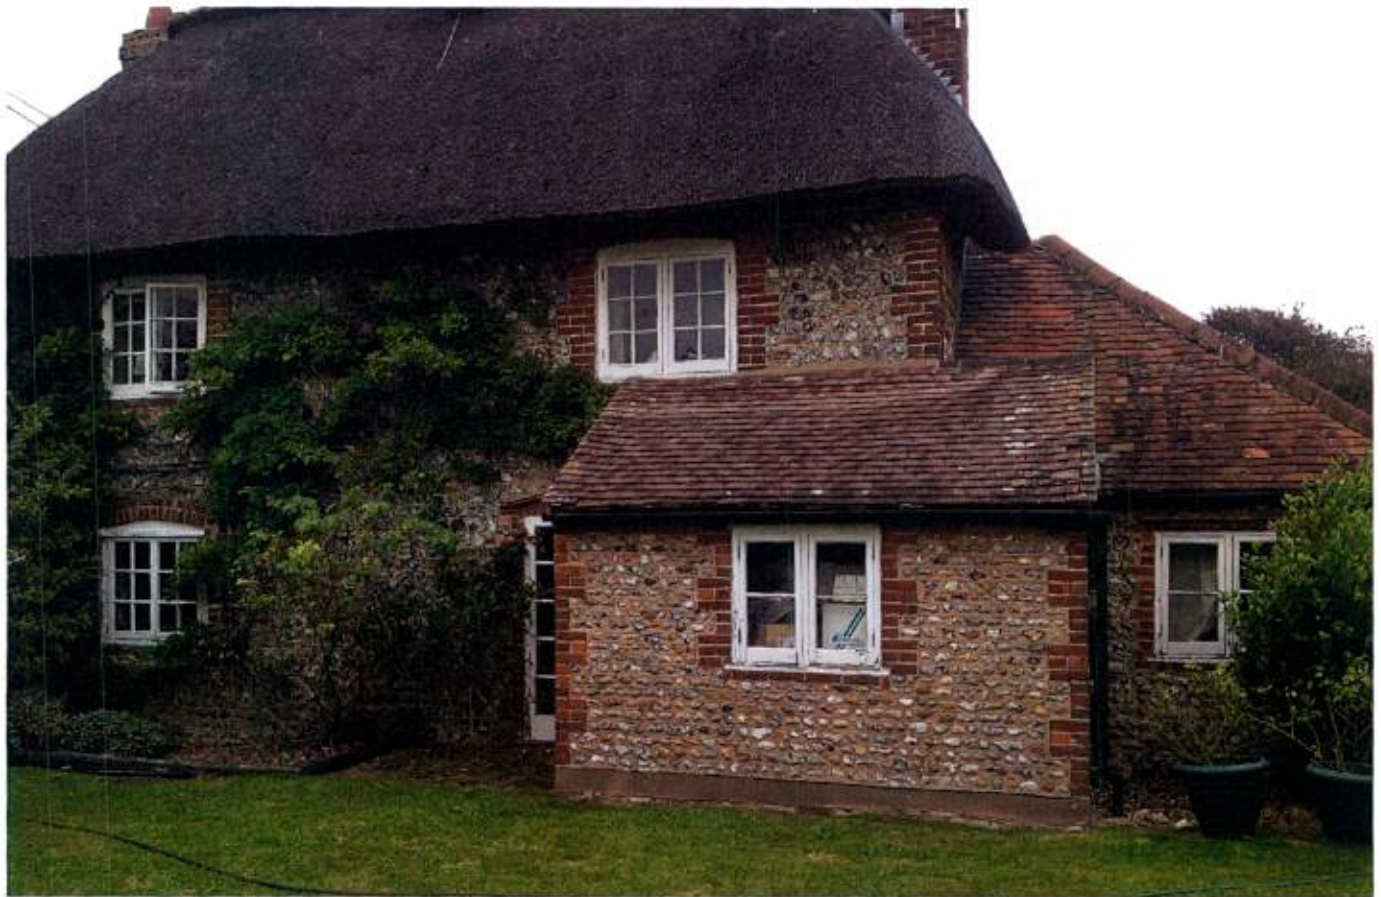
*View of the front of the house from the garden, showing the windows in question.*
