## DESIGN & ACCESS STATEMENT

### REMEDIAL WORKS TO WEST FACING GABLE WALL INCLUDING REMOVAL OF CHIMNEY

#### THE CHASE

re: **Structural Bulging Defect to West Facing Gable Wall**  
- "The Chase", 101 North Bersted Street, North Bersted, Bognor Regis.

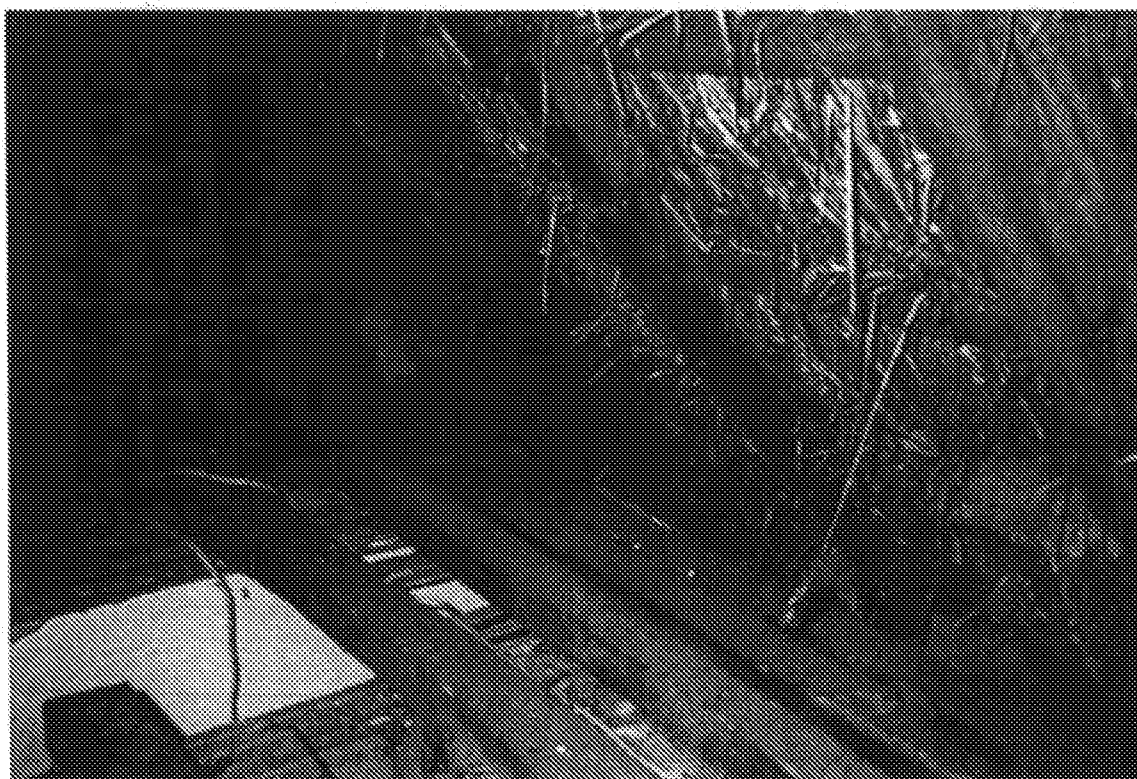
PHOTOGRAPH 3

We noted that close to the westernmost access off bedroom 4, a section of purlin beneath the south slope is missing completely (Photograph 3) and may have been too badly damaged, and removed in the past. As a precaution, you may consider introducing a supplementary purlin in this area, but the practical problem is introducing timbers of sufficient length to get any significant benefit in load-bearing. It might be prudent to instruct a specialist carpenter or builder to inspect this particular

location to determine the practical possibilities here but, on balance, there is nothing to suggest that the structural integrity of the roof is at risk to make this repair vital at the current time. However, from the access hatch in the en-suite shower room at the east end, we did note that the first strut on the south side, at the end of the new binder, has lost its fixing to the rafter (Photograph 4) which is badly damaged at this point, and a repair should be effected, possibly incorporating a supplementary rafter fixed to the other side of the existing one and bolted through. We recommended this repair in our report four years ago - although there are no signs of serious problems, a repair here is nevertheless advised.

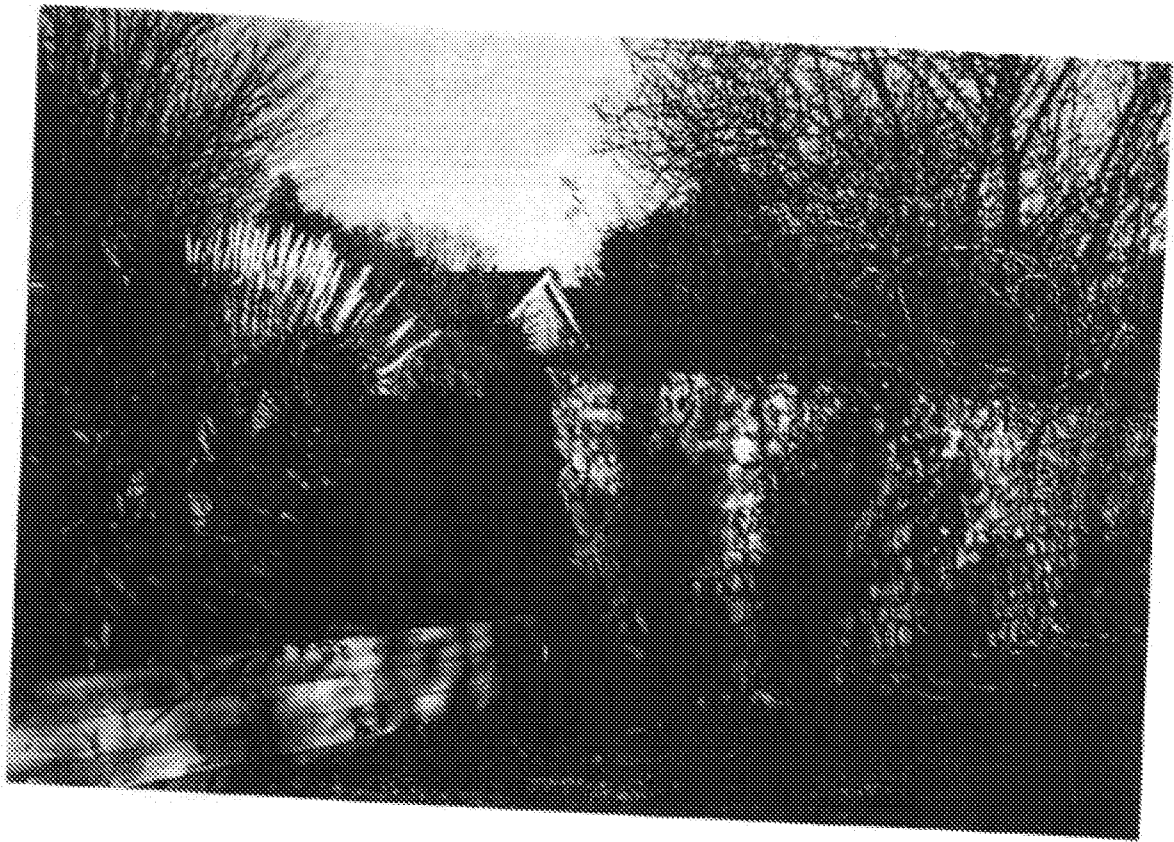
PHOTOGRAPH 6

damaged brickwork at the north end adjoining the steps up from the lawn and some minor re-pointing also needed to a low brick wall on the north side of these steps. In front of the pool house, is a brick paved area but here, spalled and damaged bricks need replacing and will continue to weather. The pool itself has not been inspected but we were informed by the vendor that it is to be relined at her expense and this should be verified by your Legal Advisers. There is a brick screen wall separating the formal area of garden to the land beyond but the brickwork here is concealed beneath creeper growth. In the informal garden area, there is no fencing on the west side and there is some gapping in the tree and shrub screen, separating the garden from the gravel track belonging to an adjoining owner. We have mentioned the need to check rights of access along the west boundary for maintenance purposes. More importantly though, a section of flint walling abutting this track, just beyond the formal garden area, is cracked and leaning dangerously and will need to be demolished as a matter of urgency. (Photograph 6).
