## Oldlands Farm

Bognor Regis

### Ground Conditions Desk Study Report

Hydrock Ref: R.14459.002

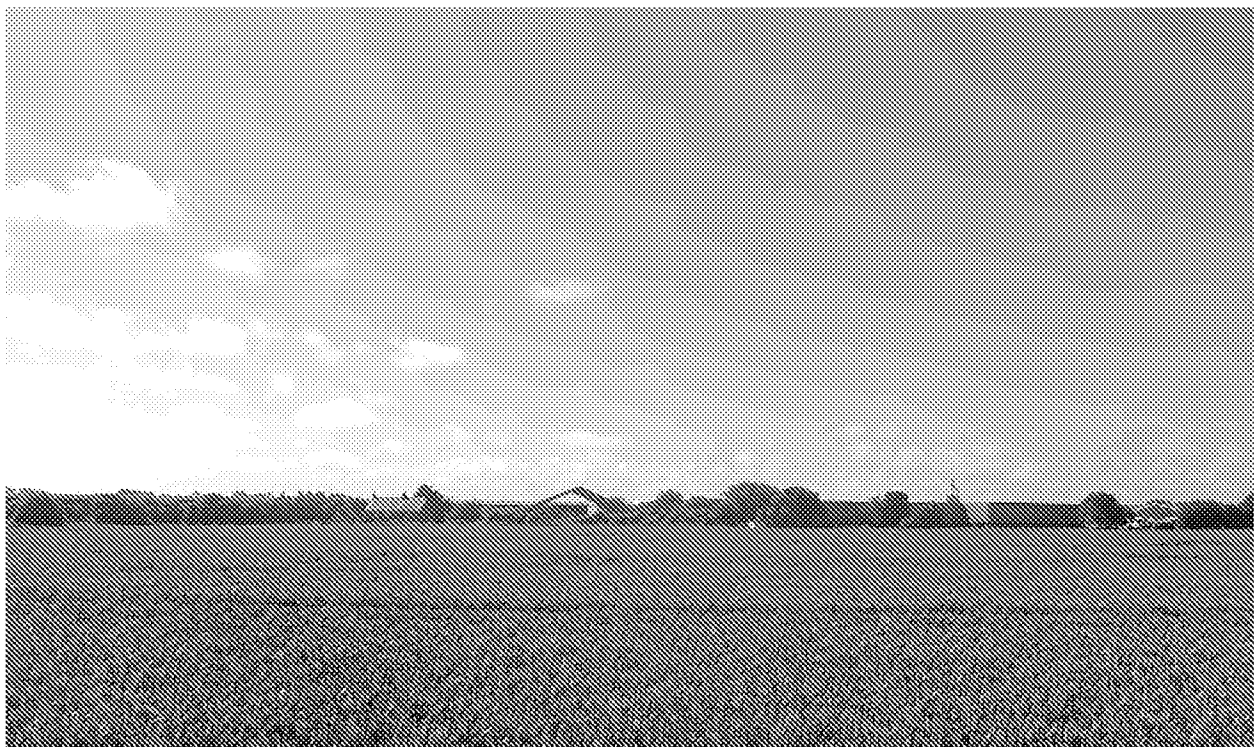
Figure 1: General view of the site.

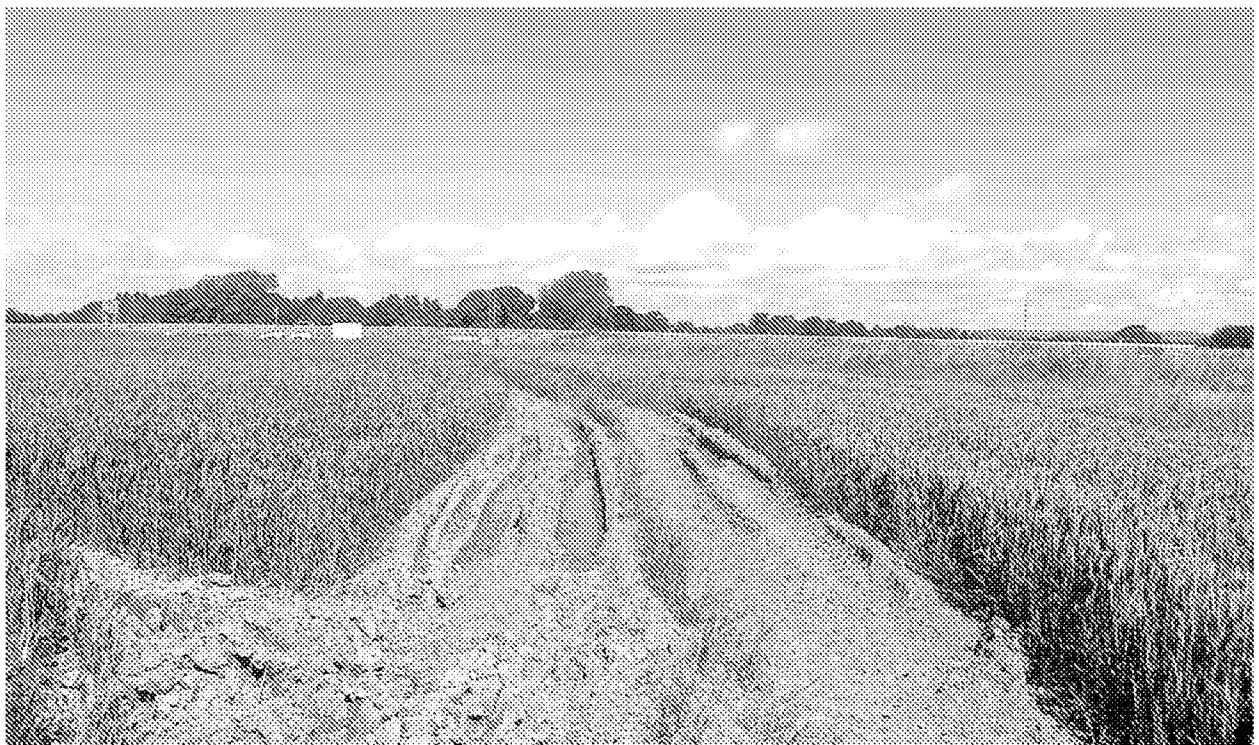
Figure 2: General view of the site.

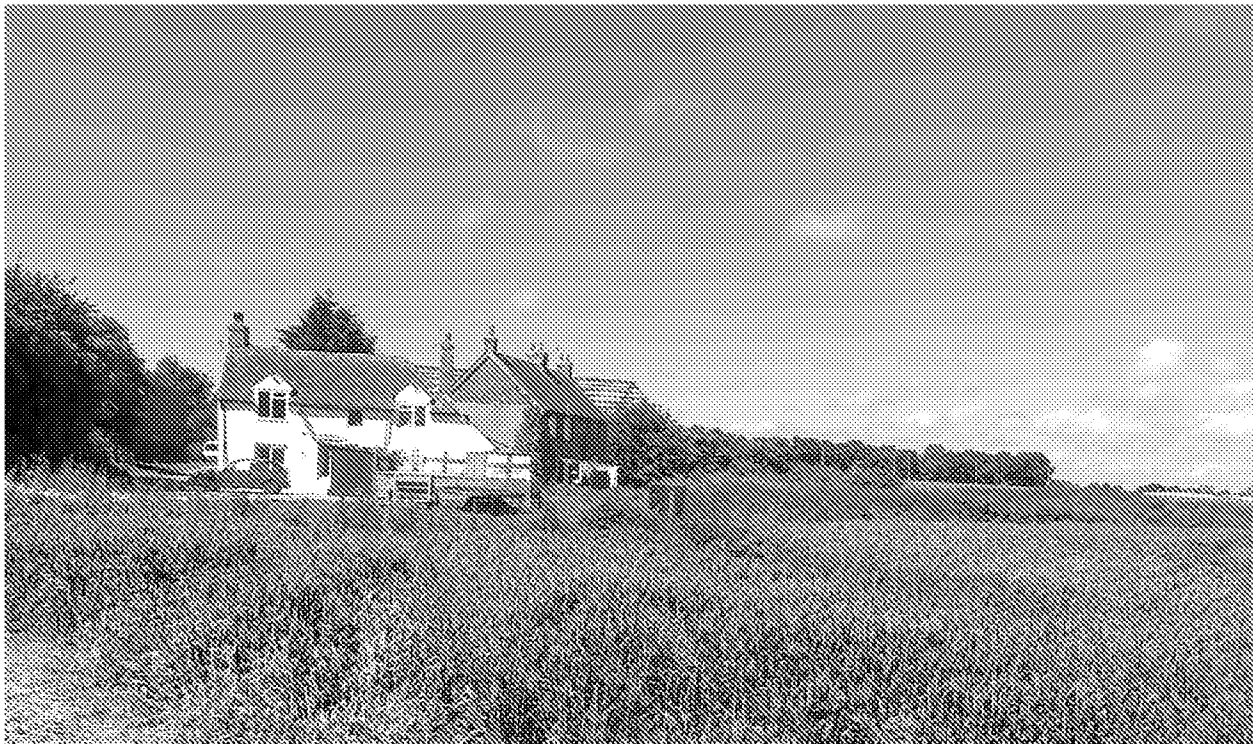
Figure 3: Farm buildings to the south of the site.

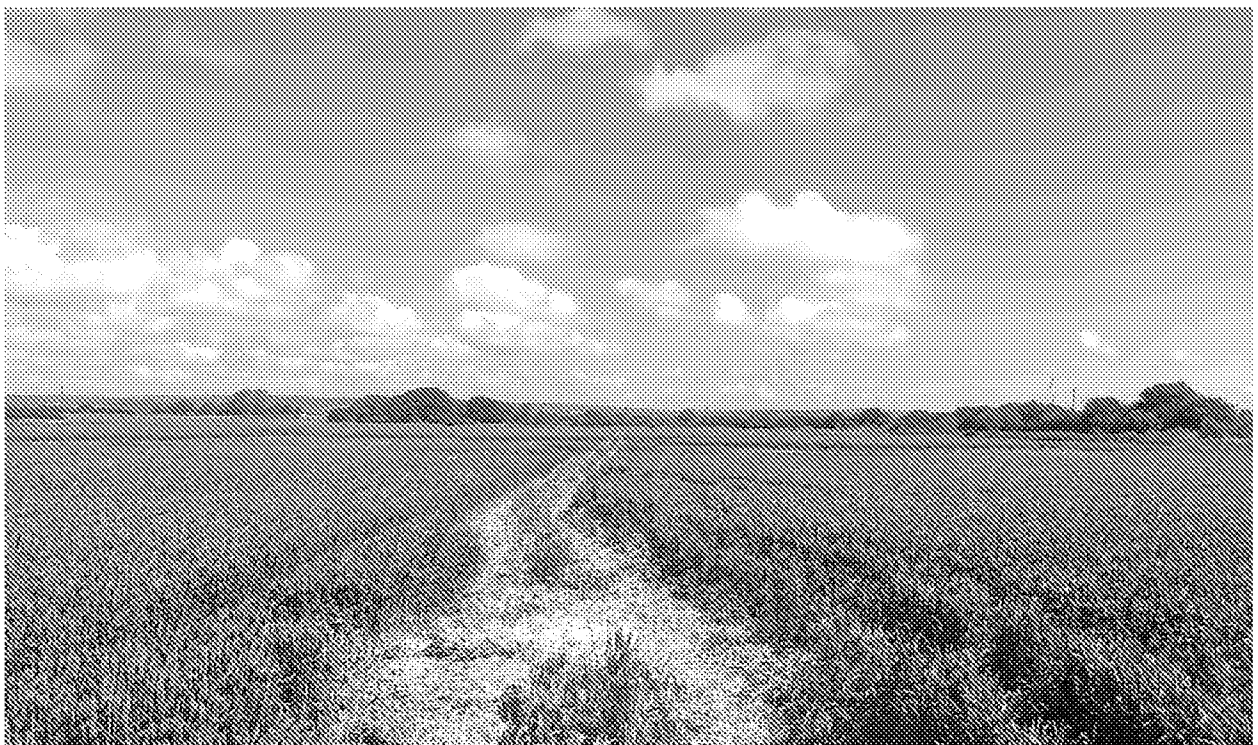
Figure 4: General view of the site.
