**Arboricultural Implication Assessment  
Angels Nursery Site  
Yapton Road  
Barnham  
West Sussex**

PJC Ref No: PJC/901/09

1.1 **Brief:** I have been commissioned by Paul Collins of PPC Planning, to provide a tree survey and arboricultural implication assessment for the site at the former Angels Nursery, Yapton Road, Barnham.

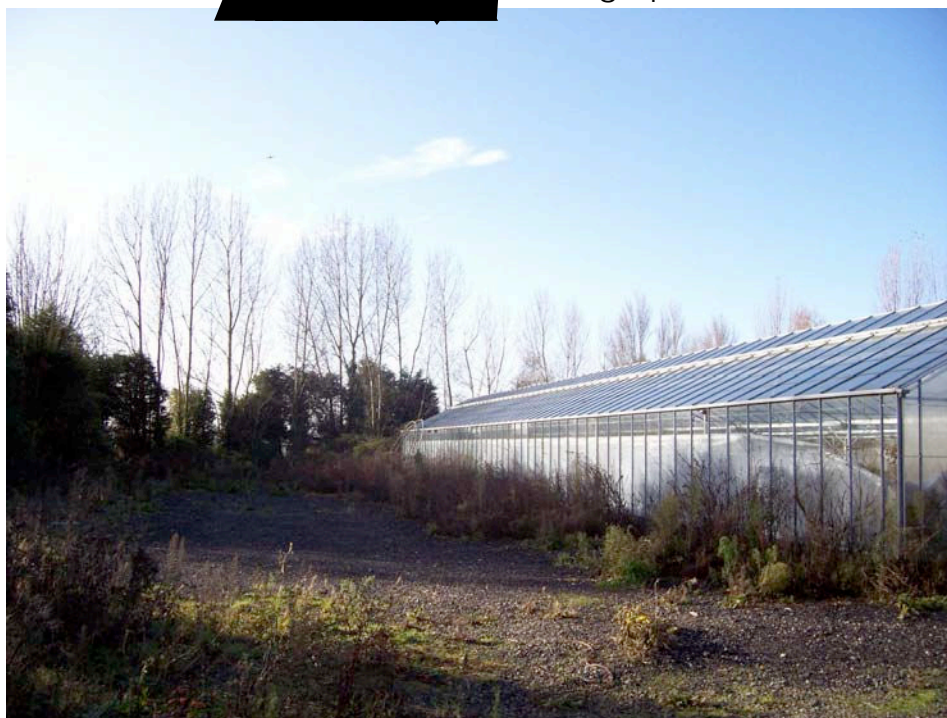
Photograph 1

3.3 The site comprises of a number of buildings related to the raising of plant stock, open areas of dense scrub and a residential property and garden to the east. The site as a whole is neglected and heavily overgrown, with weed species such as bramble and nettle making access to areas difficult and in places impossible. The trees on the site are predominantly located on the boundaries forming shelterbelts, which would previously have protected the plant stock from extremities of weather. Trees within the site are self-seeded saplings, internal shelterbelts or the occasional individual tree. *Photographs 1 and 2, Appendix 7.*

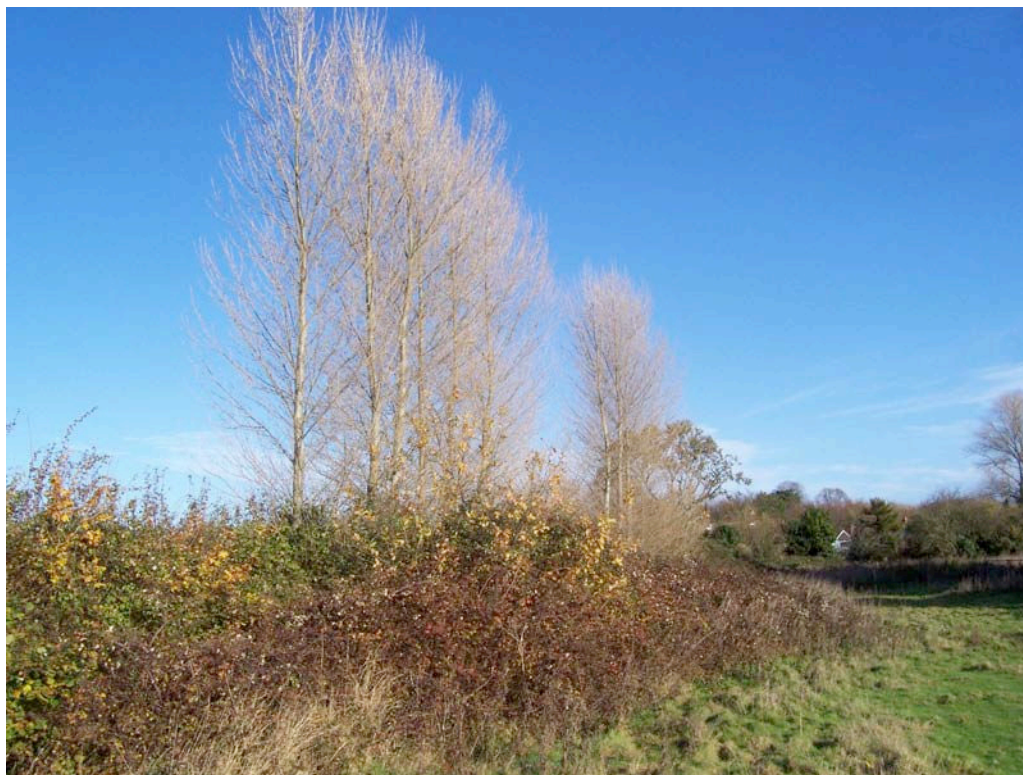
Photograph 3

3.8 In the south western corner of the site are T10 – T13, four larger white poplars. T10 is suppressed on one side by T11. Apart from some minor deadwood, these trees have no visible major defects however the view of the stems is once again obscured. To the north of these trees is another white poplar screen. It is an isolated screen that provides little in the way of a visual barrier. *Photograph 3, Appendix 7.*

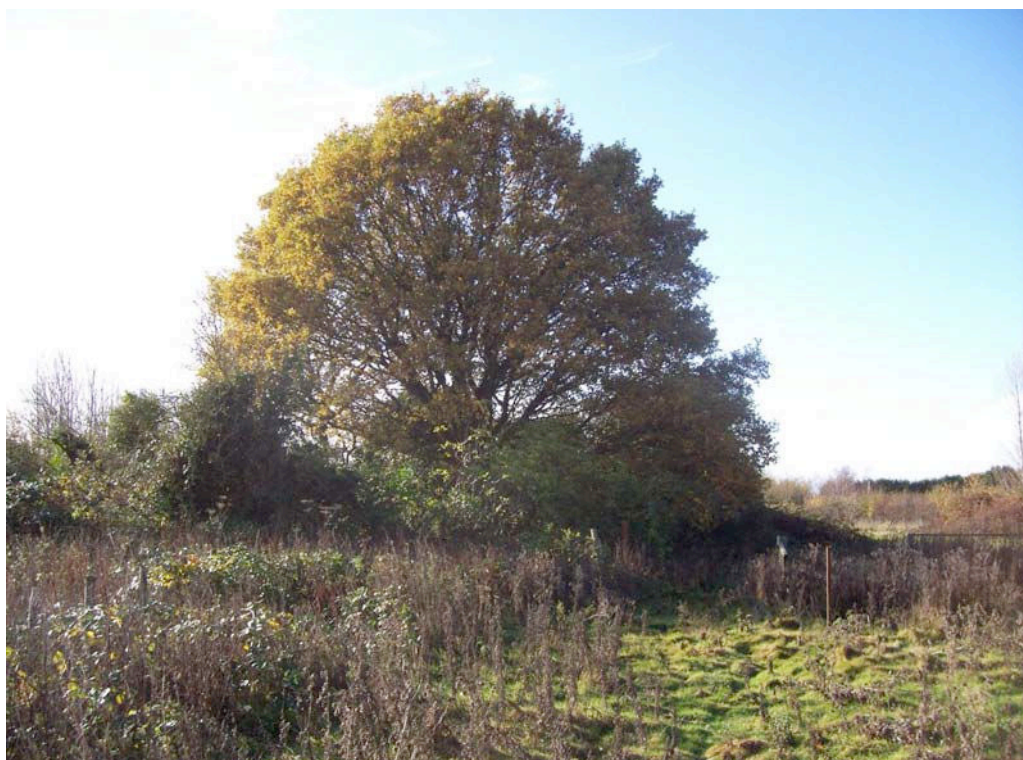
Photograph 4

3.9 Located in the centre of the site are two English oak (T15 and T16). These trees show high crown virility although T15 has minor deadwood and a slightly congested crown. Due to the size, good condition and aesthetic value, these trees are of high value to the site. *Photograph 4, Appendix 7.*

4.4 The two oaks (T15 and T16) should be retained. These are the two highest value trees on the site and the design should take into account their location and root protection areas. It would be advisable to remove the minor deadwood from the crown of T15 before construction works commence. Both trees have the potential for long-term contribution of visual amenity to the site, providing an internal focal point.

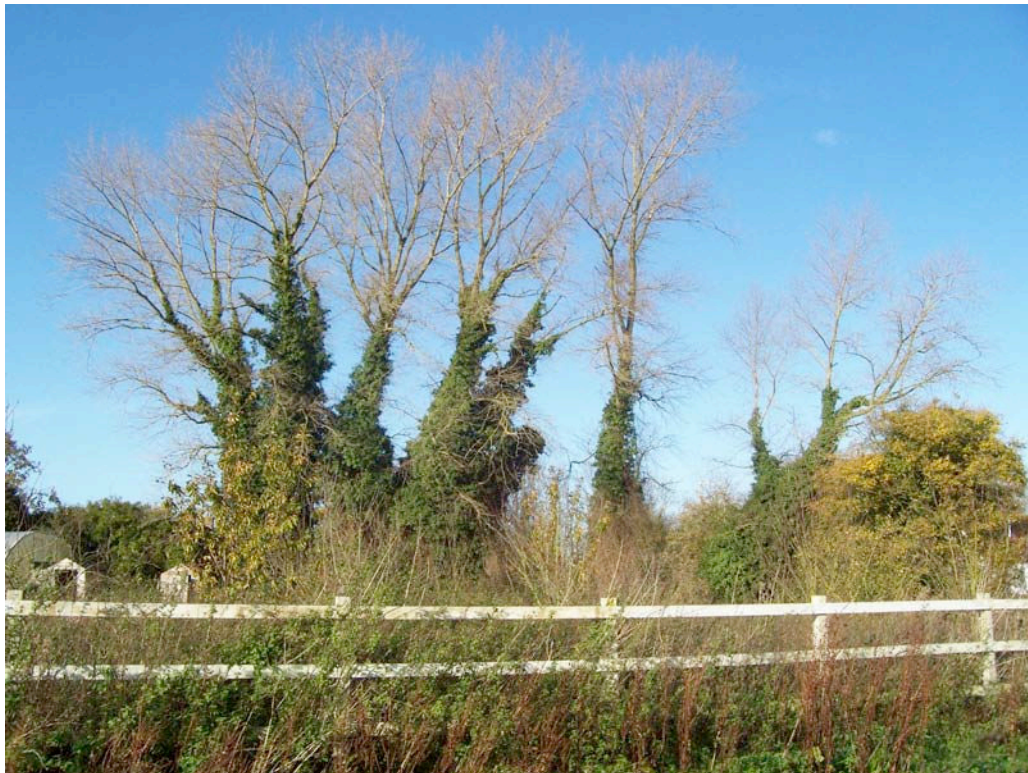
Photograph 5

3.10 At the north of the site are T18 – T23, which are six large white poplar. They have an inaccessible understorey of bramble, ivy and one juvenile, suppressed horse chestnut (*Aesculus hippocastanum*), which prevent detailed inspection of the stems. T21 is demonstrating a sparse crown, although the remaining trees have satisfactory crowns with some minor deadwood. *Photograph 5 and 6, Appendix 7.*
