## Hill View, Eastergate Factual Letter Report

Our Ref: 24.1172 Rev 1

### Re: Hill View, Shallow Boreholes - Winter Groundwater Monitoring Rev 1

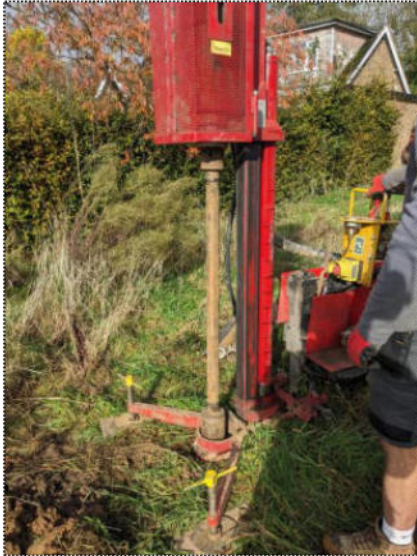
1.

- 1) BH1 position
- 2) Site entrance looking south
- 3) BH1 1-2mbgl
- 4) BH1 2-3mbgl

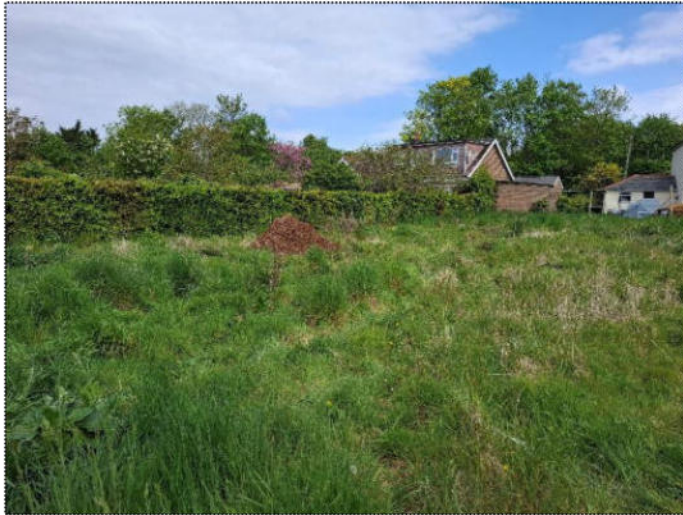
1.

- 1) TP01 location adjacent to hedgerow facing northwest
- 2) TP01 location in relation to northeast structures, facing south east
- 3) TP01 0.0-1.6m bgl
- 4) TP01 spoil

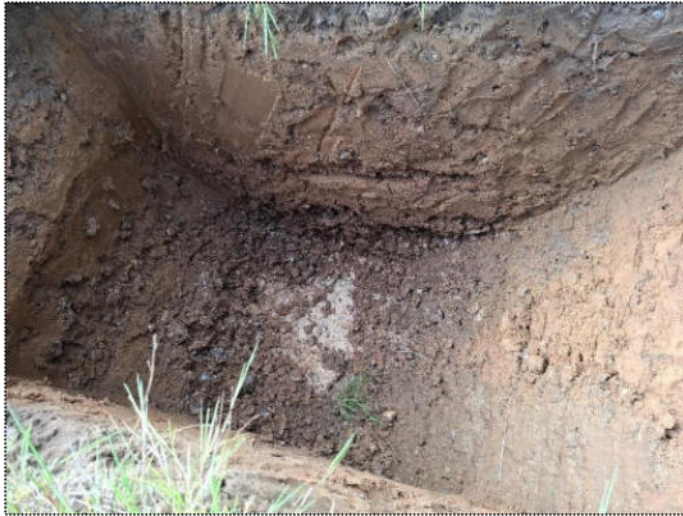
5.

- 5) TP01 side wall 0.0-1.6m bgl
- 6) TP02 location in southwest fields facing southwest
- 7) TP02 in relation to adjacent site facing north
- 8) TP02 0.0-1.6m bgl

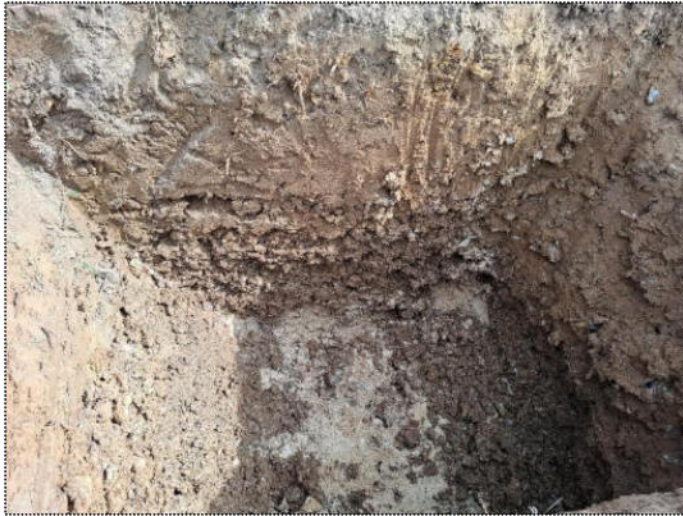
9.

- 9) TP02 side wall 0.0-1.6m bgl
- 10) TP02 spoil
- 11) TP01 post testing
- 12) TP02 post testing

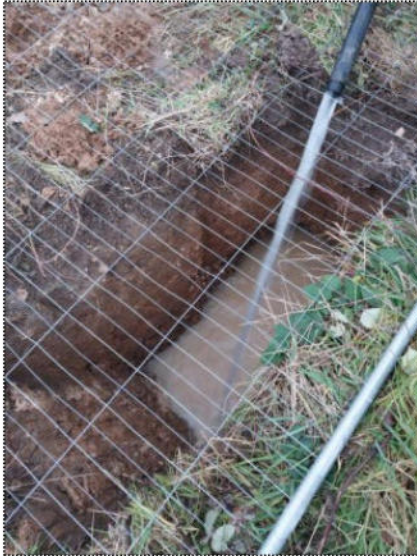
1.

- 1) BRE 365 testing
- 2) BRE 365 testing
- 3) BRE 365 testing
- 4) BRE 365 testing
