# LAND ADJACENT 37 HILL LANE

## DRAINAGE STATEMENT

### **Soil Infiltration Testing and Groundwater Monitoring – 37 Hill Lane, Barnham**

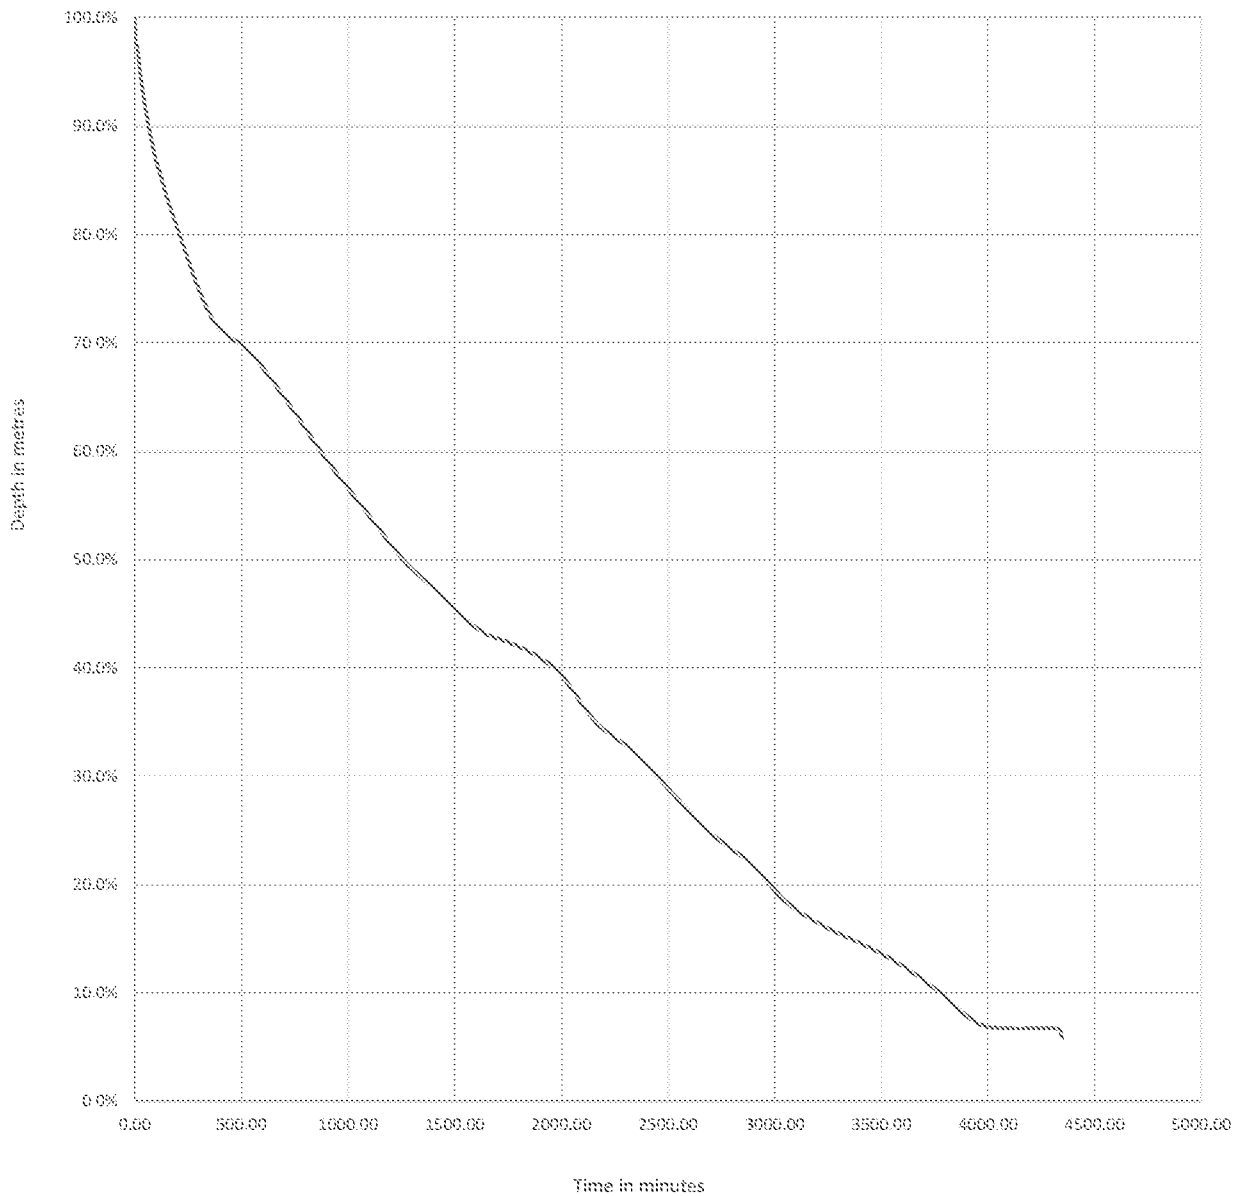
Trial Hole: TP1

The 25% marker was reached in TP1 only, over the time period tested. On this basis, a soil infiltration rate for TP1 of  $1.02 \times 10^{-6}$  has been calculated. TP2 did not reach the 25% marker during the allotted time, due to slower infiltration, however an extrapolated soil infiltration rate of  $3.5 \times 10^{-7}$  has been calculated on the review of the data.

1.02006E-06

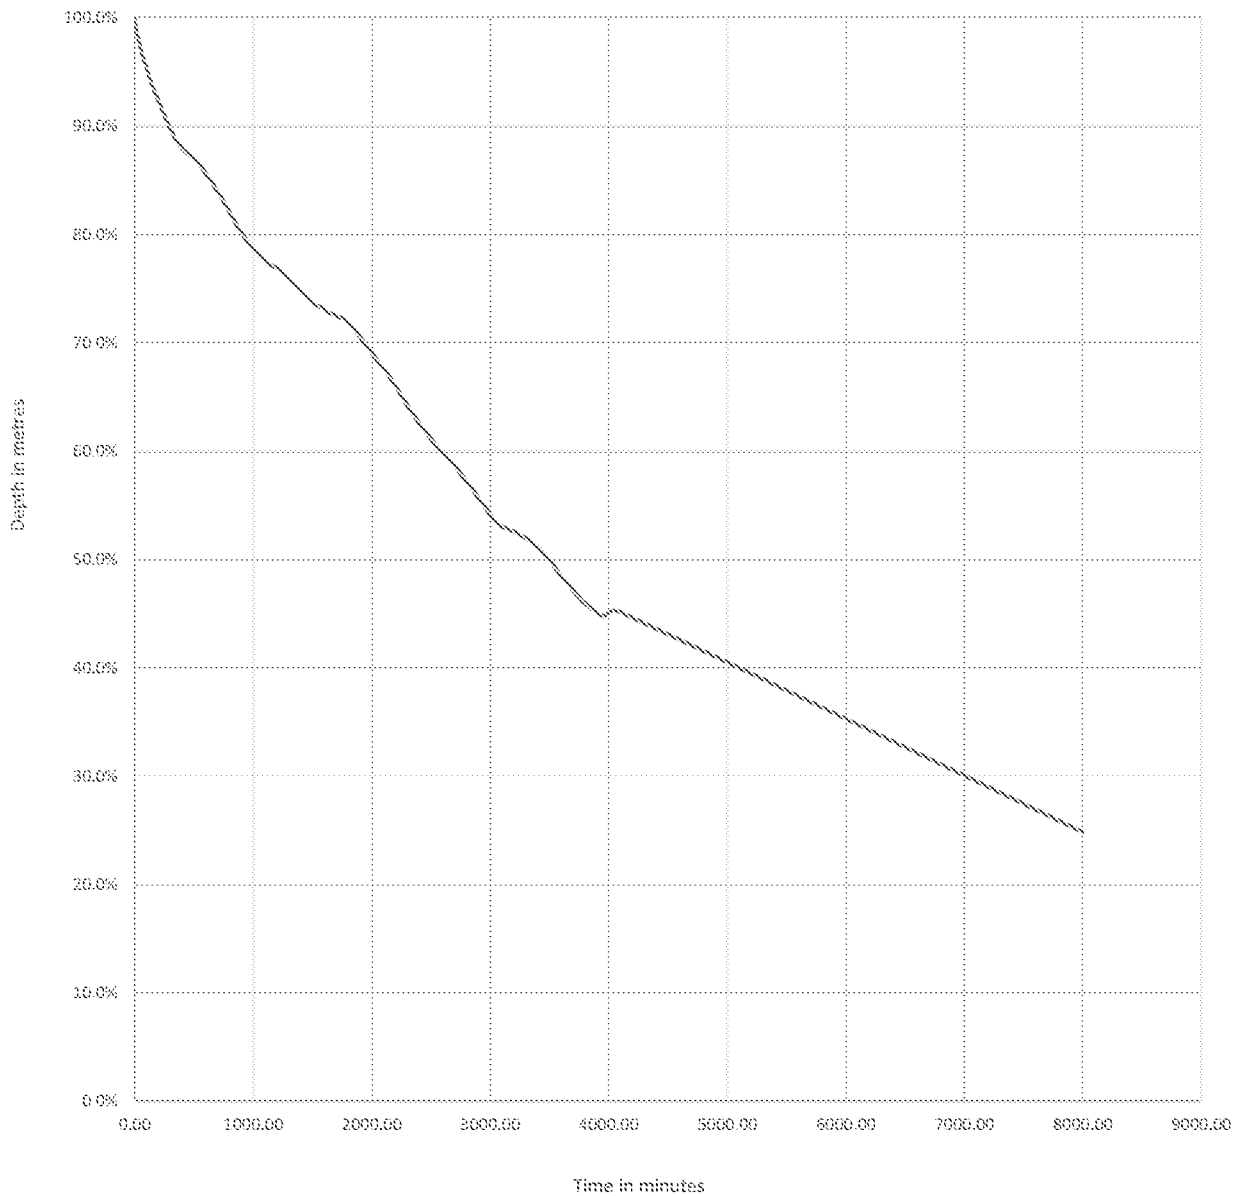
Trial Hole: TP2

\*estimated from graph. use with caution

3.50952E-07
