# Arboricultural Impact Assessment

43-45 Pevensey Road  
Bognor Regis  
West Sussex  
PO21 5NY

9<sup>th</sup> August 2017

PJC ref: 4524/17-02

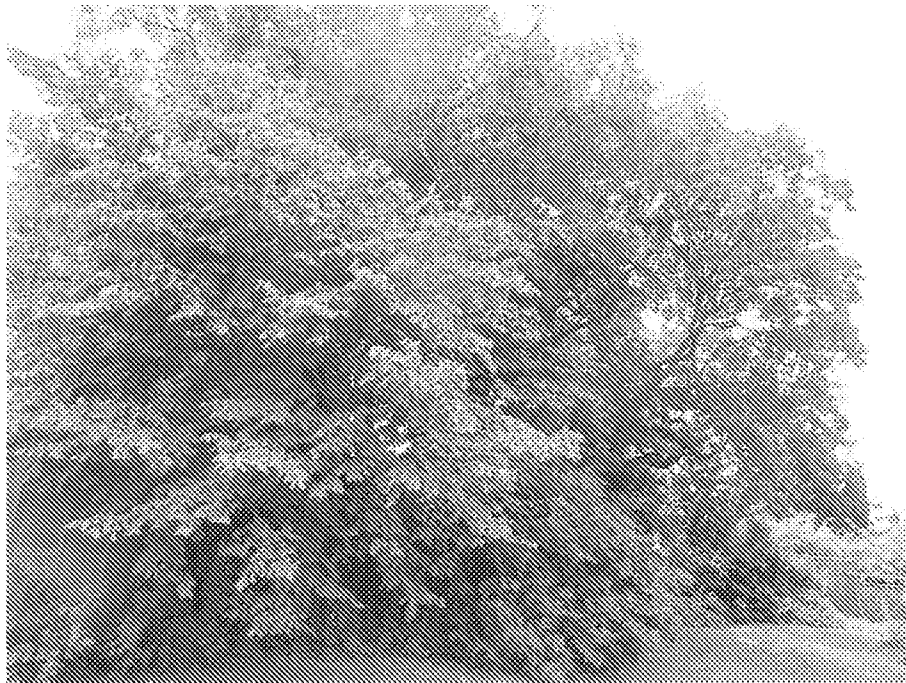
**Photograph 1 – Trees T1, T2 and T4**

| | | | | Client: Mr John Parsons<br>Site: 43-45 Pevensey Road, Bognor Regis<br>Survey date: 13/07/2017<br>Surveyor: Peter Davies | | | | | | | T: Individual tree or shrub<br>G: Group of 2 or more trees<br>H: Hedgerow<br>W: Woodland block | | |
|---|---|---|---|---|---|---|---|---|---|---|---|---|---|
| T1 | Field maple (Acer campestre) | 10 | 500 est | N: 5<br>E: 3<br>S: 4<br>W: 4 | Crown: 0 south<br>Branch: 3 south | Over mature | Good | Fair | Previously crown lifted. North lean to 3m. Stem straddles boundary fence. Elder under-storey inhibits inspection. | No action required. | B2 | 113.1 | 6.0 |
| T2 | Ash (Fraxinus excelsior) | 12 | 450, 400, 150 est | N: 4<br>E: 5<br>S: 5<br>W: 3 | Crown: 7 west<br>Branch: 2 average | Mature | Fair | Fair | Third party tree only viewed from site. Multi-stemmed. Decay cavity in main stem. Minor crown dieback. | TPO - No action required. | C2 | 174.2 | 7.4 |
| T4 | Hazel (Corylus avellana) | 7 | 100 average x6 stems | N: 5<br>E: 4<br>S: 3<br>W: 3 | Crown: 0 north<br>Branch: N/A | Mature | Good | Fair | Third party shrub overhanging site boundary. Ivy clad. | Reduce over site by 2m on north side of crown. | C2 | 27.1 | 2.9 |

| Tree number | Species | Works required | Reason for works |
|---|---|---|---|
| T4 | Hazel | Reduce crown over site by 2m on north side. | To increase usable garden space and reduce shade to dwelling in plot 4. |

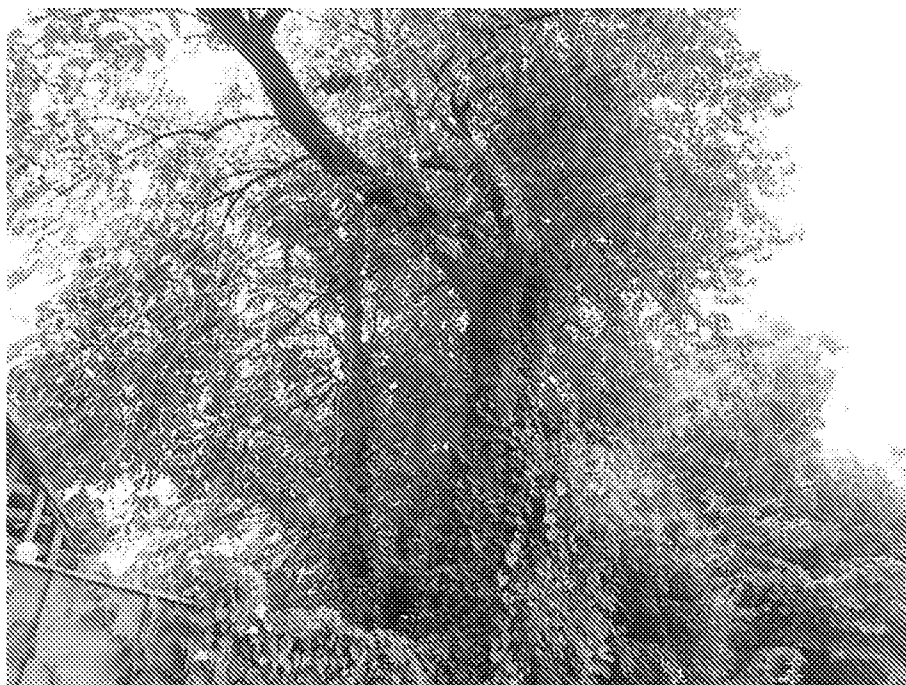
**Photograph 2 – Trees T11-T12**

**4.9 Post development tree pressures and management:** Tree T11 has historically been heavily reduced over the site, leaving almost no crown overhanging the proposed parking bays. Continuation of this process (ensuring all future pruning cuts comply with recommendations in BS3998: 2010) will minimise any potential nuisance from leaf detritus or honeydew on parked cars.

| | | | | Client: Mr John Parsons<br>Site: 43-45 Pevensey Road, Bognor Regis<br>Survey date: 13/07/2017<br>Surveyor: Peter Davies | | | | | | | T: Individual tree or shrub<br>G: Group of 2 or more trees<br>H: Hedgerow<br>W: Woodland block | | |
|---|---|---|---|---|---|---|---|---|---|---|---|---|---|
| T11 | Cherry (Prunus avium) | 10 | 560 over ivy | N: 5<br>E: 5<br>S: 4<br>W: 2 | Crown: 2 east<br>Branch: 4 east | Mature | Good | Fair | Stem straddles boundary and is ivy clad. Previously heavily reduced over site. | Sever ivy around stem (above fence). | B2 | 141.9 | 6.7 |
| T12 | Walnut (Juglans regia) | 12 | 300, 450 est | N: 3<br>E: 4<br>S: 4<br>W: 3 | Crown: 1 average<br>Branch: 1 average | Mature | Good | Fair | Third party tree only viewed from site. 1x stem failed/pollarded. | TPO - No action required. | B1/2 | 140.9 | 6.7 |

| Tree number | Species | Works required | Reason for works |
|---|---|---|---|
| T11 | Cherry | Sever ivy around stem (above fence). | To allow comprehensive future tree inspections. |

**4.6** Four new parking bays will be constructed within the root protection areas of trees T11 and T12 in the area highlighted purple in the Tree Retention Plan. In order that both the tree roots and rooting medium are not damaged during construction of this surface, or post development, the four parking bays shall be constructed to the following specification:

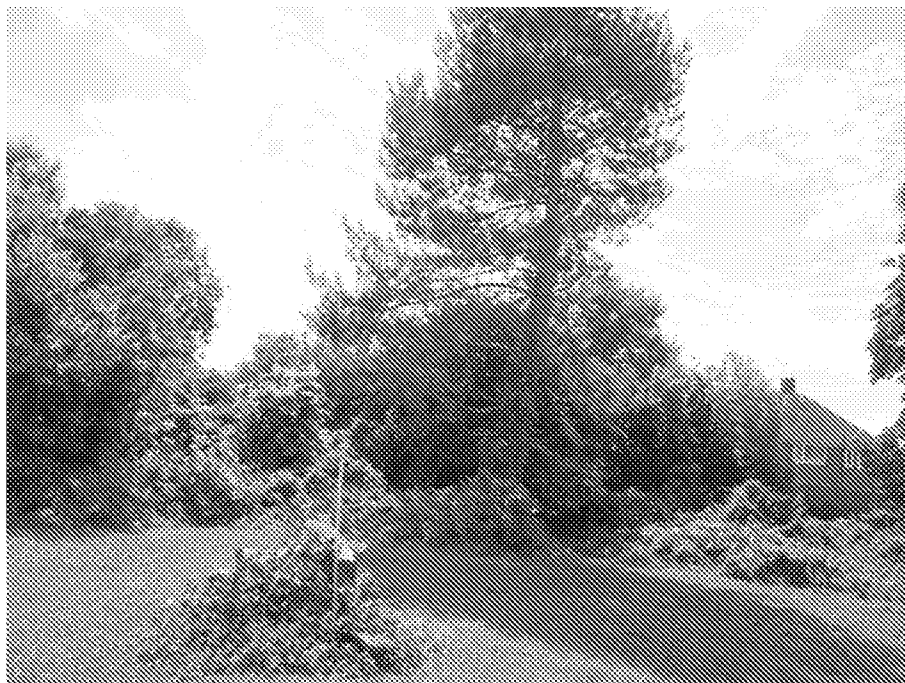
**Photograph 3 – Tree T13, T14 and T16**

4.11 Tree T13 and T14 are located to the south of the dwelling in plot 2. T14 (hazel) is only 7m in height and located 15m from the house. It is not expected to increase significantly in height, therefore will not pose a shading constraint. T13 is a mature Scots pine, and will cast shade onto the dwelling for part of the day. Given the species, adequate levels of natural light should be able to penetrate the crown of T13 to allow reasonable use and enjoyment of the property without regular applications to undertake crown reductions or remove the tree.

| | | | | Client: Mr John Parsons<br>Site: 43-45 Pevensey Road, Bognor Regis<br>Survey date: 13/07/2017<br>Surveyor: Peter Davies | | | | | | T: Individual tree or shrub<br>G: Group of 2 or more trees<br>H: Hedgerow<br>W: Woodland block | | | |
|---|---|---|---|---|---|---|---|---|---|---|---|---|---|
| T13 | Scots pine ( <i>Pinus sylvestris</i> ) | 16 | 600 over ivy | N: 4<br>E: 5<br>S: 4<br>W: 3 | Crown: 4 east<br>Branch: 5 east | Mature | Good | Good | Ivy clad stem. Deadwood in lower crown. No major visible defects. | TPO - Remove deadwood for aesthetics. Sever ivy around base. | B1 | 162.9 | 7.2 |
| T14 | Hazel ( <i>Corylus avellana</i> ) | 7 | 50 average x25 stems est | N: 5<br>E: 4<br>S: 3<br>W: 4 | Crown: 1 average<br>Branch: 0 average | Early mature | Good | Fair | Typical example of species. | Crown lift/coppice stems as required to allow installation of garden fence. | C1 | 28.3 | 3.0 |
| T16 | Ash ( <i>Fraxinus excelsior</i> ) | 9 | 340 | N: 4<br>E: 3<br>S: 3<br>W: 3 | Crown: 1 north<br>Branch: 1 north | Early mature | Good | Good | Reasonable form. Small deadwood due to suppression. No major visible defects. | No action required. | B1/2 | 52.3 | 4.1 |

| Tree number | Species | Works required | Reason for works |
|---|---|---|---|
| T13 | Scots pine | Remove deadwood and sever ivy around base. | To improve aesthetics of tree and due to the increased frequency of use within trees target area. |
| T14 | Hazel | Crown lift or coppice stems over new garden boundary. | To create adequate clearance to construct new garden fence. |

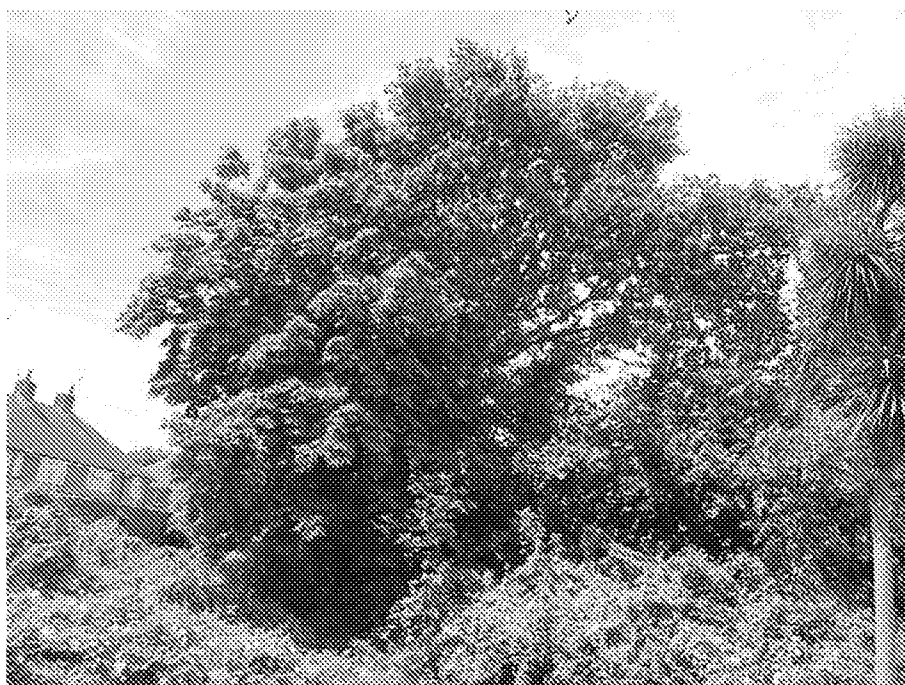
**Photograph 4 – Trees T19-T20**

4.12 Trees T19 (horse chestnut) and T20 (oak) are located to the south-west of the houses in plots 1 and 2. They are situated a suitable distance away from the houses that it is not expected they will create more than a minor shading constraint for a short period of the day.

| | | | | Client: Mr John Parsons<br>Site: 43-45 Pevensey Road, Bognor Regis<br>Survey date: 13/07/2017<br>Surveyor: Peter Davies | | | | | | | T: Individual tree or shrub<br>G: Group of 2 or more trees<br>H: Hedgerow<br>W: Woodland block | | |
|---|---|---|---|---|---|---|---|---|---|---|---|---|---|
| T19 | Horse chestnut (Aesculus hippocastanum) | 15 | 390, 260, 330, 410 over ivy | N: 4<br>E: 6<br>S: 5<br>W: 5 | Crown: 1 east<br>Branch: 1 south | Mature | Good | Good | Multi-stemmed from 1m. Ivy clad stem. Leaf miner moth. No major visible defects. | Sever ivy around base. | B1/2 | 224.7 | 8.5 |
| T20 | Pedunculate oak (Quercus robur) | 17 | 700 over ivy | N: 7<br>E: 4<br>S: 2<br>W: 5 | Crown: 4 north<br>Branch: 2 north | Mature | Good | Good | Crown bias north due to suppression from T19. Ivy inhibits inspection. Crown lifted over neighbours garden. | TPO - Sever ivy around base. | B1 | 221.7 | 8.4 |

| Tree number | Species | Works required | Reason for works |
|---|---|---|---|
| T19 | Horse chestnut | Sever ivy around base of stem. | To allow comprehensive future tree inspections. |
| T20 | Oak | Sever ivy around base of stem. | To allow comprehensive future tree inspections. |

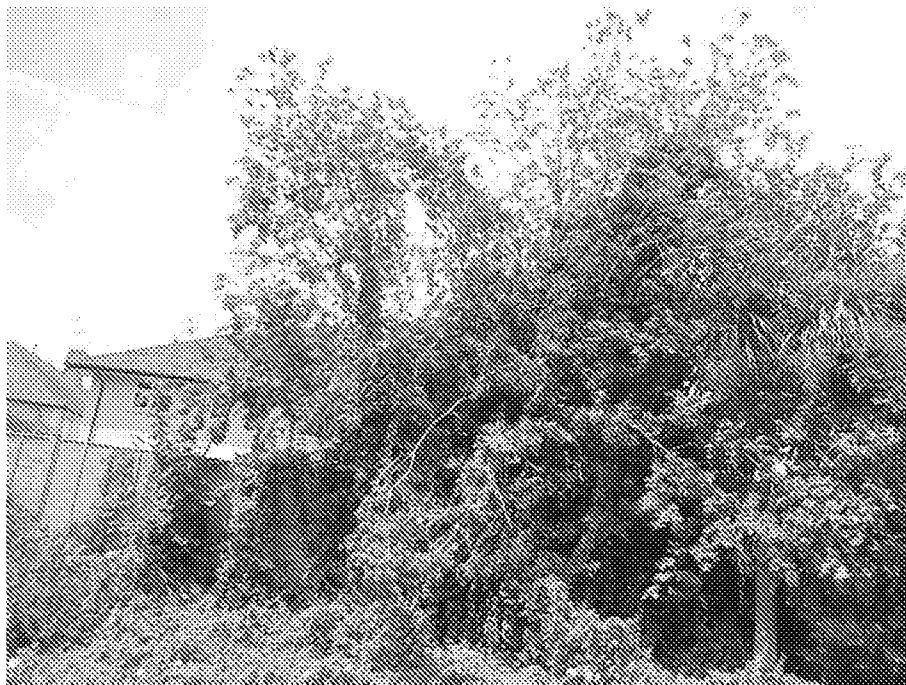
**Photograph 5 – Trees G22-T23**

| | | | | Client: Mr John Parsons<br>Site: 43-45 Pevensey Road, Bognor Regis<br>Survey date: 13/07/2017<br>Surveyor: Peter Davies | | | | | | | T: Individual tree or shrub<br>G: Group of 2 or more trees<br>H: Hedgerow<br>W: Woodland block | | |
|---|---|---|---|---|---|---|---|---|---|---|---|---|---|
| G22 | Field maple (Acer campestre) | 6-8 average | Up to 150 average est | 2 average | 1-3 average | Semi mature | Fair | Poor | Dense ivy and bindweed prevent thorough inspection. Some crown dieback and small split limbs. | No action required on date of survey. | C2 | 10.2 average | 1.8 average |
| T23 | Yucca (Yucca spp.) | 5 | 210 | N: 1<br>E: 2<br>S: 2<br>W: 1 | Crown: 3 average<br>Branch: N/A | Early mature | Good | Fair | Typical example of species. Crown encroached by field maple and hazel. | Fell to ground level and remove stump. | C1 | 20.0 | 2.5 |
